CITY OF CARSON

PLANNING COMMISSION STAFF REPORT

PUBLIC HEARING: June 10, 2008
SUBJECT: Conditional Use Permit No. 700-08
APPLICANT: Guy L. Andriole
3120 San Anseline
Long Beach, CA 90808
REQUEST: To approve a Conditional Use Permit for an existing legal non-conforming second dwelling located within the RS (Residential, Single Family) zone district
PROPERTY INVOLVED: 2600 E. Jefferson Street

Property Inspection Report

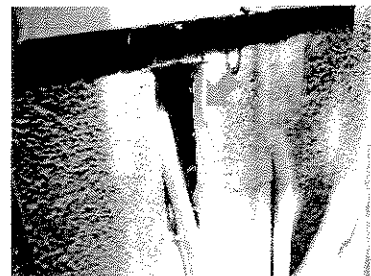
STUCCO SIDING: [CR] There were cracks/holes in the stucco siding. These conditions are conducive to moisture intrusion/deterioration. We recommend further evaluation and corrections by a specialist in the appropriate trade prior to the close of escrow..(bel.ow electrical panel), (see photo in body of the report)

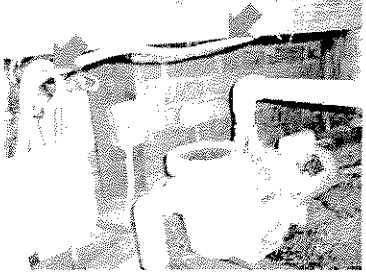
- EXT ELECTRICAL:** [SC] One or more of the following covers were damaged and/or missing switch. We recommend further evaluation of the conditions noted by a specialist in the appropriate trade prior to the close of escrow. We recommend correcting the condition(s) noted by using a specialist in the appropriate trade prior to the close of escrow.(near pool entry)
[CR] [SC] There is improper wiring in the form of nonmetallic wiring exposed to human contact and/or mechanical damage. We recommend further evaluation of the conditions noted by a specialist in the appropriate trade prior to the close of escrow.
We recommend correcting the condition(s) noted by using a specialist in the appropriate trade prior to the close of escrow. (see photo in body of the report)

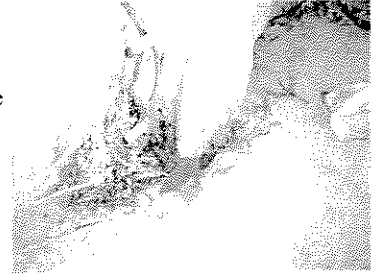
PATIO COVERS: [FE] Damaged/deteriorated wood noted on the patio cover at the following locations; roof sheathing, We recommend further evaluation and corrections by a specialist in the appropriate trade.(side of rear house) [CR] Numerous post are rotted and in need of replacement at the patio cover over the car port. (see photo in body of the report)

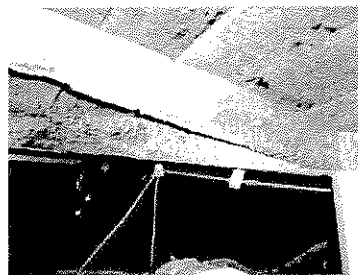
ACCESS: The inspection of the attic space was conducted from the opening only due to limited access.
FRAMING: [FE] The roof framing showed evidence of fire damage. The correction(s) and/or replacement of damaged materials appeared satisfactory. We recommend inquiring for further information regarding the condition and permits and inspections for the correction(s).(front house)

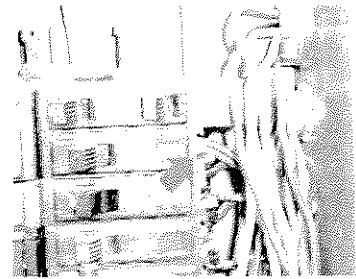
WORKMANSHIP: [SC] Double lugging was noted at the circuit breaker(s) in the panel. We recommend further evaluation and correction by a specialist in the appropriate trade. (see photo in body of the report) (front house)

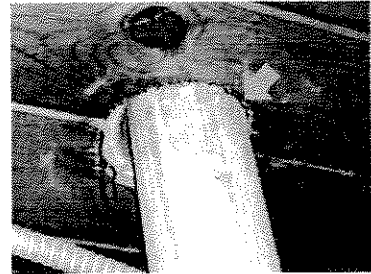
[SC] The flue vent piping was close to or in contact with combustible materials, this condition is a fire hazard. We recommend correcting the condition(s) noted. (rumpus room) (see photo in body of the report)

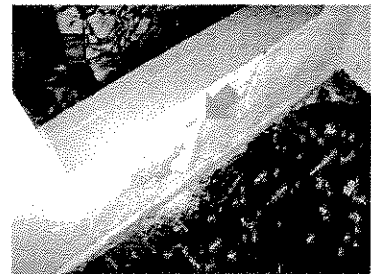
WALLS/CEILING: [CR] Damage was noted on the wall(s)/ceiling. We recommend correcting the condition(s) noted.(behind toilet and at shower base) (see photo in body of the report)

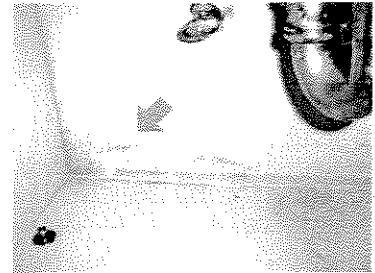
WALLS/CEILING: [FE] [CR] There were signs of what appears to be mold growth. We recommend having this area tested. Contact your building inspector for further information. (under sink walls), (see photo in body of the report)

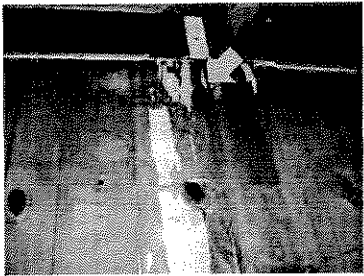
- WALLS/CEILING:** [CR] Moisture stains were noted on the wall(s)/ceiling. We recommend locating and correcting the source and any damaged materials. The area tested dry during the inspection. We recommend locating and correcting the source and any damaged materials. [CR] Damage was noted on the wall(s)/ceiling. We recommend correcting the condition(s) noted. (see photo in body of the report)
