## CITY OF CARSON

### PLANNING COMMISSION STAFF REPORT

PUBLIC HEARING: April 27, 2010  
SUBJECT: Conditional Use Permit No. 757-09  
APPLICANT: Willie Quiday  
On behalf of Juan Lagmay, Sr.  
608 W. 230<sup>th</sup> Street  
Carson, CA 90745

# Property Inspection Report

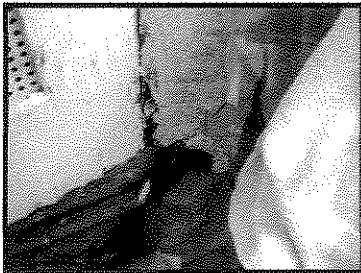
1. The stucco siding appeared serviceable, with minor cracking and common signs of aging/wear, no action needed at this time. with exceptions noted.
  - a. [CR] The stucco siding was damaged/deteriorated at the rear of the building. These conditions are conducive to moisture intrusion/deterioration. We recommend correcting the condition(s) noted by using a specialist in the appropriate trade prior to the close of escrow. rear.

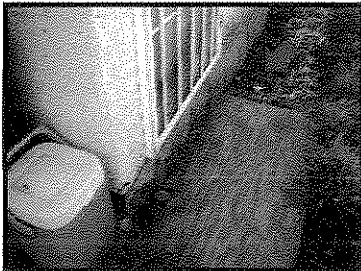
2. The doors viewed from the exterior appeared serviceable. No action needed at this time. with exceptions noted.
  - a. [CR] The rear door of the left unit has no step outside the door. We recommend repair.

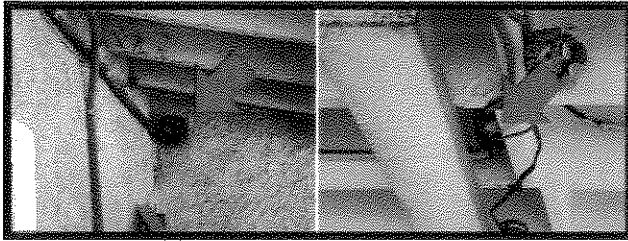
3. [SC] One or more of the following covers were damaged and/or missing receptacle. We recommend correcting the conditions noted by using a specialist in the appropriate trade prior to the close of escrow.(rear junction box)

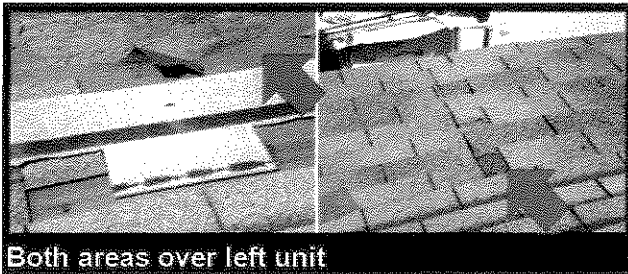
Both areas over left unit

4. [CR] [FE] There is a section(s) of the roofing surface that is damaged and in need of further evaluation and repair.

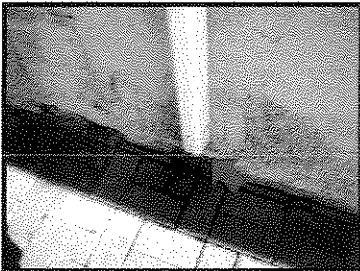
5. [CR] Runoff water from the roof discharged next to the building. We recommend the downspouts be routed sufficiently away from the building to prevent ponding, pooling, and saturation of the soil at the foundation.(front)

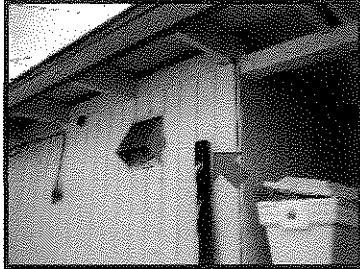
6. The visible areas of the vent pipes appeared serviceable. with exceptions noted.  
a. The vent piping was too short and is in need of repair or replacement. (rear)

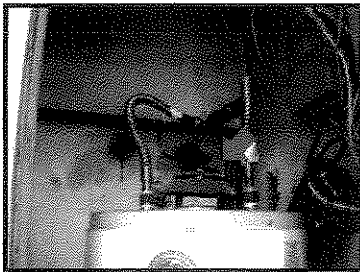
8. [SC] The flue vent pipe was disconnected. We recommend correcting the condition(s) noted.(missing from both units)

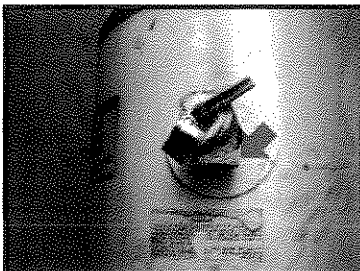
9. [SC] The temperature & pressure relief valve was leaking water from the discharge line. We recommend replacing the valve and installing an approved discharge line that extends to the exterior and terminates close to the ground facing downward.(left unit), [SC] The temperature & pressure relief valve's discharge line was missing. We recommend installing an approved discharge line that extends to the exterior and terminates close to the ground facing downward.(both)

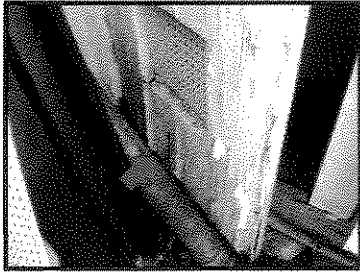
10. [CR] The enclosure door is damaged and is need of repair or replacement.

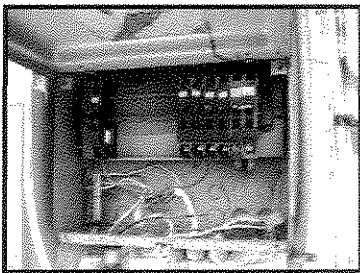
11. [SC] The protective "dead front" cover was missing from the panel. We recommend correcting the condition(s) noted.

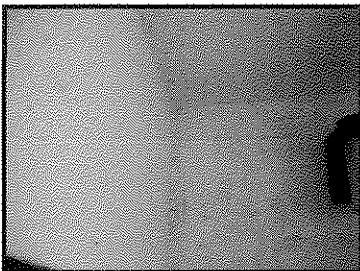
13. [CR] Moisture stains and damage were noted on the wall(s)/ceiling. The area tested wet during the inspection. We recommend locating correcting the source and any damaged materials. [FE] [CR] There were signs of what appears to be mold growth. We recommend having this area tested. Contact your building inspector for further information. (walls)

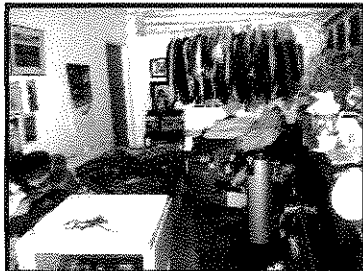
20. [CR] The garage was being used as a living area. There was no ability to park a car in this garage. Much of this area was inaccessible due to personal belongings. The door could not be tested as it was blocked by personal belongings recommend further inspection once all the belongings are removed.

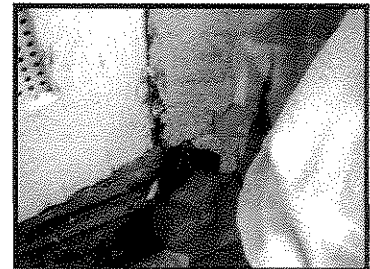
a. [CR] The stucco siding was damaged/deteriorated at the rear of the building. These conditions are conducive to moisture intrusion/deterioration. We recommend correcting the condition(s) noted by using a specialist in the appropriate trade prior to the close of escrow. rear.

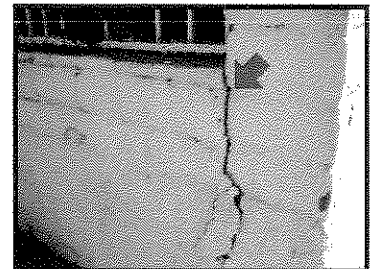
[CR] The block walls were damaged/deteriorated at the front left of the building. These conditions are conducive to moisture intrusion/deterioration. We recommend correcting the condition(s) noted by using a specialist in the appropriate trade prior to the close of escrow.

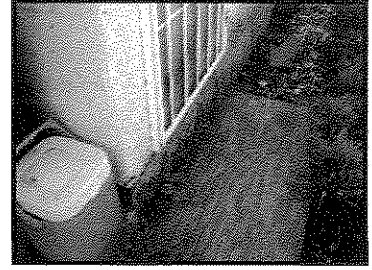
The doors viewed from the exterior appeared serviceable. No action needed at this time. with exceptions noted.  
a. [CR] The rear door of the left unit has no step outside the door. We recommend repair.

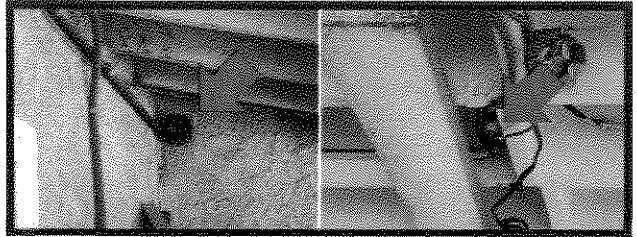
[SC] One or more of the following covers were damaged and/or missing receptacle. We recommend correcting the conditions noted by using a specialist in the appropriate trade prior to the close of escrow.(rear junction box)

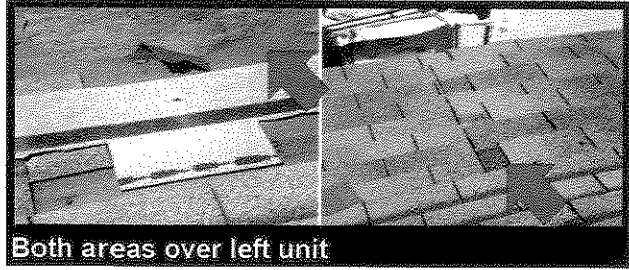
[CR] [FE] There is a section(s) of the roofing surface that is damaged and in need of further evaluation and repair.

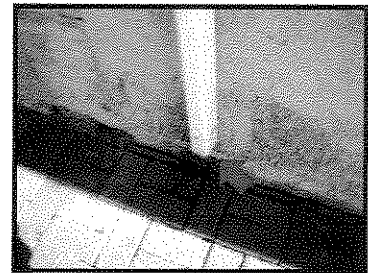
[CR] Runoff water from the roof discharged next to the building. We recommend the downspouts be routed sufficiently away from the building to prevent ponding, pooling, and saturation of the soil at the foundation.(front)

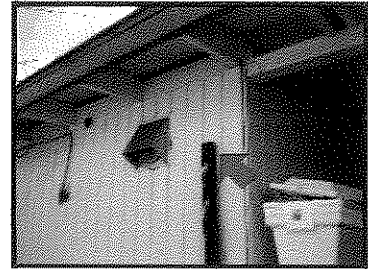
- a. The vent piping was too short and is in need of repair or replacement. (rear)

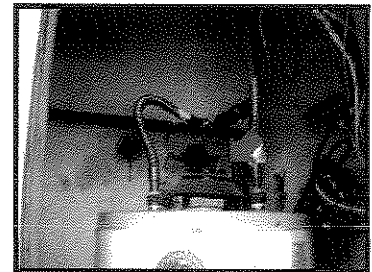
[SC] The flue vent pipe was disconnected. We recommend correcting the condition(s) noted.(missing from both units)

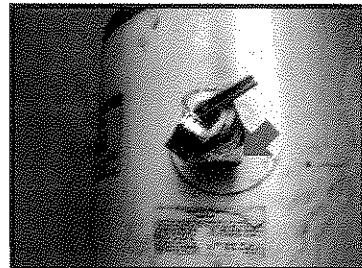
[SC] The temperature & pressure relief valve was leaking water from the discharge line. We recommend replacing the valve and installing an approved discharge line that extends to the exterior and terminates close to the ground facing downward.(left unit), [SC] The temperature & pressure relief valve's discharge line was missing. We recommend installing an approved discharge line that extends to the exterior and terminates close to the ground facing downward.(both)

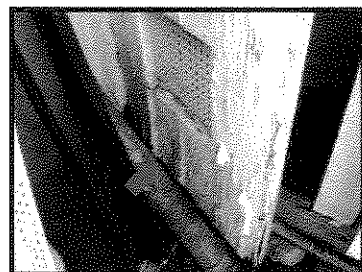
[CR] The enclosure door is damaged and is need of repair or replacement.

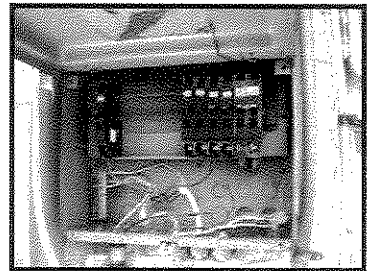
[SC] The protective "dead front" cover was missing from the panel. We recommend correcting the condition(s) noted.

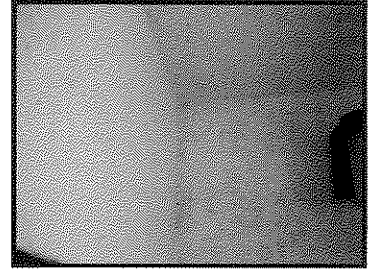
[CR] Moisture stains and damage were noted on the wall(s)/ceiling. The area tested wet during the inspection. We recommend locating correcting the source and any damaged materials. [FE] [CR] There were signs of what appears to be mold growth. We recommend having this area tested. Contact your building inspector for further information. (walls)

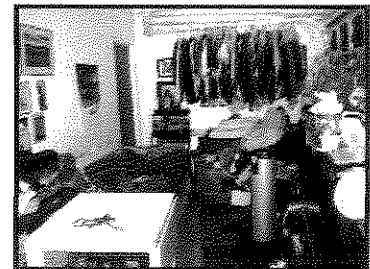
[CR] The garage was being used as a living area. There was no ability to park a car in this garage. Much of this area was inaccessible due to personal belongings. The door could not be tested as it was blocked by personal belongings recommend further inspection once all the belongings are removed.

Conditions of approval added to require the existing unpermitted garage conversion to be brought back into compliance with applicable municipal codes, and that the existing unpermitted carport structure be removed.
