CITY OF CARSON

PLANNING COMMISSION STAFF REPORT

SUBJECT: Conditional Use Permit No. 784-10

Property Inspection Report

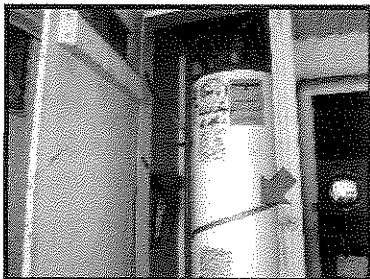
2. [SC] The water heater seismic strapping was installed in a manner that did not meet the State Architect's requirements or the water heater strapping kit manufacturers instructions. The intent is for the water heater to resist movement. We recommend correcting the condition(s) noted.

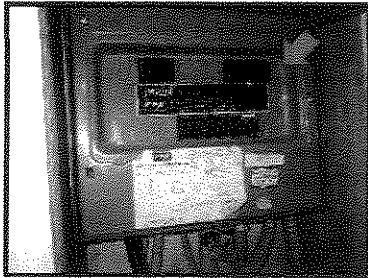
3. [SC] The buildings main electrical service panel was manufactured by Federal Pacific / Stab-Lok. This panel has been known to present latent hazards by malfunctioning under certain conditions resulting in jammed circuit breakers. The breakers may not trip (disconnect) under imposed load conditions. Failure can also occur at the connections to the bus bars due to inadequate bending space for the service entrance conductors. We recommend further evaluation by a specialist in the appropriate trade. [SC] There were missing twist-outs/unused breaker slots in the panel. This condition is a safety hazard. We recommend correcting the condition(s) noted.

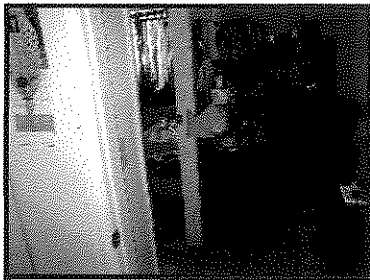
13. [CR] [SC] This bedroom only had one door. This door led to the adjoining bedroom, which led to the kitchen. This is a safety hazard. This bedroom should lead directly to a hallway or common area not to another bedroom. We recommend reconfiguration.

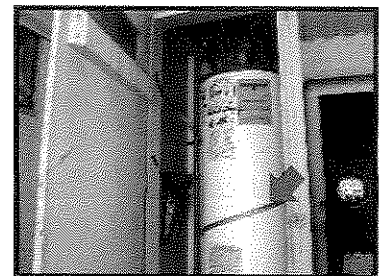
[SC] The water heater seismic strapping was installed in a manner that did not meet the State Architect's requirements or the water heater strapping kit manufacturers instructions. The intent is for the water heater to resist movement. We recommend correcting the condition(s) noted.

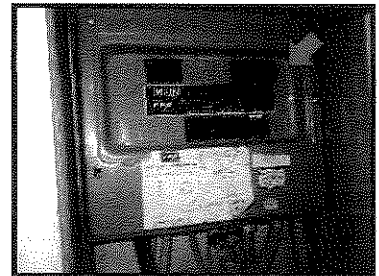
[SC] The buildings main electrical service panel was manufactured by Federal Pacific / Stab-Lok. This panel has been known to present latent hazards by malfunctioning under certain conditions resulting in jammed circuit breakers. The breakers may not trip (disconnect) under imposed load conditions. Failure can also occur at the connections to the bus bars due to inadequate bending space for the service entrance conductors. We recommend further evaluation by a specialist in the appropriate trade. [SC] There were missing twist-outs/unused breaker slots in the panel. This condition is a safety hazard. We recommend correcting the condition(s) noted.

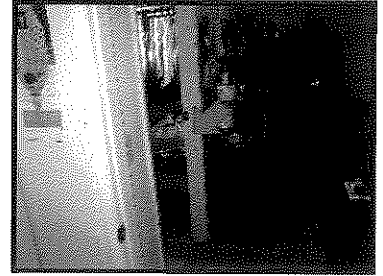
[CR] [SC] This bedroom only had one door. This door led to the adjoining bedroom, which led to the kitchen. This is a safety hazard. This bedroom should lead directly to a hallway or common area not to another bedroom. We recommend reconfiguration.
