CITY OF CARSON

PLANNING COMMISSION STAFF REPORT

PUBLIC HEARING: June 22, 2010
SUBJECT: Conditional Use Permit No. 786-10
APPLICANT: Jose R. Hernandez
433 and 435 E. Pacific Street
Carson, CA 90745
REQUEST: To approve a conditional use permit for a second dwelling located within the RS (Residential, Single Family) zoning district
PROPERTY INVOLVED: 433 and 435 E. Pacific Street

Property Inspection Report

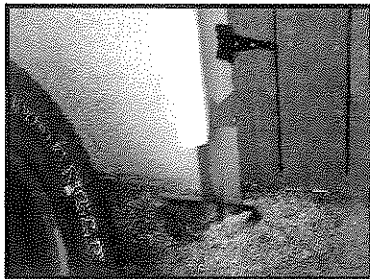
2. [CR] Runoff water from the roof discharged next to the building. We recommend the downspouts be routed sufficiently away from the building to prevent ponding, pooling, and saturation of the soil at the foundation.

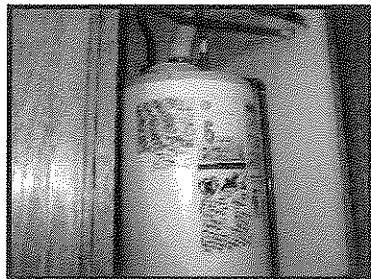
3. [SC] The water heater was not double strapped and stabilized/blocked as required by the State Architect to resist movement. We recommend correcting the condition(s) noted.

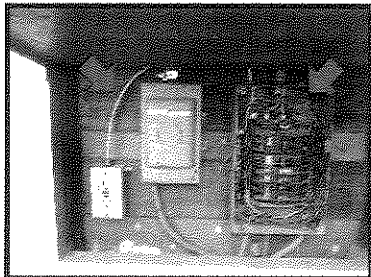
5. [SC] The protective "dead front" cover was missing from the panel. There is also exposed Romex to the left of the main fused shut off. We recommend correcting the condition(s) noted.

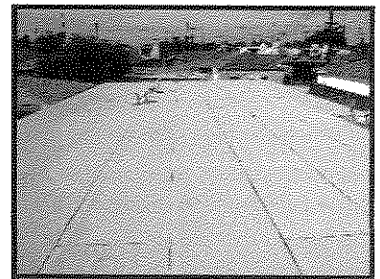
built-up with a cap sheet surface.

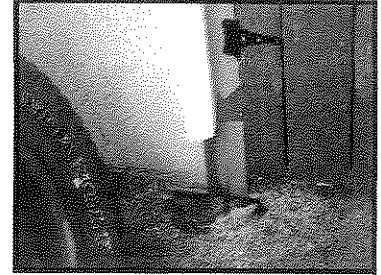
[CR] Runoff water from the roof discharged next to the building. We recommend the downspouts be routed sufficiently away from the building to prevent ponding, pooling, and saturation of the soil at the foundation.

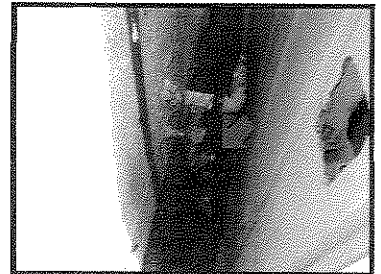
The main water shutoff valve was located at the rear of the building.

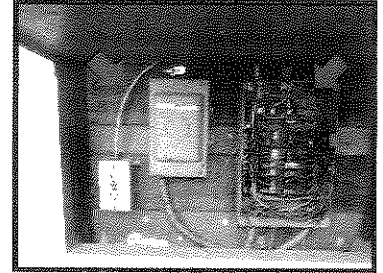
[SC] The protective "dead front" cover was missing from the panel. There is also exposed Romex to the left of the main fused shut off. We recommend correcting the condition(s) noted.
