CITY OF CARSON

PLANNING COMMISSION STAFF REPORT

SUBJECT: Conditional Use Permit No. 820-10

Home Inspection Report

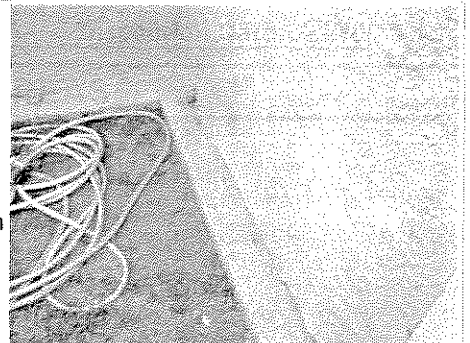
102 EXTERIOR

[FE] Concrete curbs (sometimes called "Flash Walls") were installed around the outside of the foundation in some areas. The foundation in these areas was not visible due to these curbs. Flash walls are typically installed upon the recommendation of a pest control operator (termite inspector) when there is insufficient clearance between the soil level and the wood framing/finish. Over time, flash walls often become separated from the building which can allow moisture intrusion into concealed spaces. These conditions were noted at this property. Options may include removal of the flash walls and regrading of the external soil to maintain the proper soil to wood clearance, or repair and maintenance of the flash walls. We recommend inquiring with the owner as to the history of this condition, and/or a full evaluation and/or corrections by a specialist in the appropriate trade.

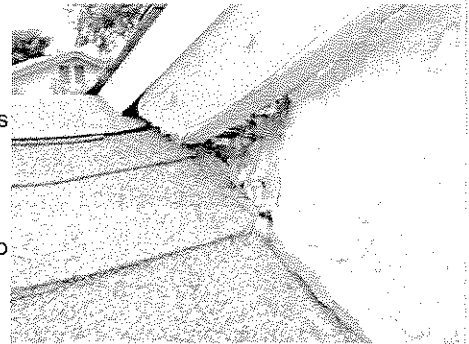
[NOTE] This building was built in an era before weep screeds were installed at the bottom edge of the stucco siding, the stucco was extended into the soil in some areas. The stucco wicks water up out of the soil which causes it to deteriorate from being moist for prolonged periods. We recommend minimizing moisture around the building to help protect the stucco and the foundation from moisture damage.

[NOTE] Past repairs were noted to the stucco wall surface(s). We recommend inquiring with the owner as to the history of this condition.

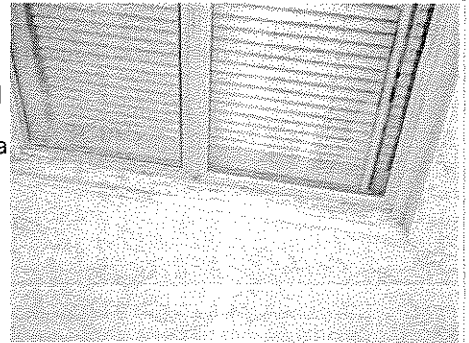
240 EXTERIOR TRIM

a. [CR] Flaking paint was noted at the window and door exterior trim. We recommend removing any loose paint and repainting these areas to maintain a weather proof surface on the wood trim.

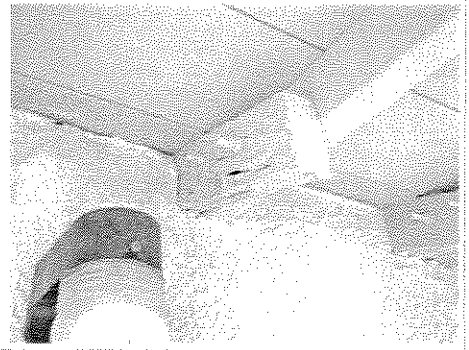
a. [FE] There were damaged/deteriorated eave and soffit materials noted at the front of the house. We recommend a full evaluation and/or corrections by a specialist in the appropriate trade.

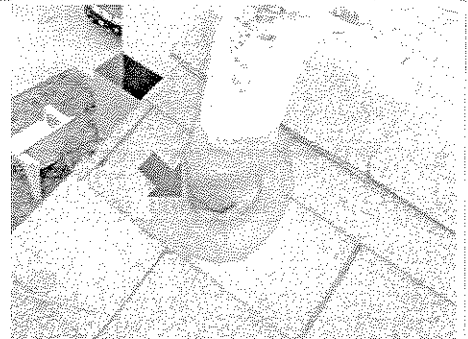
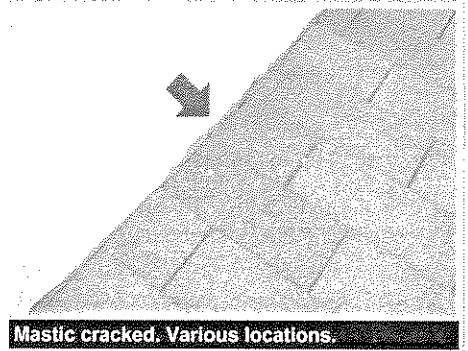
316 FLASHING(S)

[CR] The mastic used to seal some of the roof connections and penetrations was cracked. We recommend correcting the condition(s) noted using approved methods.

Mastic cracked. Various locations.

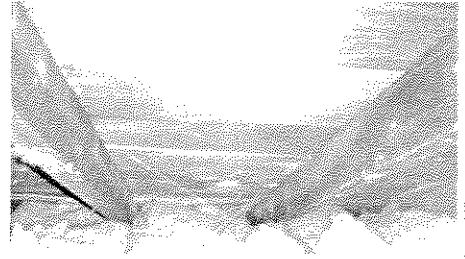
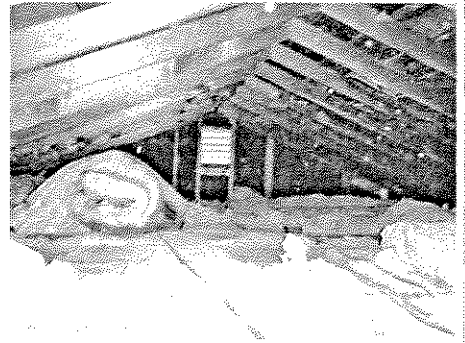
a. [FE] There was evidence of damaged wood framing in the attic at some of the rafters and sheathing. We recommend confirming that this area is identified on the termite inspection report. The termite inspection report will make recommendations for repairs or remediation necessary for damaged wood.

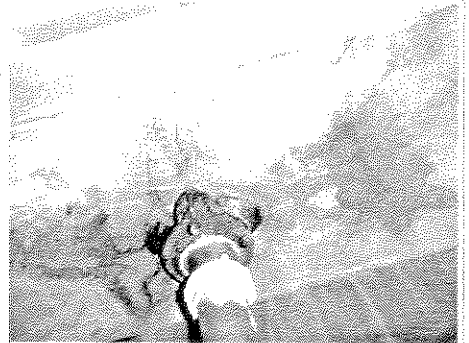
512 SINK(S)

The visible and accessible sinks appeared functional, with exceptions noted.
a. [CR] The laundry sink was cracked and leaking.
We recommend correcting the condition(s) noted.

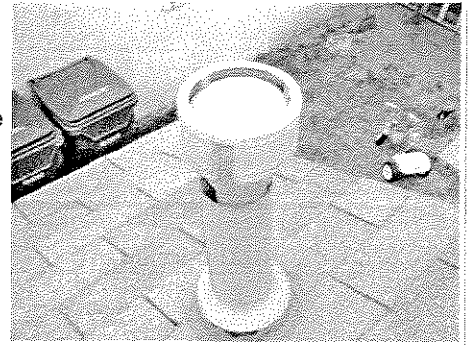
531 VENTING SYSTEM(S)

[SC] The exhaust from the water heater was spilling out the draft hood. We recommend correcting the condition(s) noted.
[NOTE] Roofing inspection revealed an oversized flue pipe cap blocking the flue. At the request of the client, the inspector removed the cap. We recommend installing a properly sized cap on the end of vent.

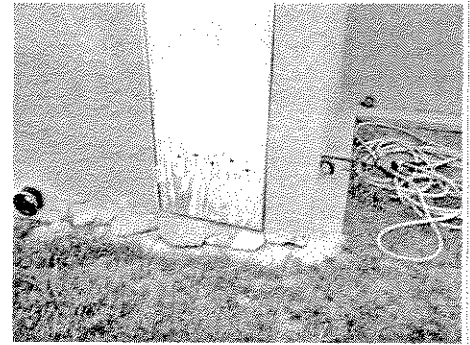
541 COMMENTS

[CR] The closet/cabinet door was damaged/deteriorated. We recommend correcting the condition(s) noted.

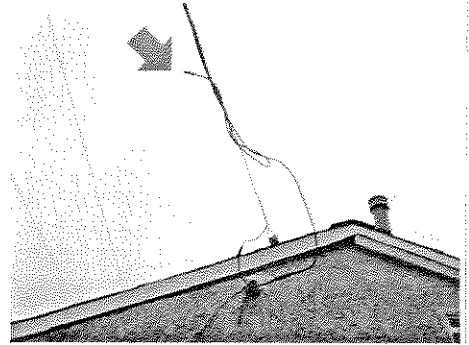
607 SERVICE WIRING

The overhead service wires and weatherhead appeared to be functional, with exceptions noted.
a. [FE] One of the current carrying conductors was not connected at the mast. This indicates that the property is provided with single phase 120V power only. This is a non-standard installation by today's standards. We recommend a full evaluation and/or corrections by a specialist in the appropriate trade.

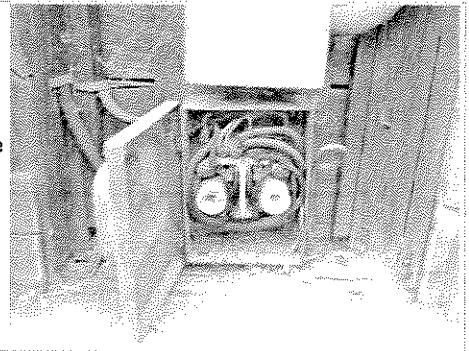
608 CAPACITY

[RU] The building's electrical service was limited to two 20-amp fused circuits, and provided with a single phase 120V power supply only. Depending upon your usage, you may find the current service to be undersized. The local electric utility company and/or a licensed electrician may be able to provide technical and cost options for upgrade if desired.

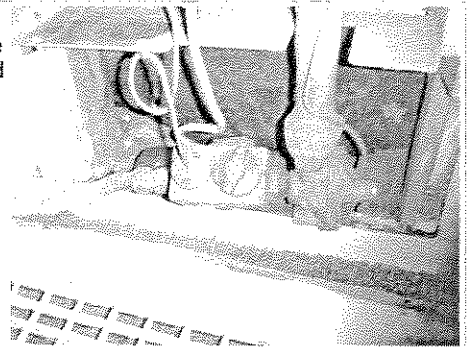
713 THERMOSTAT(S)

[RU] There was no thermostat located. The wall heater unit appears to be operated in "on-off" mode from the wall furnace control valve. We recommend installing a thermostat for improved energy efficiency and comfort.

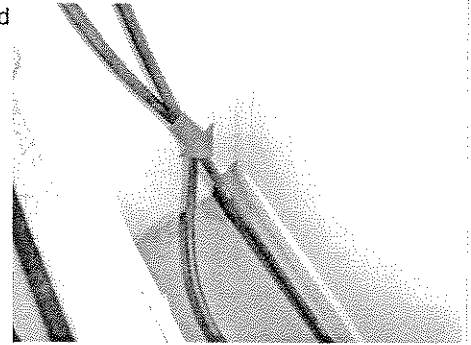
a. [CR] Damage was noted on the wall in the laundry area. We recommend correcting the condition(s) noted.

[NOTE] The ceiling height in the rear storage room did not meet current standards.
