CITY OF CARSON

PLANNING COMMISSION STAFF REPORT

PUBLIC HEARING:	January 25, 2011
SUBJECT:	Conditional Use Permit No. 846-10
APPLICANT:	Juliette Vo 4653 Carmel Mountain Road, #308-408 San Diego, CA 92130
OWNER:	SEGS LLC Attention: Suzanne E. Gornick 525 East Seaside Way, Unit 1907 Long Beach, CA 90802
REQUEST:	To approve a Conditional Use Permit for an existing second dwelling unit located within the RS (Residential, Single-Family) zoning district.
PROPERTY INVOLVED:	2661 East Adams Street
CO	MMISSION ACTION
Concurred with staff	
Did not concur with staff	
Other

Property Inspection Report

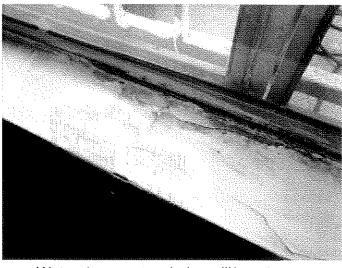
- Recommend cleaning tracts.
- Some water damage to window sill/rear house

Water damage to window sill/rear house

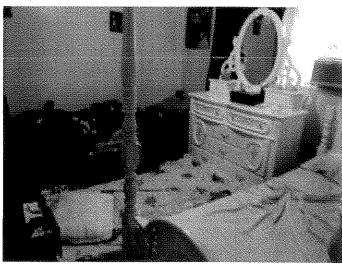
• Could not access all outlets due to beds in the northwest bedroom front house,

Could not get to all outlets

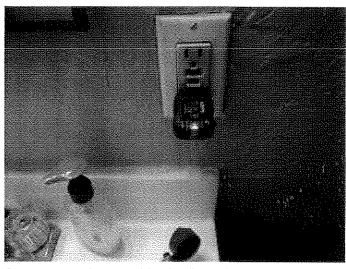
• Open grounds noted in the "rear house" bathroom.

Open grounds noted in the "rear house" bathroom.

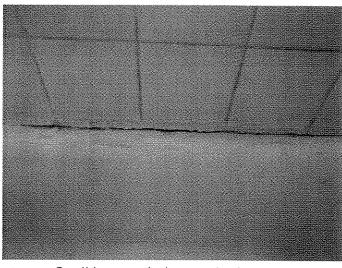
- Caulking needed around tub areas.Water damage noted. Rear house

Caulking needed around tub areas.

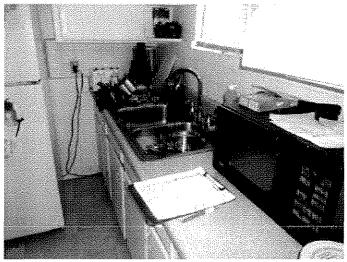
Rear house: I was not able to inspect counter tops due to dishes and stored items.

limited view

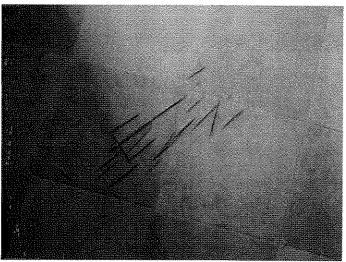
• Damage noted to floor in the front house.

Damage noted to floor in the front house.

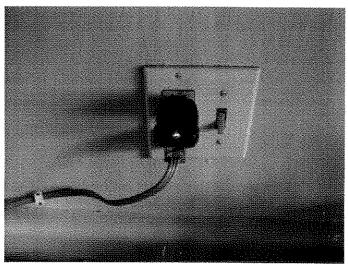
· Open ground noted in rear house.

Open ground noted in rear house.

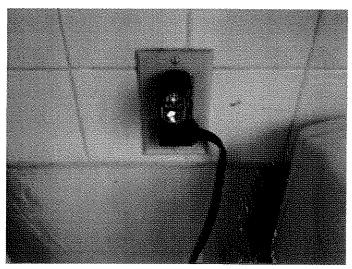
• GFCI did not respond to test. Front house

GFCI did not respond to test. Front house

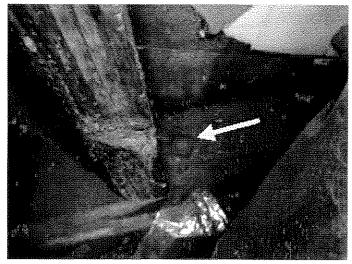
• The anchor bolte were inspected and appear to be serviceable.

The anchor bolts were inspected and appear to be serviceable.

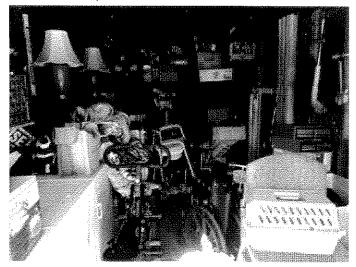
• Un able to inspected due to stored items.

Un able to inspected due to stored items.

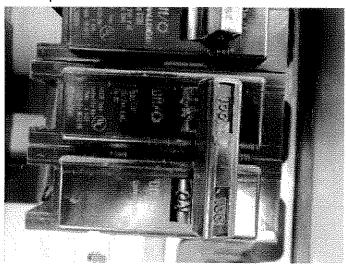
- 30 amp at rear house.
- 100 amp at front house.

100 amp at front house.

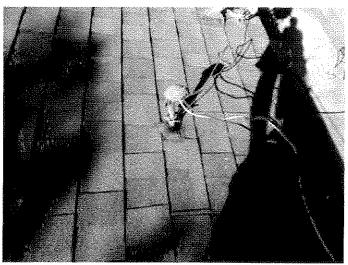
- There is an overhead service drop at both houses. No problems noted at front house.
- The rear house cable feed support has come loose. Cables are laying on roof.

The rear house cable feed support has come loose. Cables are laying on roof.

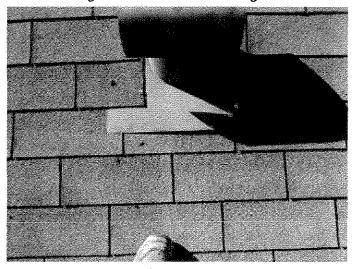
· Metal flashing on the front house. In good condition.

Metal flashing on the front house. In good condition.

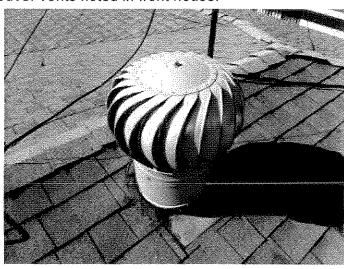
• Under eave soffit inlet vents, turbo noted in rear house. Louver vents noted in front house.

Turbo/front house

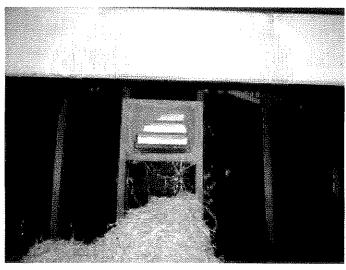
• Vent screens noted as torn.

Vent screens noted as torn.

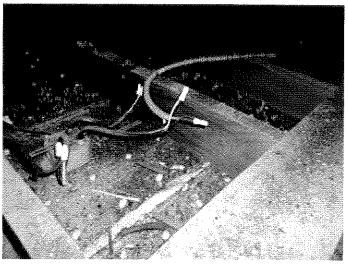
- Cloth wiring noted in both houses.Splices made outside of j-box, front house.

Splices made outside of j-box, front house.

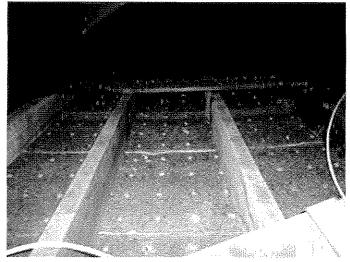
no insulation noted/front house

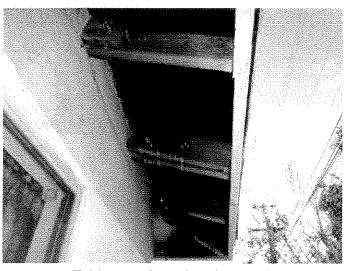
- Evidence of repairs observed.Moisture damage noted.
- · Repairs have been made to eaves at rear house.

Evidence of repairs observed.

Moisture damage noted.

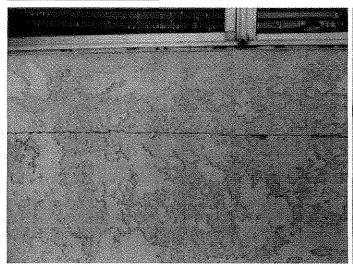
Observations:
• Some cracks noted in stucco.

Some cracks noted in stucco.

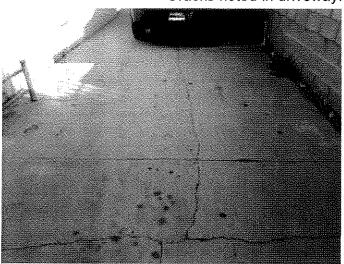
· Cracks noted in driveway.

Cracks noted in driveway.

Staff recommends rehabilitation of the existing concrete driveway.

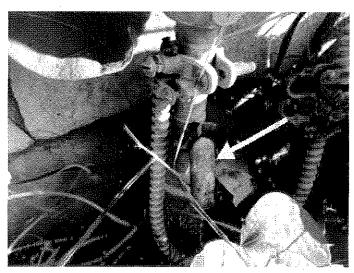
water turn off valve/front house

• Galvanized pipes have a average life time of 30 to 40 years. Front house has both copper and galvanized supply lines.
