CITY OF CARSON

PLANNING COMMISSION STAFF REPORT

PUBLIC HEARING: April 26, 2011
SUBJECT: Conditional Use Permit No. 858-11
APPLICANT: Sears Holdings Corporation
C/o: John Linegar
3333 Beverly Road, A2-248B
Hoffman Estates, IL 60179
REQUEST: Conditional Use Permit approval to facilitate exterior improvements to a Sears Automotive Center on a site located in the CR-D (Commercial, Regional-Design Overlay Review) zoning district
PROPERTY INVOLVED: 20420 S. Avalon Boulevard

Property Inspection Report

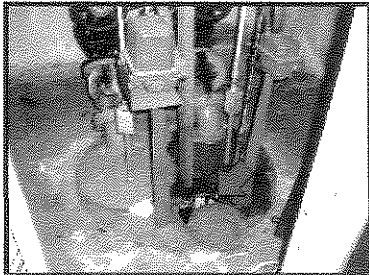
SEWAGE EJECTR:

1. [SC] The sewage ejector tank was not properly sealed, leaving raw sewage open to the environment. This condition is a health hazard. We recommend correcting the condition(s) noted.

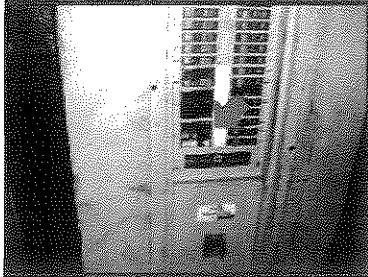
ELECTRIC PANEL:

4. [SC] There were missing twist-outs/unused breaker slots in the panel. This condition is a safety hazard. We recommend correcting the condition(s) noted. [SC] A number of breakers were not labeled. We recommend they be accurately labeled to allow individual circuits to be shut off for maintenance or emergency needs.

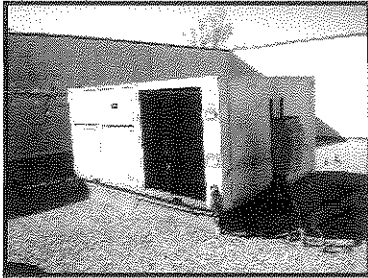
HEATING UNIT:

5. [FE] The heating system could not be checked. The thermostat was locked and the manager stated that he did not have access to it. However, two employees stated that they have never felt heat during the winter months. Although the heat pump operated in the AC mode, we could not verify the heating stage. The unit is older and in need of service and further evaluation.

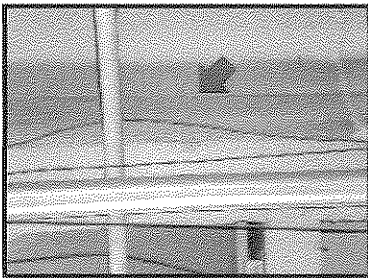
WALLS/CEILING:

6. [CR] Moisture stains were noted on the wall(s)/ceiling. We recommend locating and correcting the source and any damaged materials. This was actively leaking. We recommend locating correcting the source and any damaged materials.

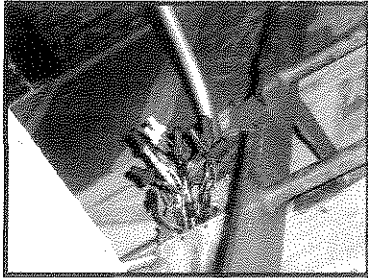
LIGHTS/FIXTURES:

7. [CR] There is a junction box located adjacent to the ladder leading to the roof. The box has too many branch circuits in it. It also lacks the proper cover. We recommend modification and repair.

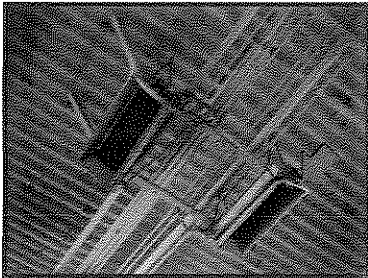
HEAT & COOL:

8. [CR] [FE] There are nine, gas fired, heating systems mounted on the ceiling. They did not respond when tested. The manager stated that he had never seen or felt them working. We recommend further evaluation by a qualified technician.

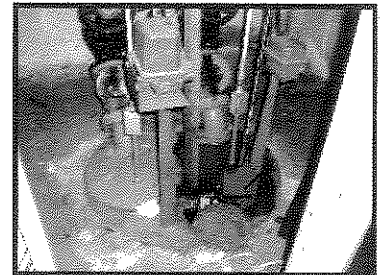
SEWAGE EJECTR:

[SC] The sewage ejector tank was not properly sealed, leaving raw sewage open to the environment. This condition is a heath hazard. We recommend correcting the condition(s) noted.

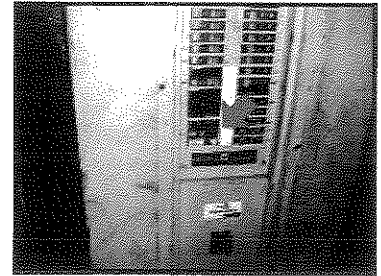
ELECTRIC PANEL:

[SC] There were missing twist-outs/unused breaker slots in the panel. This condition is a safety hazard. We recommend correcting the condition(s) noted. [SC] A number of breakers were not labeled. We recommend they be accurately labeled to allow individual circuits to be shut off for maintenance or emergency needs.

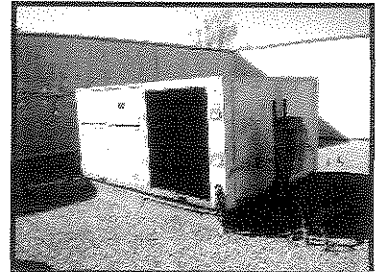
HEATING UNIT:

[FE] The heating system could not be checked. The thermostat was locked and the manager stated that he did not have access to it. However, two employees stated that they have never felt heat during the winter months. Although the heat pump operated in the AC mode, we could not verify the heating stage. The unit is older and in need of service and further evaluation.

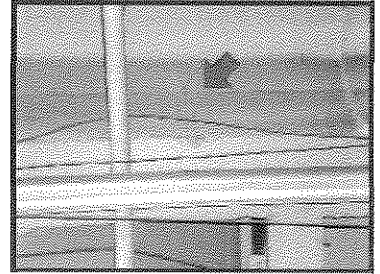
WALLS/CEILING:

[CR] Moisture stains were noted on the wall(s)/ceiling. We recommend locating and correcting the source and any damaged materials. This was actively leaking. We recommend locating correcting the source and any damaged materials.

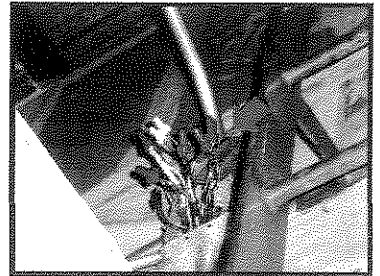
LIGHTS/FIXTURES:

[CR] There is a junction box located adjacent to the ladder leading to the roof. The box has too many branch circuits in it. It also lacks the proper cover. We recommend modification and repair.

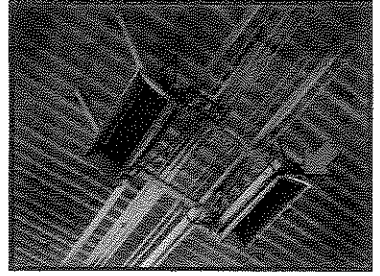
HEAT & COOL:

[CR] [FE] There are nine, gas fired, heating systmes mounted on the ceiling. They did not respond when tested. The manager stated that he had never seen or felt them working. We recommend further evaluation by a qualified technician.
