CITY OF CARSON

PLANNING COMMISSION STAFF REPORT

SUBJECT: Conditional Use Permit No. 796-10

PROPERTY INVOLVED: 2708 – 2710 East Adams Street

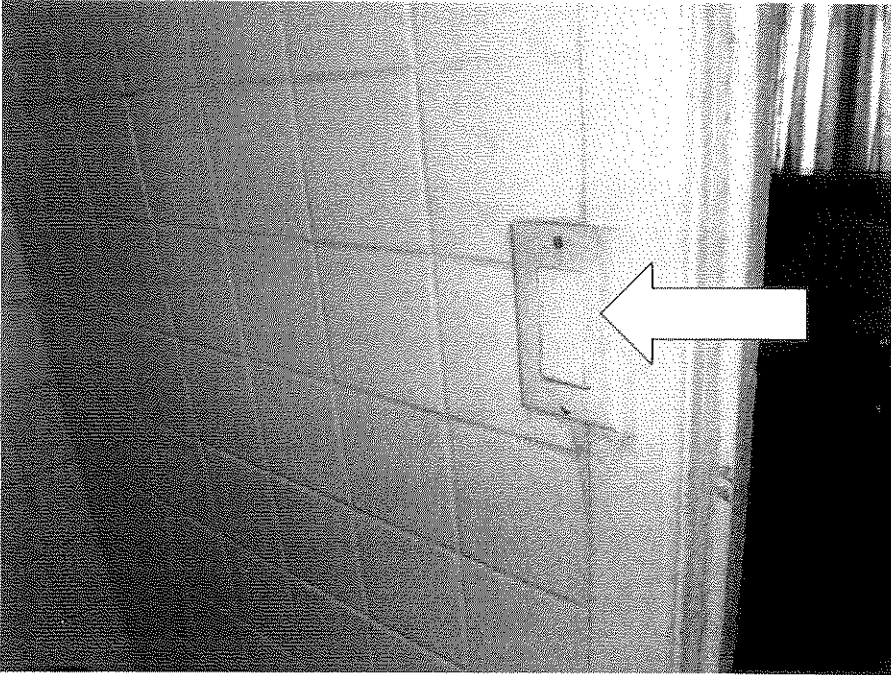
5. **Safety Issue:** A light switch was observed in close proximity to the tub/shower on the upper level (see figure 1). Suggest modification or relocation of electrical for safety reasons.

Figure 1-switch inside enclosure

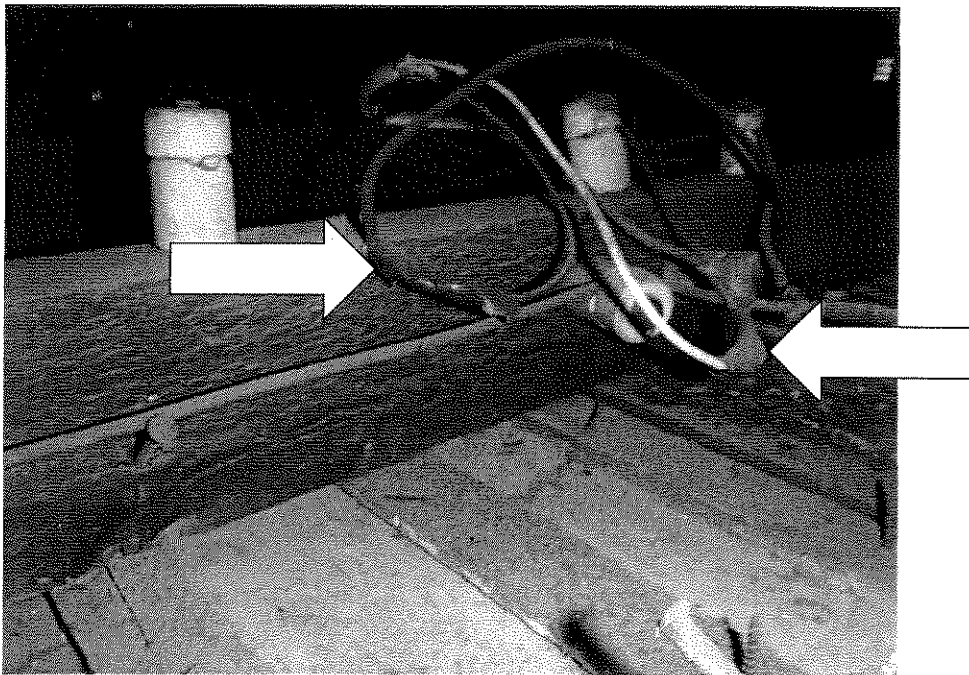
6. **Safety Issue:** Running splices and or open junction boxes noted at the attic space and garage (see figures 2 – 5); running splices noted at the attic space (older knob and tube wiring was observed in the attic to be connected to new wiring; such connections are often suspect); all electrical connections should be made within covered junction boxes; suggest conforming installation.

Figure 2-running splices new to old wiring

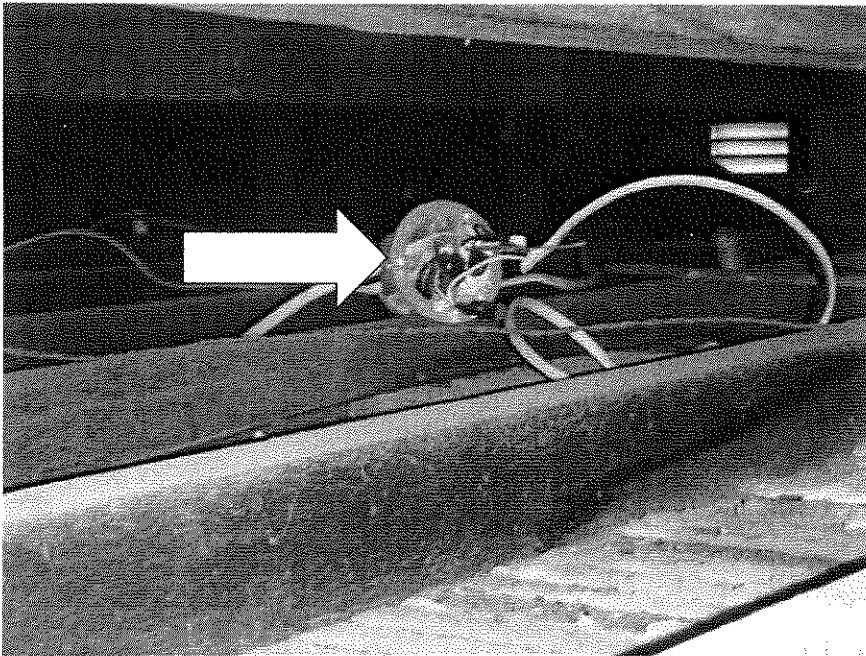
Figure 3-open and loose junction box over the living room

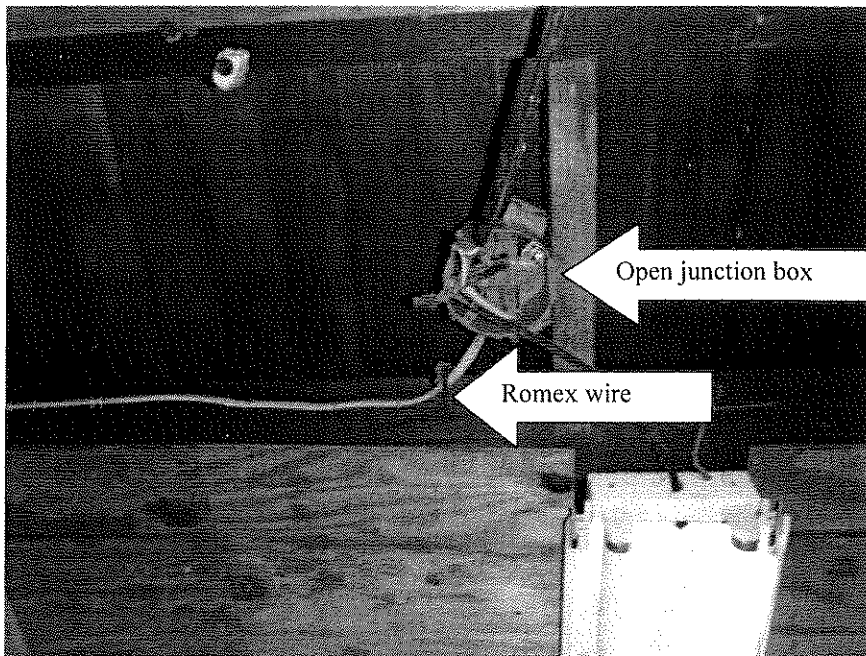
Figure 4-open junction box and exposed Romex wiring in the garage

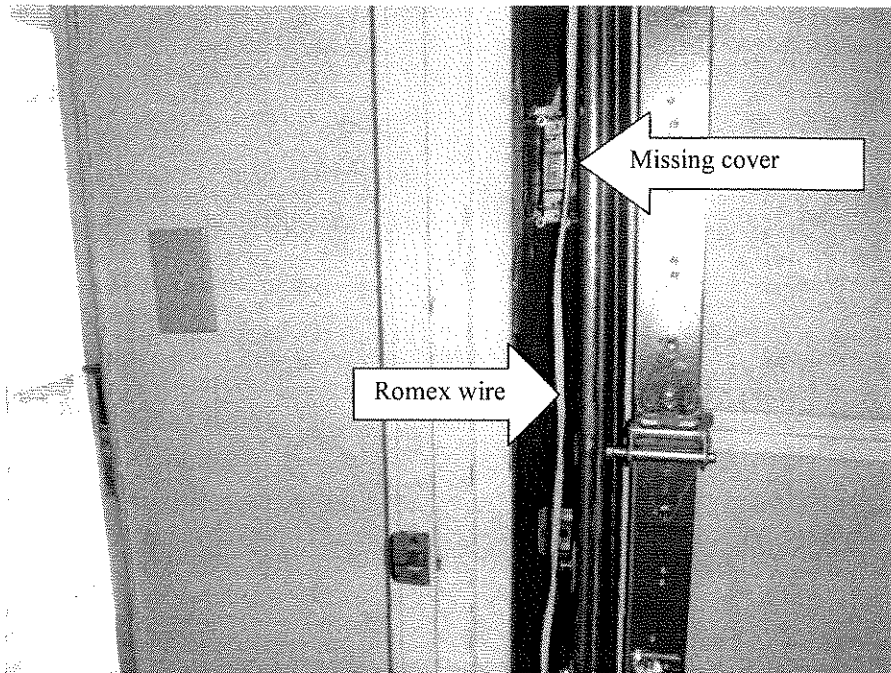
7. **Safety Issue:** Exposed romex/improper wiring noted in the garage (improper usage of material – see figures 6 as an example). All visible wiring should be enclosed within flexible or rigid metal conduit; suggest conforming installation.

Figure 6-exposed Romex wiring and missing outlet and switch wall plates

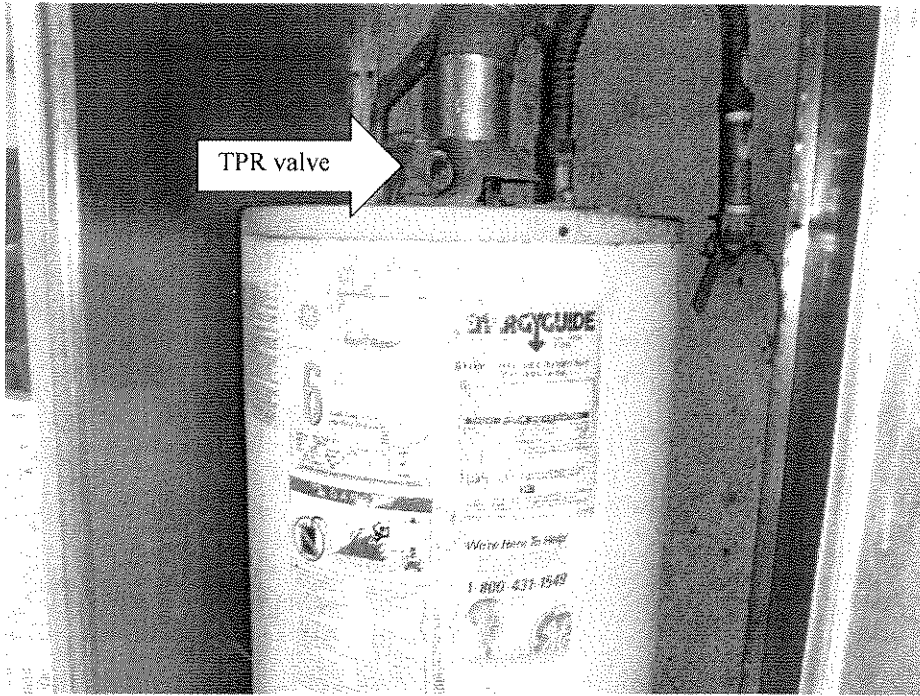
8. **Safety Issue:** The water heater is not strapped (see figure 7). Water heaters in seismic zones should be **properly double** strapped snug to the wall with approved straps at the top and bottom third of the unit (the upper strap should not be no closer than 9" from the top and the lower strap should be no lower than 4 inches above the gas connection) to resist any horizontal movement during earthquake conditions; suggest conforming installation. Note: The straps should not cover the water heater manufacture's date plate.

Figure 7-water heater is not strapped; no Temperature and Pressure Relief (TPR) Valve discharge pipe

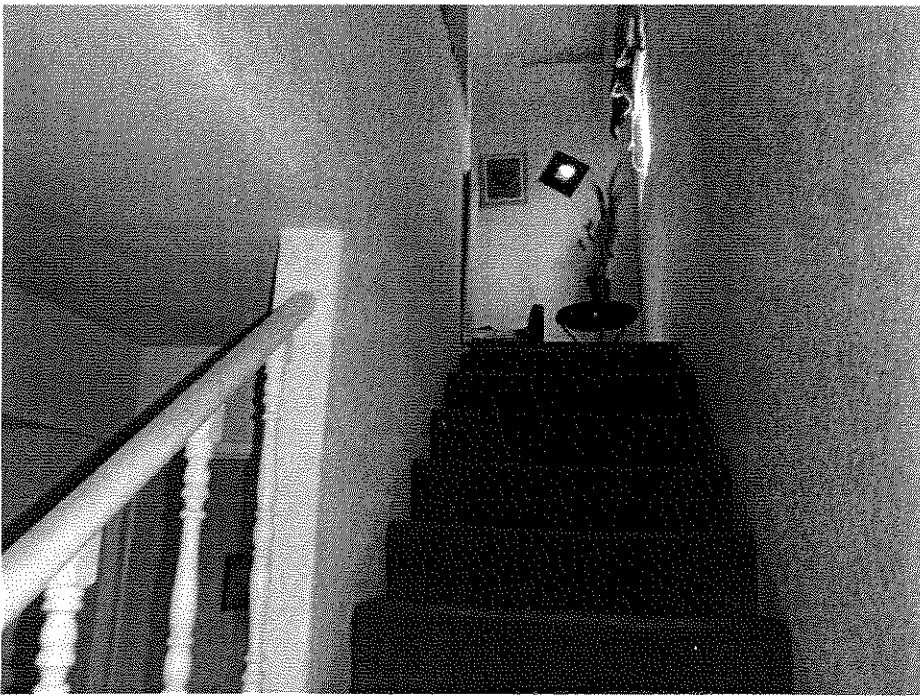
12. **Safety Issue:** For improved safety, it is recommended that a handrail be provided for the upper section of the stairway (see figure 8).
13. **Safety Issue:** The openings in the stairway railing are large enough to allow a child to fall through. It is recommended that this condition be altered for improved safety.

Figure 8-no handrail at the top section of the stairway

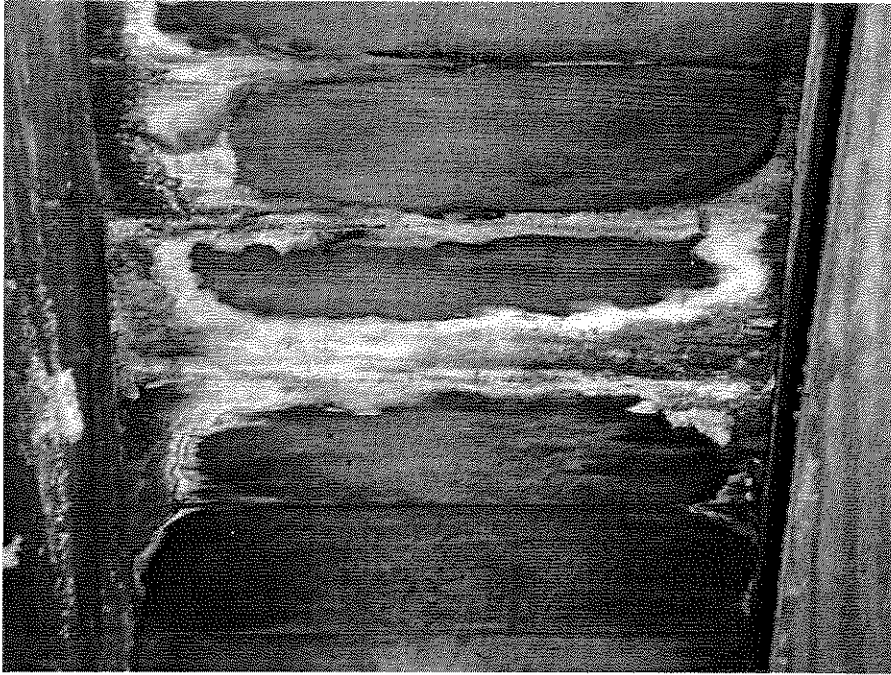
1. **Improve:** Wood deterioration noted at the sub floor located under the tub (see figure 9); suggest repair and referring to the pest control report.
2. **Improve:** Concrete/wood curb noted at the base of the garage overhead door; suggest removal. Also, the structure above the roll up door should have a single sized structural beam to support the load above.

- **Improve:** Wood deterioration noted at the sub floor located under the tub; suggest repair and referring to the pest control report.

Figure 9-wood deterioration below upper level bathroom

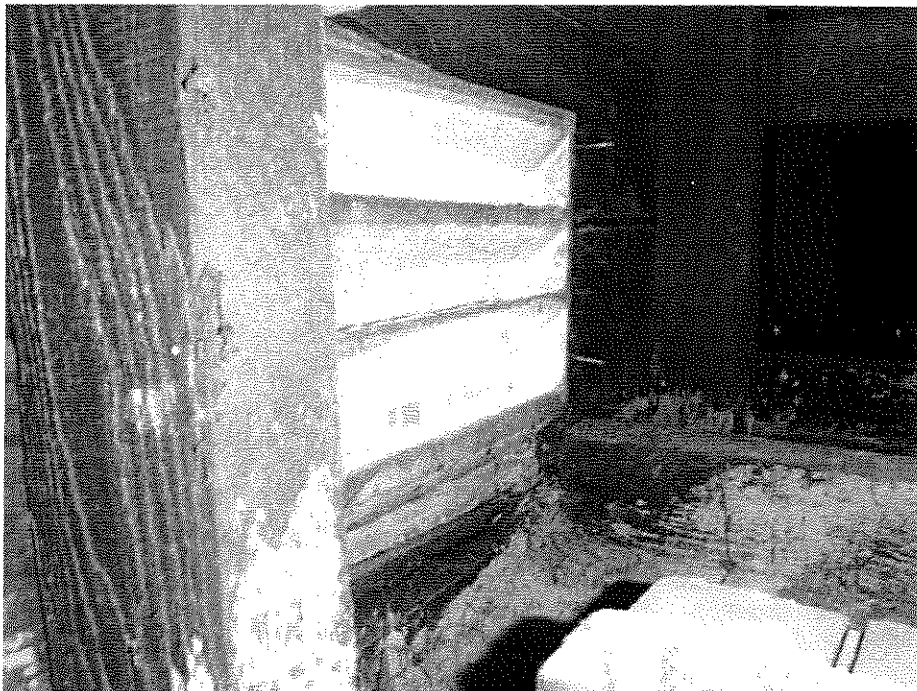
5. **Improve:** There is no heating source for the lower level living space.
6. **Improve:** Various attic ventilation screens are been obstructed/damaged/missing (see figure 10 as an example). Suggest repairs as needed.

Figure 10-one the many damaged/missing attic ventilation screens

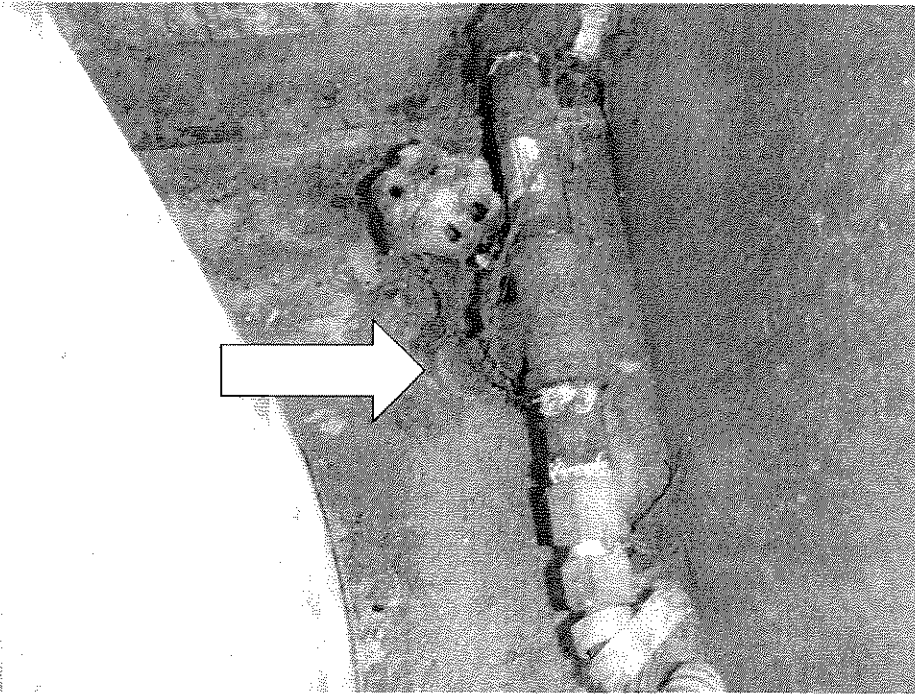
7. **Improve:** Gas supply pipe at the water heater is embedded in concrete without the benefit of pipe wrap (see figure 11). This tape will prevent corrosion of the pipe and allow it some movement during seismic activity.

Figure 11-gas line embedded in concrete

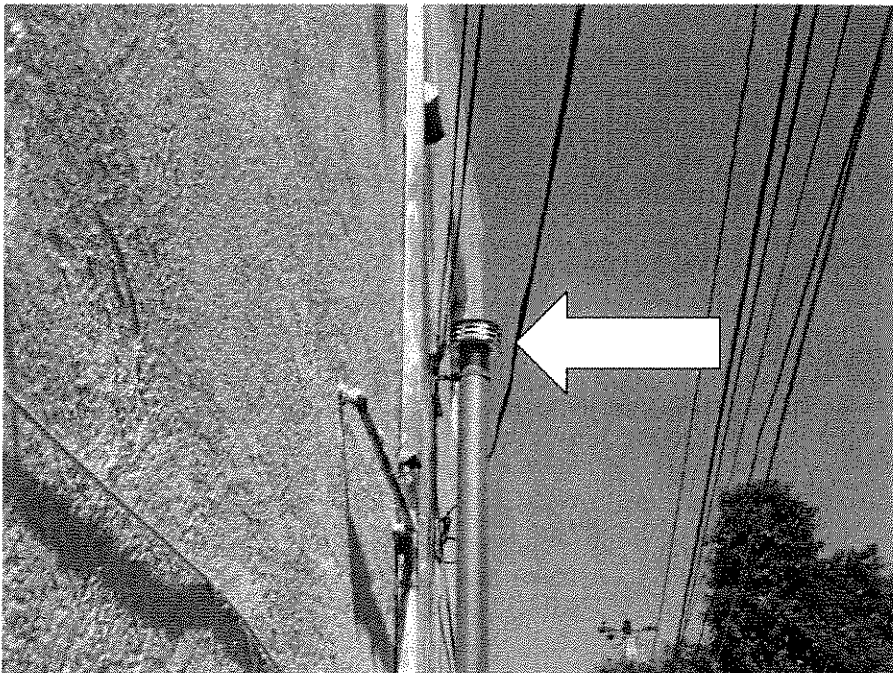
Figure 12-water heater vent does not discharge pass roof

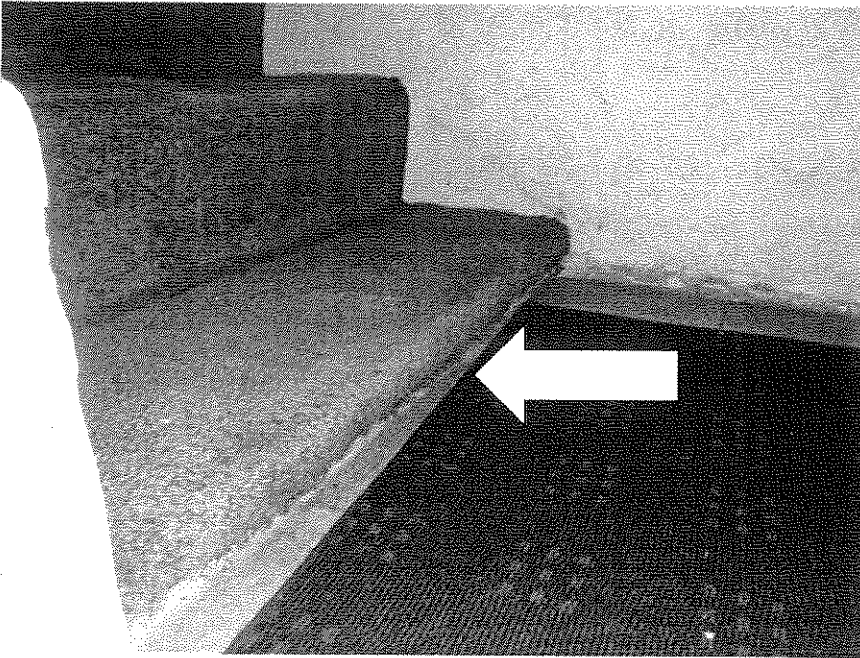
12. **Improve:** The kitchen exhaust hood light and fan are inoperative.
13. **Improve:** The size and/or orientation of the stairway first riser may make the stairway difficult to negotiate (see figure 13). Ideally, this condition should be altered for improved safety.

Figure 13-uneven height of the first riser with the other risers

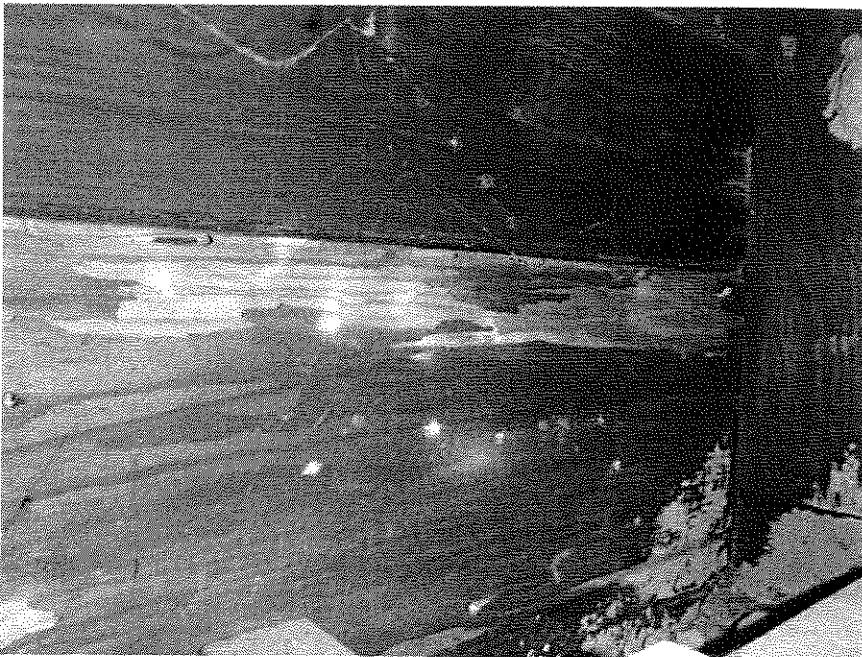
2. **Monitor:** Evidence of wood boring insect activity was observed in the attic at the SW corner of the exterior wall (see figure 14). A licensed pest control specialist should be engaged to evaluate this condition and recommend measures to eliminate further wood boring insect activity within the home.

- **Monitor:** Evidence of wood boring insect activity was observed in the attic at the SW corner of the exterior wall. A licensed pest control specialist should be engaged to evaluate this condition and recommend measures to eliminate further wood boring insect activity within the home.

Figure 14-wood boring insect activity in the attic at the SW corner
