CITY OF CARSON

PLANNING COMMISSION STAFF REPORT

SUBJECT: Conditional Use Permit No. 823-10

Property Inspection Report

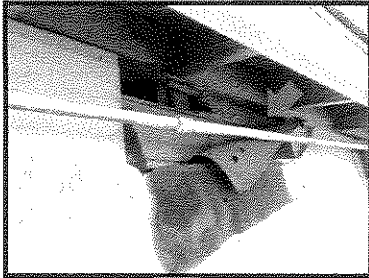
STUCCO SIDING:

1. [CR] The stucco siding was damaged/deteriorated at the right and rear sides of the building. There is also visible framing damage. These conditions are conducive to moisture intrusion/deterioration. We recommend correcting the condition(s) noted by using a specialist in the appropriate trade prior to the close of escrow. right side.

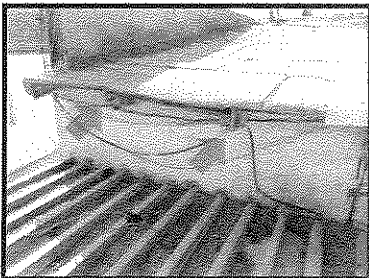
EXT TRIM:

2. [CR] The trim was weathered beyond normal wear. We recommend correcting the condition(s) noted by using a specialist in the appropriate trade prior to the close of escrow. [FE] There were damaged/deteriorated trim surfaces noted at the fascia boards, eave boards, and, rafter tails, We recommend further evaluation and corrections by a specialist in the appropriate trade prior to the close of escrow.

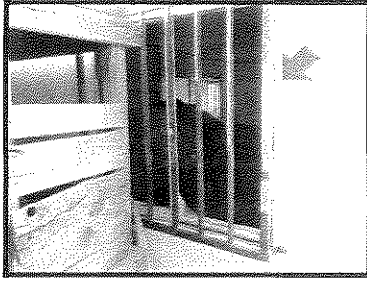
WINDOWS:

3. [CR] Broken glass was noted at the window(s). We recommend correcting the condition(s) noted by using a specialist in the appropriate trade prior to the close of escrow.(right side)

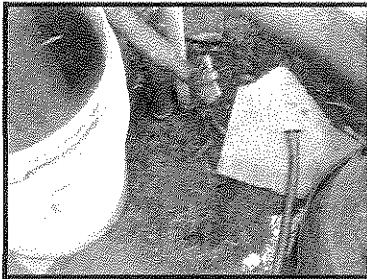
WATER SHUTOFF:

4. [FE] The main water shutoff valve was buried in the dirt. We recommend correcting the condition(s) noted.

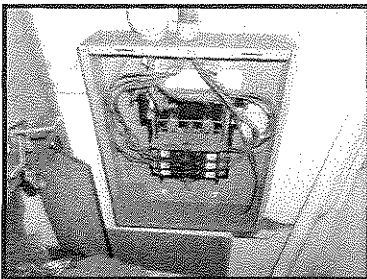
ELECTRIC PANEL:

5. [SC] The protective "dead front" cover was missing from the panel. We recommend correcting the condition(s) noted. [CR] The subpanel is not wired correctly. We recommend contacting a licensed electrical contractor for a full evaluation and repair.

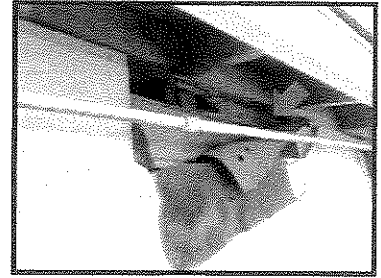
STUCCO SIDING:

[CR] The stucco siding was damaged/deteriorated at the right and rear sides of the building. There is also visible framing damage. These conditions are conducive to moisture intrusion/deterioration. We recommend correcting the condition(s) noted by using a specialist in the appropriate trade prior to the close of escrow. right side.

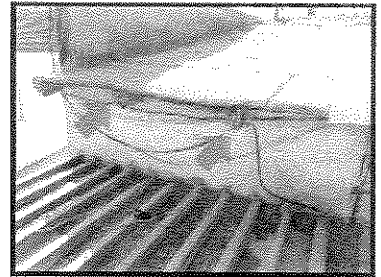
EXT TRIM:

[CR] The trim was weathered beyond normal wear. We recommend correcting the condition(s) noted by using a specialist in the appropriate trade prior to the close of escrow.
[FE] There were damaged/deteriorated trim surfaces noted at the fascia boards, eave boards, and, rafter tails, We recommend further evaluation and corrections by a specialist in the appropriate trade prior to the close of escrow.

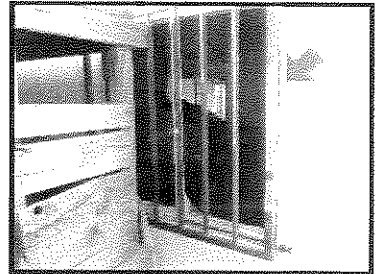
WINDOWS:

[CR] Broken glass was noted at the window(s). We recommend correcting the condition(s) noted by using a specialist in the appropriate trade prior to the close of escrow.(right side)

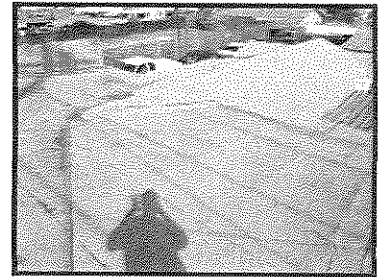
COMP SHINGLE:

The visible areas of the roof appeared serviceable with signs of weathering and aging. Periodic maintenance and inspection is recommended.

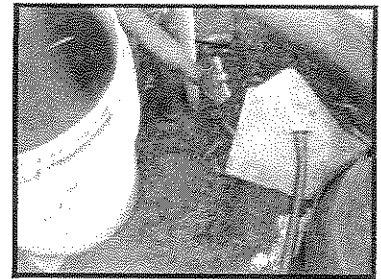
WATER SHUTOFF:

[FE] The main water shutoff valve was buried in the dirt. We recommend correcting the condition(s) noted.

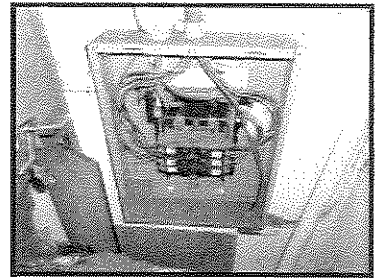
ELECTRIC PANEL:

[SC] The protective "dead front" cover was missing from the panel. We recommend correcting the condition(s) noted. [CR] The subpanel is not wired correctly. We recommend contacting a licensed electrical contractor for a full evaluation and repair.

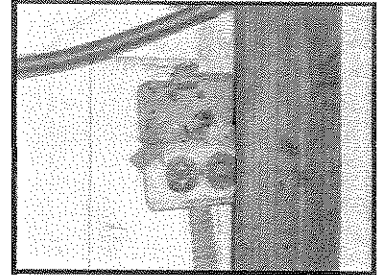
LIGHTS/FIXTURES:

[CR] Some of the lights failed to function. [CR] There is an open junction box located in the rear office. We recommend correcting the condition(s) noted.(numerous)
