CITY OF CARSON

PLANNING COMMISSION STAFF REPORT

PUBLIC HEARING: August 25, 2009
SUBJECT: Conditional Use Permit No. 738-09
APPLICANT: Ren Smith
450 Washington Boulevard
Marina Del Ray, CA 90292

Property Inspection Report

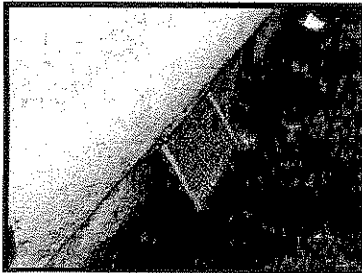
1. Accessed from the exterior at the left side of the building. [CR] The access door did not have a proper curb surrounding it. This will allow water under the structure.. We recommend it be repaired.

[CR] The crawl space access was limited due to plumbing pipes, heating ducts, debris and/or faulty grade. Only the accessible sections were inspected, this is a limited inspection.

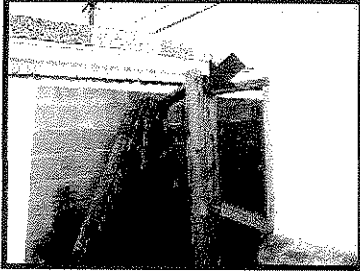
3. The yard fencing appeared serviceable, with common signs of aging and wear present. Periodic maintenance is recommended to minimize damage and extend the service life. with exceptions noted.
- a. [CR] The metal fencing had damaged/missing parts, We recommend correcting the condition(s) noted.(rear left)

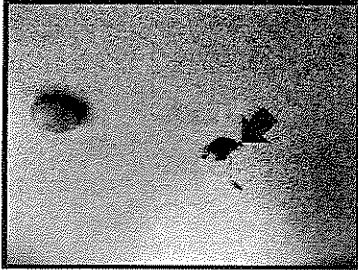
14. There is a missing fixture(s) . We recommend correcting the condition(s) noted.

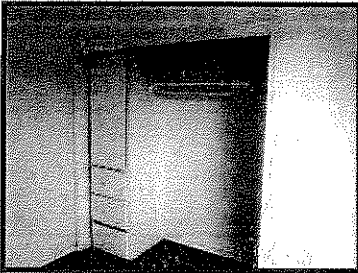
15. [CR] The door(s) had been removed. We recommend inquiring about the condition(s) noted.

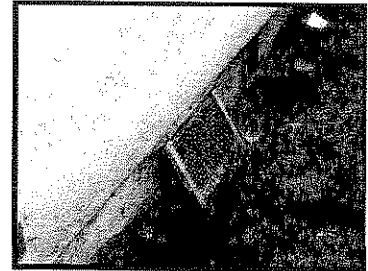
Accessed from the exterior at the left side of the building. [CR] The access door did not have a proper curb surrounding it. This will allow water under the structure.. We recommend it be repaired. [CR] The crawl space access was limited due to plumbing pipes, heating ducts, debris and/or faulty grade. Only the accessible sections were inspected, this is a limited inspection.

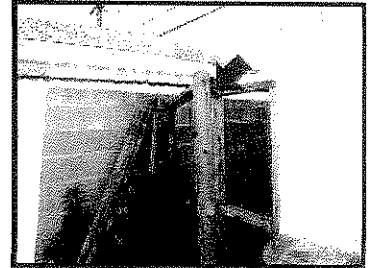
- DRIVEWAY:**
There were common cracks in the driveway, no action is needed at this time.
- WALKWAYS:**
There were common cracks noted in the walkways, no action is needed at this time.
- PATIOS:**
There were common cracks in the patio, no action is needed at this time.
- FENCING & GATES:**
The yard fencing appeared serviceable, with common signs of aging and wear present. Periodic maintenance is recommended to minimize damage and extend the service life. with exceptions noted.
a. [CR] The metal fencing had damaged/missing parts, We recommend correcting the condition(s) noted.(rear left)

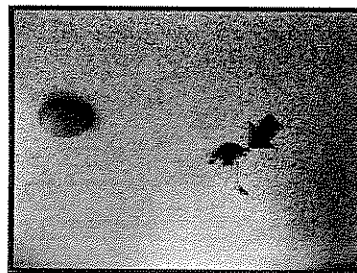
There is a missing fixture(s) . We recommend correcting the condition(s) noted.

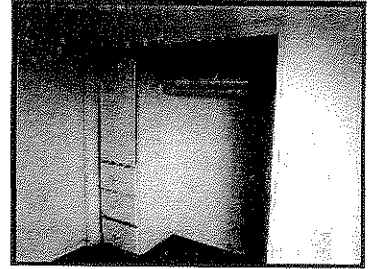
[CR] The door(s) had been removed. We recommend inquiring about the condition(s) noted.
