CITY OF CARSON

PLANNING COMMISSION STAFF REPORT

SUBJECT: Conditional Use Permit No. 932-13

Property Inspection Report

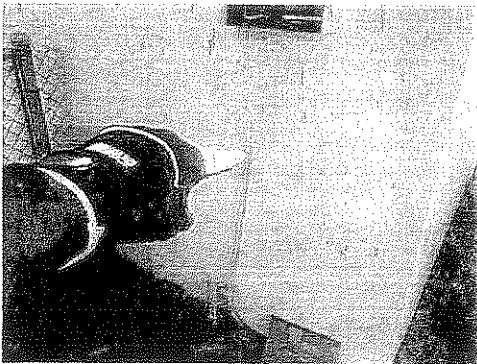
Photo 39

Non-metallic sheathed wiring is routed in one or more areas so it is subject to damage, such as on wall or ceiling surfaces. The insulation can be damaged by objects coming in contact with it and/or it being repeatedly moved. This is a safety hazard due to the risk of shock and fire. A qualified electrician should evaluate and repair as necessary. For example, rewire using conduit, or re-routing through wall cavities.

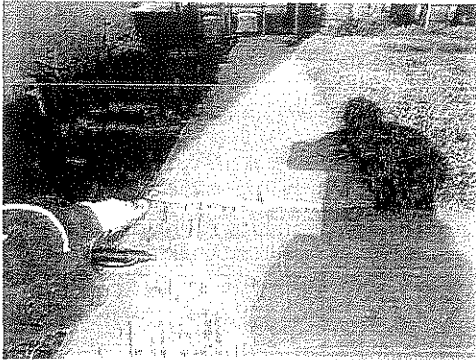
Photo 2

One or more trip hazards were found in sidewalk and/or patio sections due to cracks, settlement and/or heaving. A qualified contractor should evaluate and repair or replace sidewalk and/or patio sections as necessary to eliminate trip hazards.

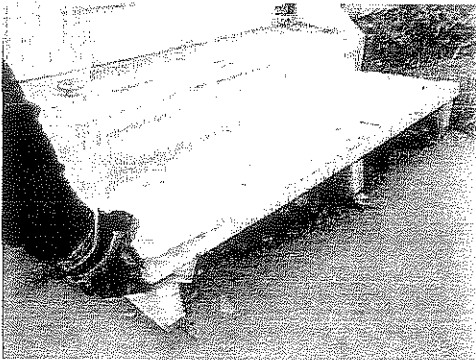
Photo 12

One or more sets of stairs are wobbly. A qualified contractor should evaluate and repair as necessary, such as installing additional supports and/or diagonal bracing.

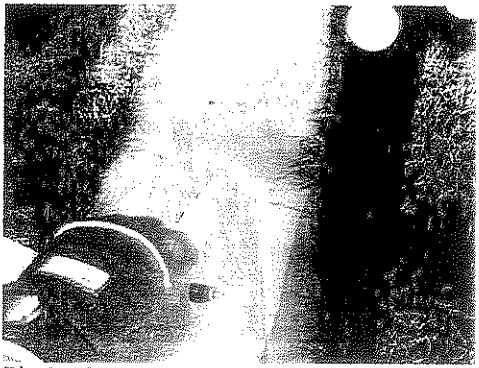
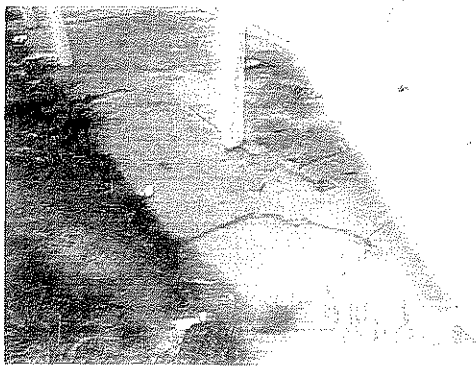
Sidewalks and/or patios have cracks and/or deterioration in one or more areas. A qualified contractor should evaluate and repair or replace sidewalk and/or patio sections as necessary.

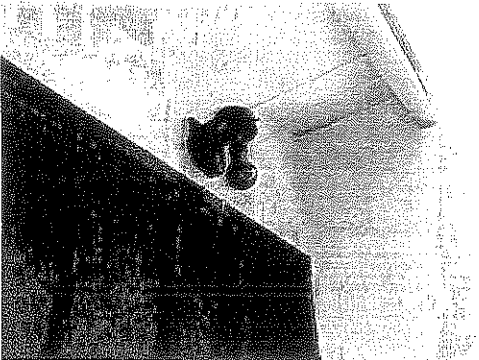
Photo 24

One or more light fixtures are damaged and/or deteriorated. A qualified electrician should evaluate and repair or replace light fixtures where necessary.

Missing cover

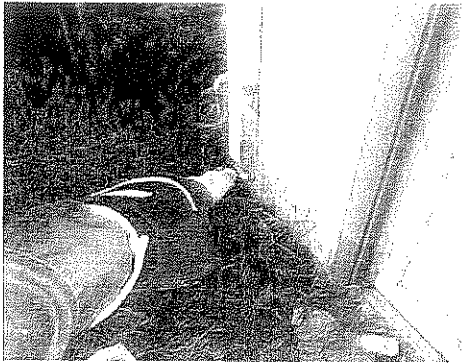
Photo 17

One or more downspouts have no extensions, or have extensions that are ineffective. This can result in water accumulating around the structure's foundation, or in basements and crawl spaces if they exist. Accumulated water is a conducive condition to wood destroying insects and organisms, and may also cause the foundation to settle and possibly fail over time. Repairs should be made as necessary, such as installing or repositioning splash blocks, or installing and/or repairing tie-ins to underground drain lines, so rain water is carried at least several feet away from the structure to soil that slopes down and away from the structure.

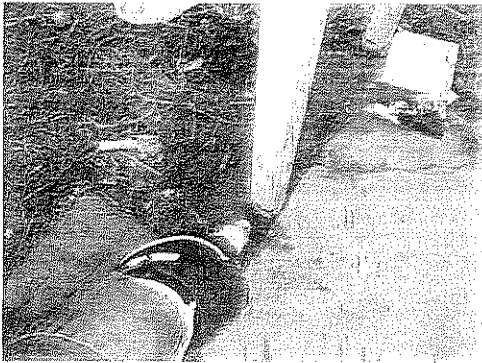
Photo 15

One or more wooden deck support posts are in contact with soil. This is a conducive condition for wood destroying insects and organisms. However no damage from wood destroying insects or organisms was found. Standard building practices require that there be at least 6" of space between any wood and the soil below, even if the wood is treated. If possible, soil should be removed or graded so a 6" clearance is maintained. Otherwise recommend installing borate based Impel rods to prevent rot. For more information, visit: <http://www.google.com/search?q=impel+rods>

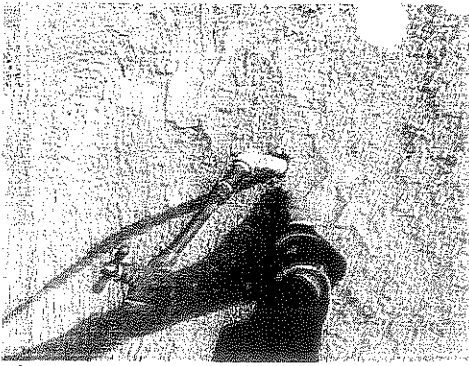
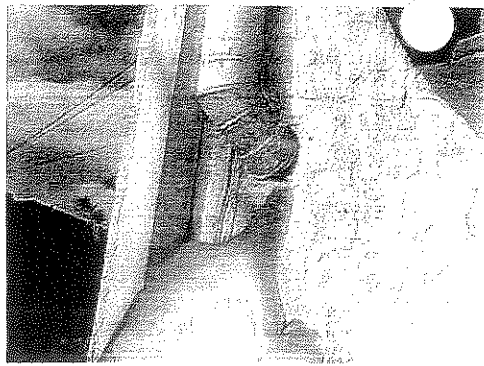
Gaps exist at one or more openings around the exterior, such as those where outside faucets, refrigerant lines, and/or gas supply pipes penetrate the exterior. Gaps should be sealed as necessary to prevent moisture intrusion and entry by vermin.

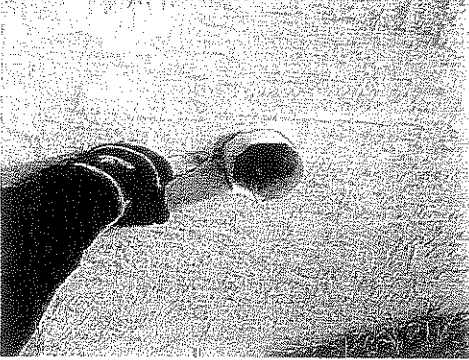
Photo 19

One or more exhaust duct end caps are missing. Their purpose is to prevent unconditioned air from entering the house, and keep out birds, rodents and insects. Blocked ducts can cause fan motors and/or clothes dryers to overheat and may pose a fire hazard. Vent cap(s) should be installed where necessary.

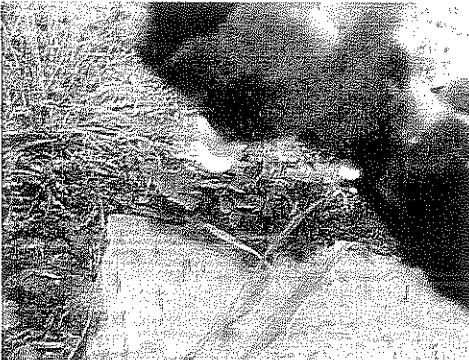
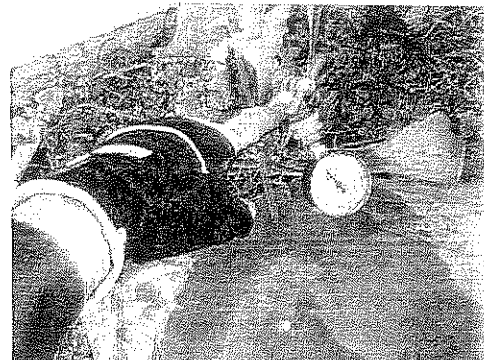
One or more outside faucets leak. For example, from the valve stem when turned on or from the spigot when turned off. A qualified plumber should evaluate and repair as necessary.

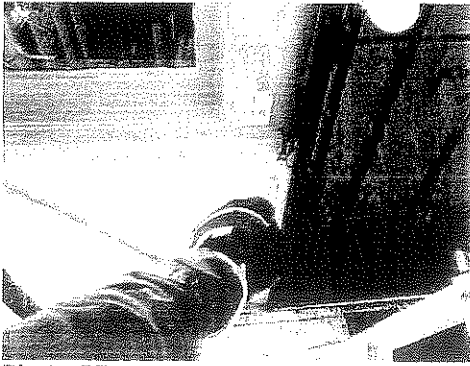
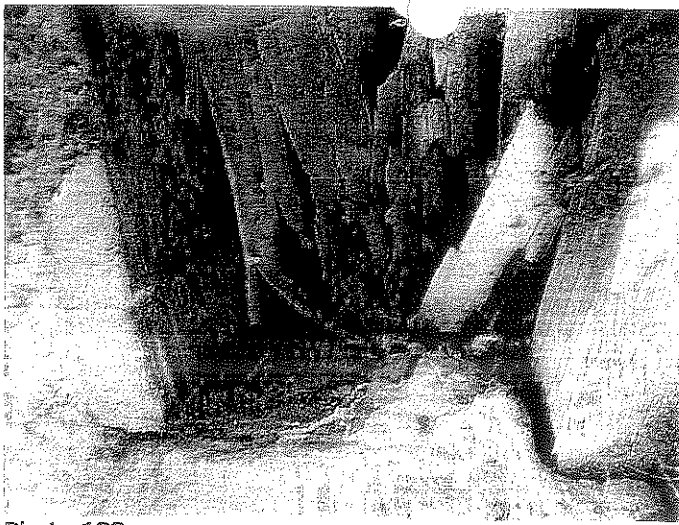
At the time of inspection there appeared to be evidence of infestation of wood destroying insects or organisms (Live or dead insect bodies, shelter tubes, pellets, fungal growth, etc.) Recommend having a qualified pest control specialist evaluate, maintain and/or treat as necessary.

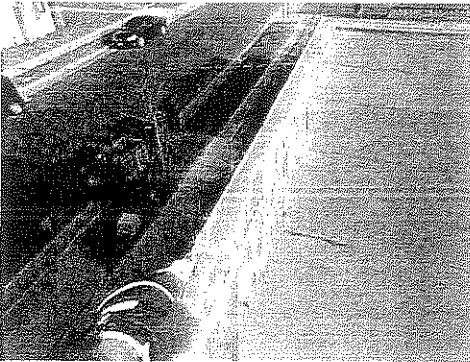
Photo 26

One or more flashings at parapet walls are deteriorated and/or substandard. These may result in leaks. A qualified roofing contractor should evaluate and repair as necessary.

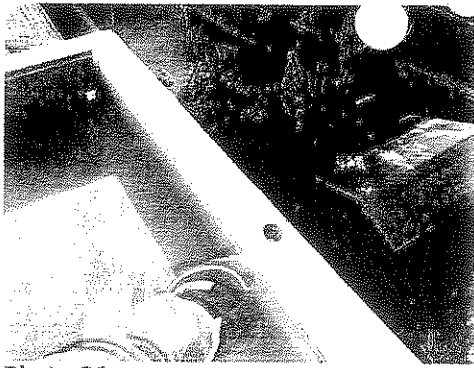
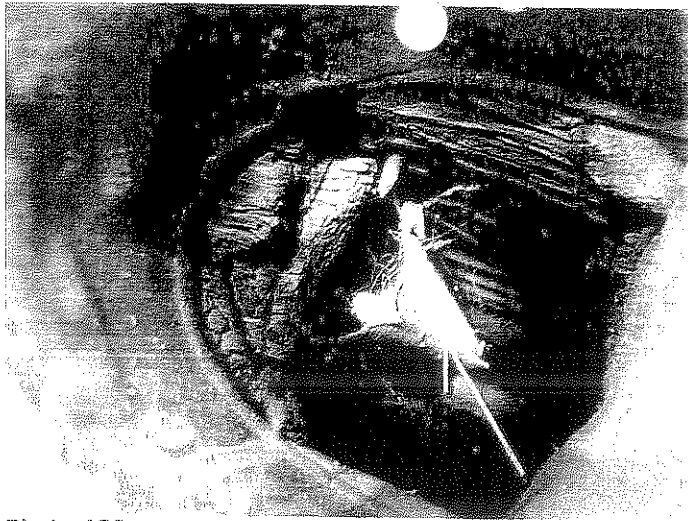
Lead flashing at one or more plumbing vent pipes is improperly installed. For example, shorter than the vent pipe, not bent over the edge of the vent pipe, etc. Properly installed, the flashing should extend up and over the top edge of the pipe, and be bent down into the pipe. Otherwise, rain water may flow between the pipe and the flashing, resulting in leaks. A qualified roofing contractor should make repairs as necessary so flashings are installed as per standard building practices.

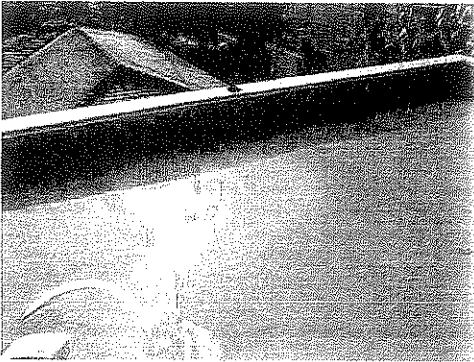
Photo 28

Standing water was found on the flat roof. It should evaporate within 48 hours after it rains. If standing water remains after 48 hours, then the roof installation is likely substandard. A qualified roofing contractor should evaluate and repair if necessary to prevent prolonged standing water.

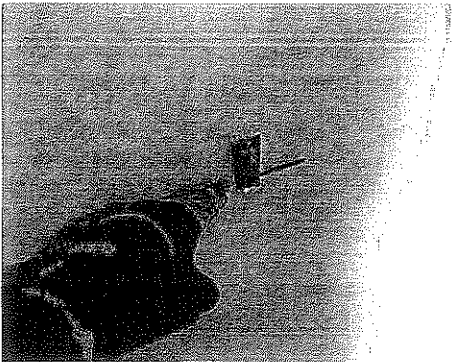
Photo 58

Cover plate(s) are missing from one or more electric boxes, such as for receptacles, switches and/or junction boxes. They are intended to contain fire and prevent electric shock from exposed wires. This is a safety hazard due to the risk of fire and shock. Cover plates should be installed where missing.

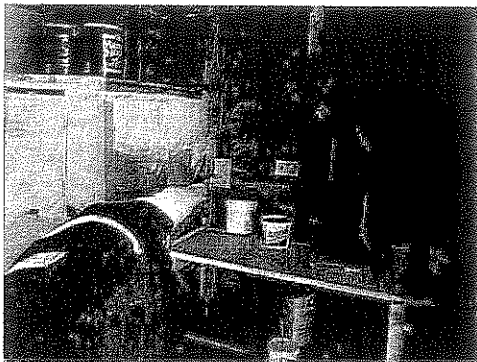
Photo 54

One or more garage electric receptacles appear to have no ground fault circuit interrupter (GFCI) protection. This is a safety hazard due to the risk of shock. A qualified electrician should evaluate to determine if GFCI protection exists, and if not, repairs should be made so that all garage receptacles, except for one for use with a refrigerator or freezer, have GFCI protection. For example, install GFCI receptacles or circuit breaker(s) as needed.

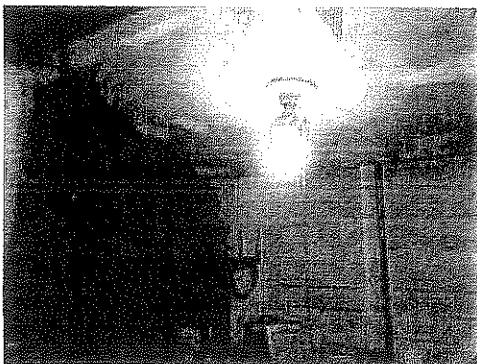
Photo 53

Lamp holders or light fixtures with fully or partially exposed bulbs are installed in one or more closets. This is a safety hazard due to the risk of fire. Flammable stored items may come into contact with hot bulbs, and hot fragments from broken bulbs may fall on combustible materials. Standard building practices require closet lighting to use fluorescent light fixtures, or to use fully enclosed incandescent fixtures. Installing a compact fluorescent lamp in a lamp holder is not an acceptable practice. A qualified electrician should replace closet lights as necessary and as per standard building practices.

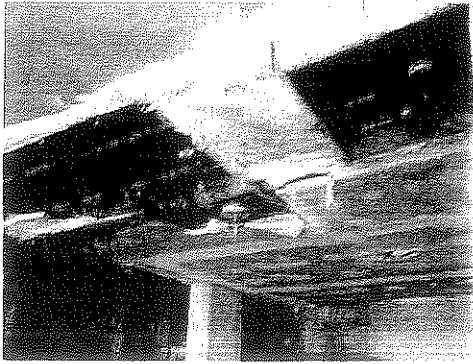
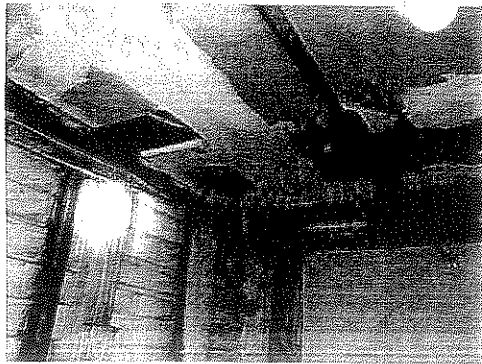
One or more gaps, holes were found in the attached garage walls or ceilings. Current standard building practices call for wooden-framed ceilings and walls that divide the house and garage to provide limited fire-resistance rating to prevent the spread of fire from the garage to the house. Recommend that a qualified person repair per standard building practices. For example, by patching openings or holes, firestopping holes or gaps with fire-resistant caulking, and/or installing fire-resistant wall covering (e.g. Type X drywall). For more information, visit: <http://www.reporthost.com/?AGFR>

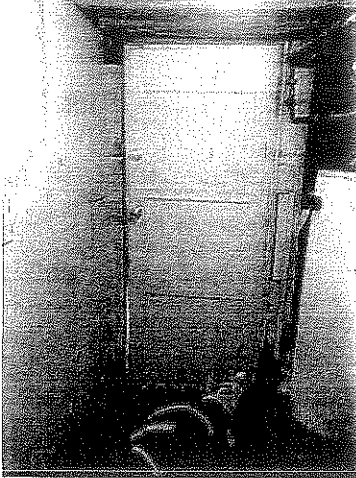
Photo 62

One or more exterior entrance doors are damaged and/or deteriorated and should be repaired or replaced by a qualified contractor.

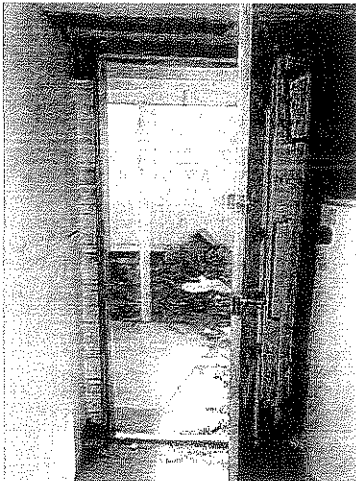
Photo 59

The weatherstrip around one or more exterior entry doors is missing and/or deteriorated. Weatherstrip should be installed where missing and/or replaced where deteriorated, and by a qualified contractor if necessary.

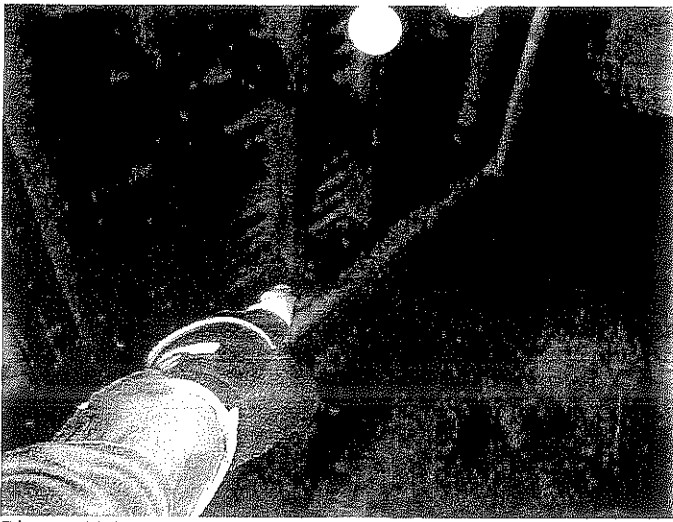
Photo 191

Seismic reinforcements such as anchor bolts, hold-downs and/or metal straps were missing in one or more locations. A qualif

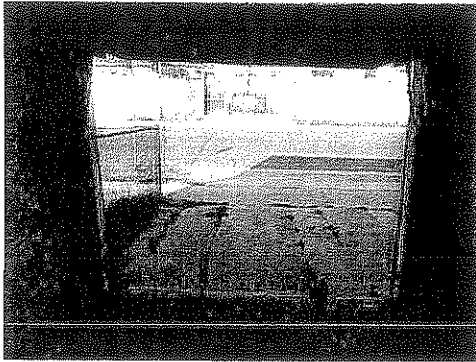
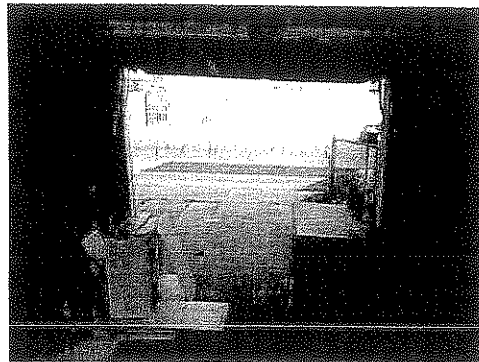
34) 🔍 Weatherstrip at the sides and/or bottom of the vehicle door is missing. It should be installed where missing to prevent water and vermin intrusion.

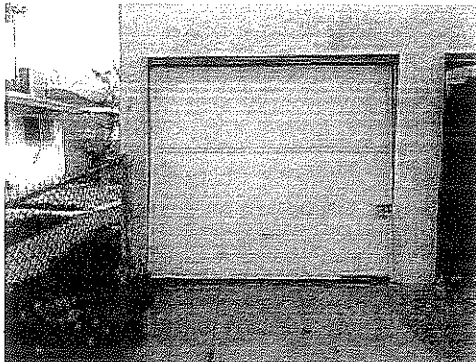
Photo 65

35) 🔍 One or more garage vehicle doors were difficult or unable to open or close. Vehicle doors should open and close smoothly and easily. A qualified person should evaluate and repair as necessary. This may require lubrication or repair to hardware such as rollers or brackets.

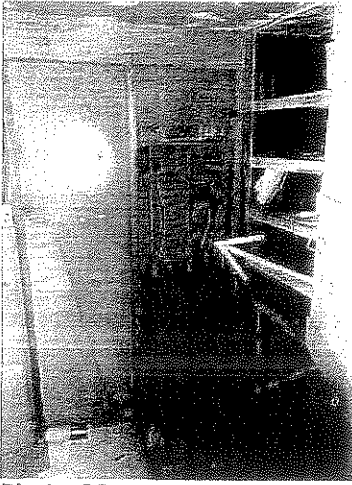
Photo 66

36) 🔍 Cracks or deterioration were found in walls in one or more areas. They do not appear to be a structural concern, but the client(s) may wish to repair these for aesthetic reasons.

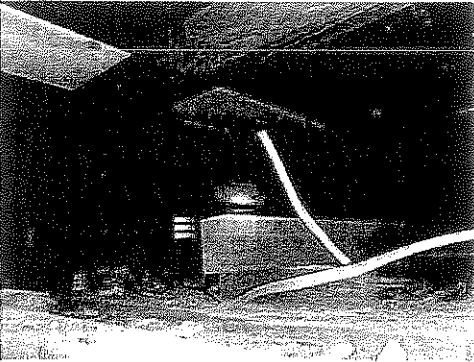
Photo 76

One or more sections of wiring that weren't terminated were found. This is a potential safety hazard due to the risk of shock. A qualified electrician should evaluate and repair as necessary. For example, cutting the wire to length and terminating the wire with wire nuts in a securely anchored, covered, properly sized junction box.

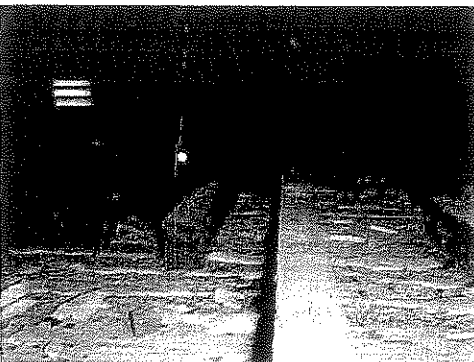
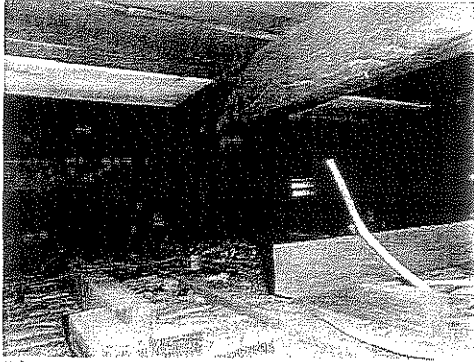
No ceiling insulation is installed in the attic. A qualified contractor should install insulation for better energy efficiency and as per standard building practices with an R rating recommended for this area.

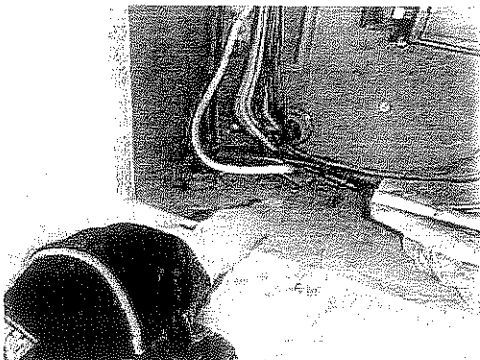
Photo 40

40) ⚡ One or more loose conductors in the main service panel have bare ends and are not connected to an overcurrent protection device (circuit breakers or fuses). This is a safety hazard due to the risk of fire if the bare conductors come into contact with other components in the panel. A qualified electrician should evaluate and repair as necessary. For example, removing wires that aren't terminated or installing wire nuts.

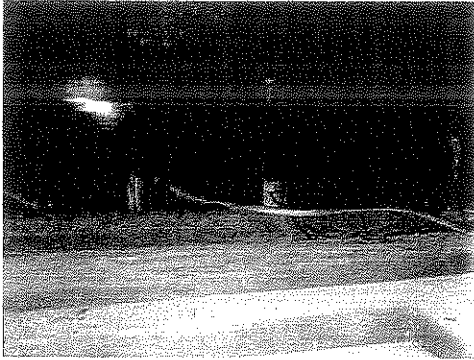
Photo 73

The inspector did not find any energized knob and tube wiring during the inspection. However this is no indication that all the knob and tube wiring has been abandoned. It is not within the scope of this inspection to determine what percentage of this property's wiring is of the knob and tube type, or to determine what percentage of the knob and tube wiring is energized vs. abandoned. A qualified electrician should evaluate this wiring and make repairs or replace wiring if necessary.

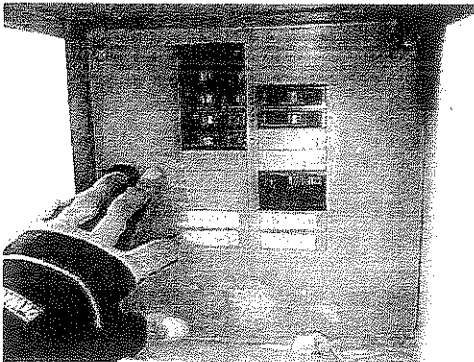
Photo 42

The legend for overcurrent protection devices (breakers or fuses) in the main service panel is missing, unreadable or incomplete. Recommend installing, updating or correcting the legend as necessary so it's accurate. Evaluation by a qualified electrician may be necessary.

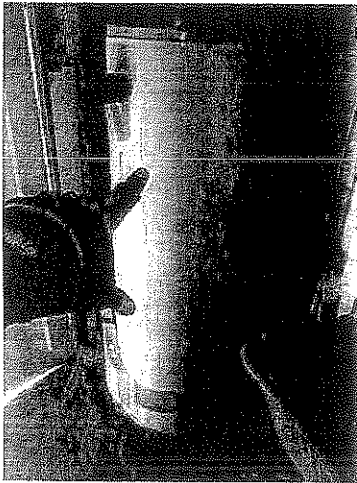
Photo 57

The water heater does not have seismic straps or struts installed. This is a potential safety hazard since movement can cause leaks in the gas supply lines or damage wiring. Leaks may also occur in water supply pipes. A qualified contractor should install seismic straps or struts as necessary and as per standard building practices.

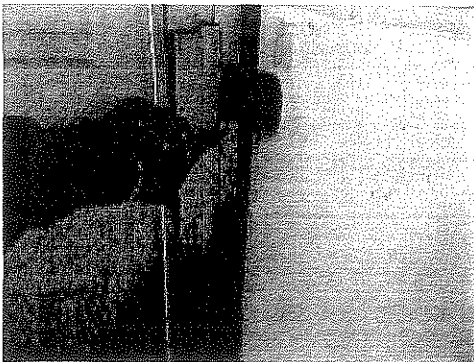
Photo 61

No drain line is installed for the temperature-pressure relief valve. This is a potential safety hazard due to the risk of scalding if someone is standing next to the water heater when the valve opens. A qualified plumber should install a drain line as per standard building practices. For example, extending to 6 inches from the floor, or routed so as to drain outside.

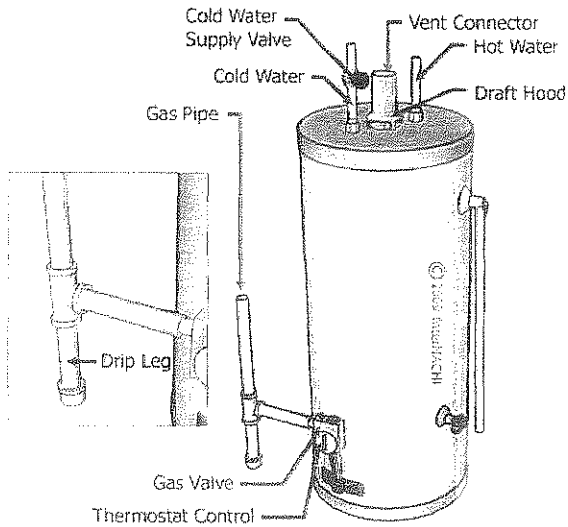
Photo 201

47) 🔍 No drip leg is installed on the water heater gas supply line. Drip legs are intended to trap oil, scale, water condensation and/or debris from the gas supply lines before they reach and damage the water heater components. A qualified contractor should install a drip leg as per standard building practices.
• Note that depending on the quality of the gas being delivered in some municipalities, the installation of a drip leg or dirt leg may not be required by local officials.

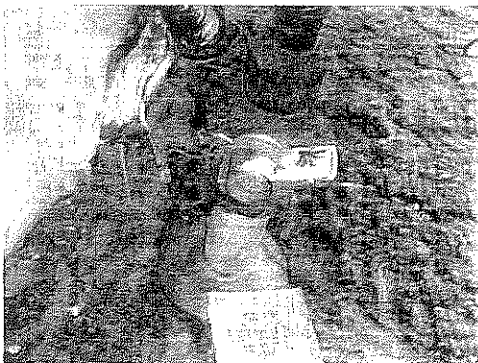
Photo 78

48) Ⓢ The furnace was shut off at the time of the inspection. For example, the gas supply was shut off, the pilot light was out, and/or the electric supply was turned off. As a result, the inspector was unable to fully evaluate this unit.

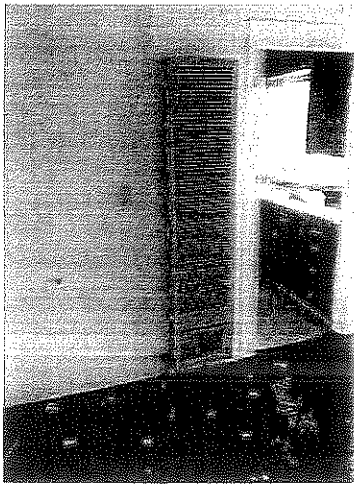
Photo 77

49) Ⓢ The estimated useful life for most furnaces is 15 to 20 years. This furnace appears to be at this age or older and may need replacing at any time. Recommend budgeting for a replacement in the near future.

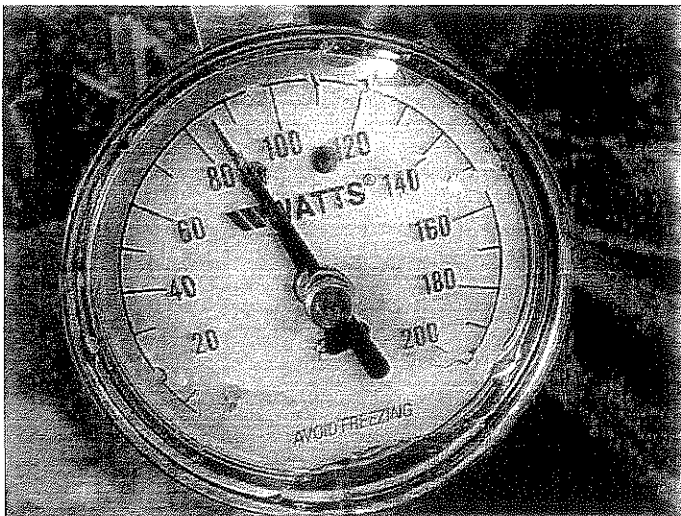
Photo 190

The water supply pressure is greater than 80 psi. Pressures above 80 psi may void warranties for some appliances such as water heaters or washing machines. Flexible supply lines to washing machines are more likely to burst with higher pressures. Typically the pressure cannot be regulated at the water meter. Recommend having a qualified plumber evaluate and make modifications to reduce the pressure below 80 psi. Installing a pressure reducing valve on the main service pipe is a common solution to this problem. If one exists, then it should be adjusted for lower pressures.

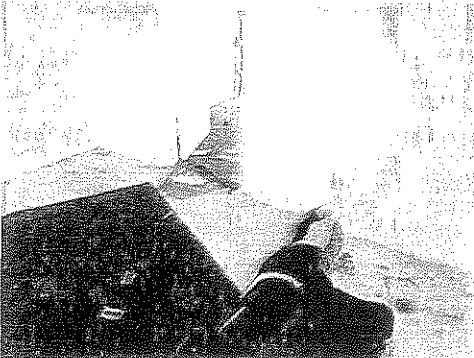
Photo 87

53) ⚡🔍 One or more electric receptacles have reverse-polarity wiring, where the hot and neutral wires are reversed. This is a safety hazard due to the risk of shock. A qualified electrician should evaluate and make repairs as necessary.

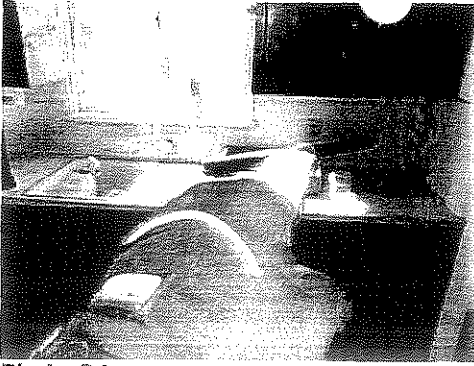
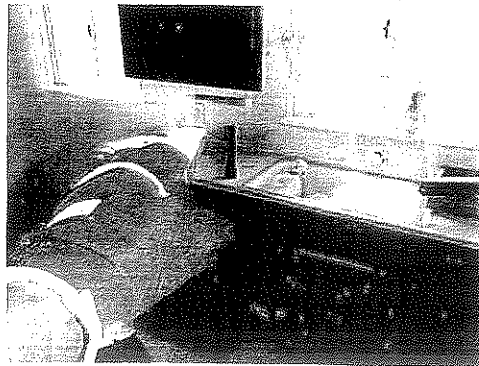
54) ⚡🔍 One or more electric receptacles that serve countertop surfaces within six feet of a sink appear to have no ground fault circuit interrupter (GFCI) protection. This is a safety hazard due to the risk of shock. A qualified electrician should evaluate to determine if GFCI protection exists, and if not, repairs should be made so that all receptacles that serve countertop surfaces within six feet of sinks have GFCI protection. For example, install GFCI receptacles or circuit breaker(s) as needed.

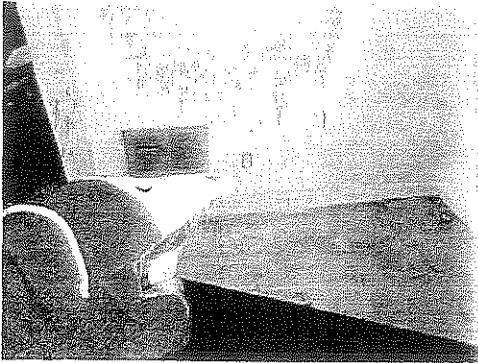
Photo 90

55) ⚠️ Cover plate(s) are missing from one or more electric boxes, such as for receptacles, switches and/or junction boxes. They are intended to contain fire and prevent electric shock from exposed wires. This is a safety hazard due to the risk of fire and shock. Cover plates should be installed where missing.

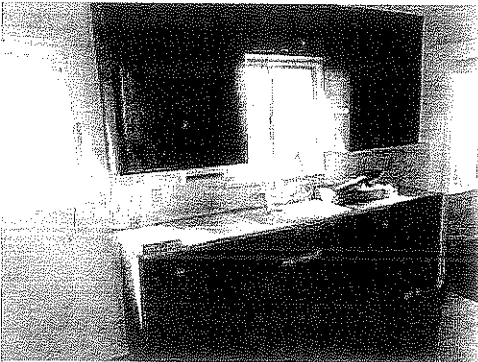
Photo 79

56) 🔧 One or more cabinets and/or drawers are damaged and/or deteriorated. A qualified contractor should evaluate and repair or replace cabinets and/or components as necessary.

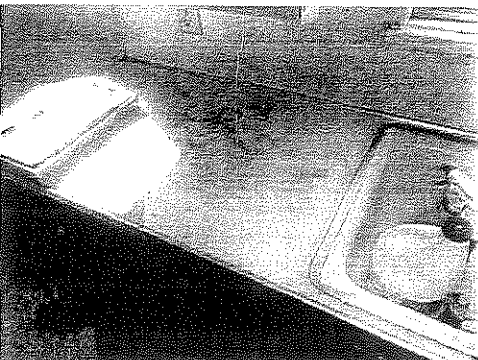
Photo 80

57) 🔧 Countertops are damaged and/or deteriorated in one or more areas. A qualified contractor should evaluate and repair or replace countertops as necessary.
