City of Carson Report to Mayor and City Council

October 1, 2013
Unfinished Business

SUBJECT: CONSIDER STATUS REPORT ON THE REGIONAL WATER QUALITY CONTROL BOARD ENVIRONMENTAL INVESTIGATION AND CARSON DECLARATION OF THE EXISTENCE OF AN EMERGENCY WITHIN THE CAROUSEL TRACT

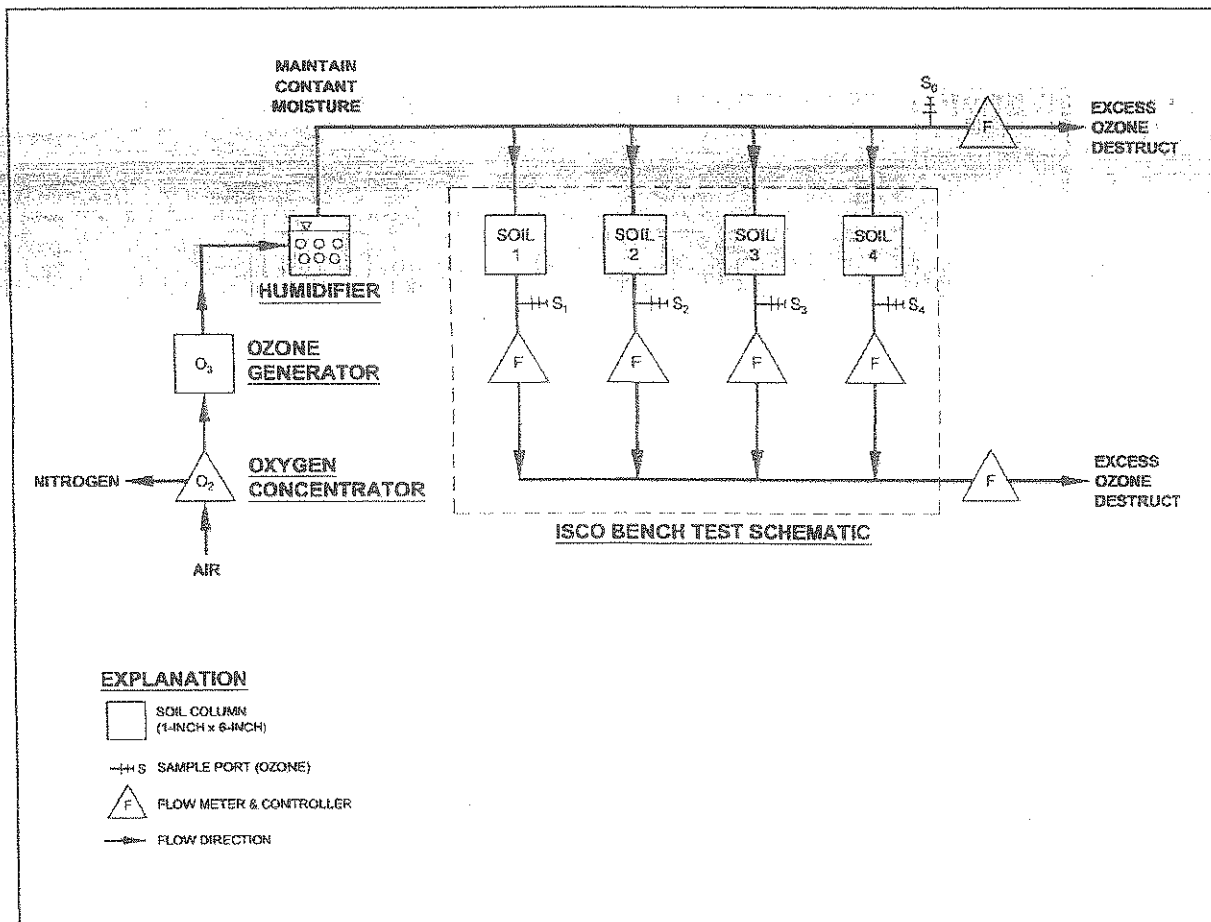
Method 3: In Situ Chemical Oxidation

- Strong chemical oxidizers (ozone) are injected directly into soil to destroy chemical contaminants
