CITY OF CARSON

PLANNING COMMISSION STAFF REPORT

PUBLIC HEARING: February 9, 2010
SUBJECT: Conditional Use Permit No. 778-09
APPLICANT: Carolyn Davis
21365 Prospect Avenue
Long Beach, CA 90810
REQUEST: To approve a Conditional Use Permit for a second dwelling located within the RS (Residential, Single Family) zone district
PROPERTY INVOLVED: 21365 Prospect Avenue

PROPERTY INSPECTION REPORT

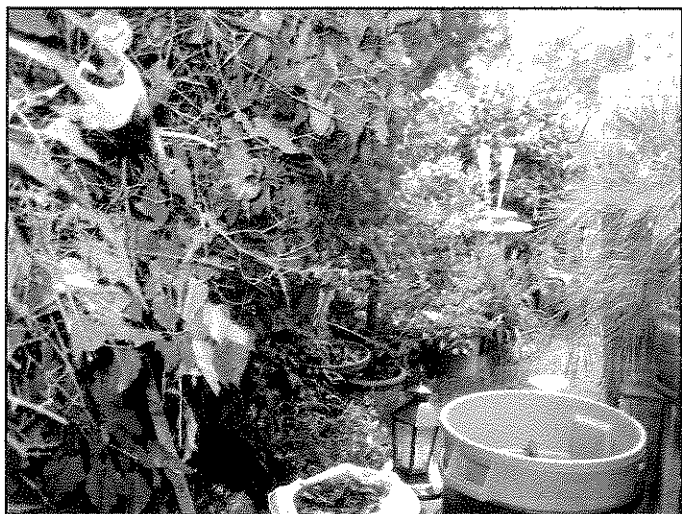
Reference Page: Grounds
Reference Area: Main Water Valve

Location: west side
worn valve

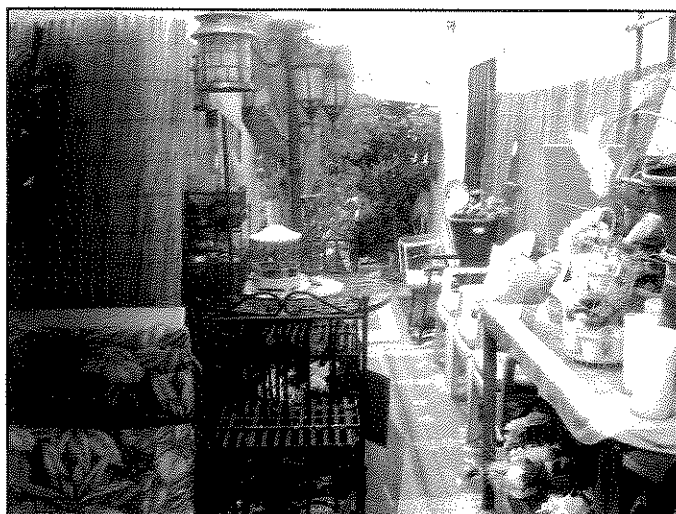
Reference Page: Grounds
Reference Area: Walkways

Includes driveways, walkways, patios, porches, decks and pool areas should they exist.
cracked-NFAM, N/A due to personal items

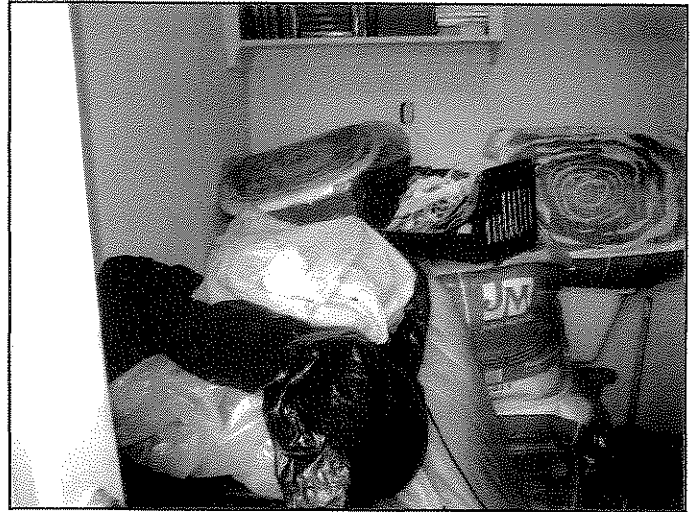
Reference Page: Laundry Area
Reference Area: General View

Dryer Vent: missing-NTBS, does not extend to outside air-NTBS

missing-NTBS, does not extend to outside air-NTBS

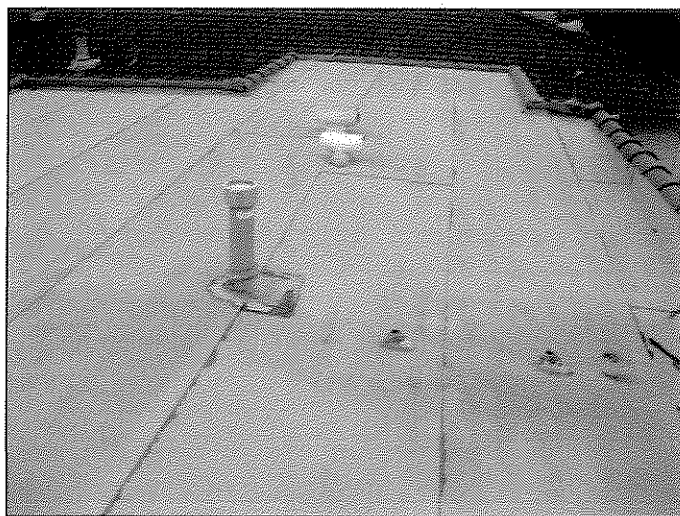
Reference Page: Roof
Reference Area: Vents/Vent Caps

5. VENTS/
VENT CAPS rusted
