## CITY OF CARSON

### PLANNING COMMISSION STAFF REPORT

PUBLIC HEARING: January 26, 2016  
SUBJECT: Conditional Use Permit No. 924-12  
APPLICANT: Henry Espiritu  
REQUEST: To approve a conditional use permit for an existing second dwelling unit located within the RS (Residential, Single-Family) zoning district  
PROPERTY INVOLVED: 20807-20807 ½ Margaret Street

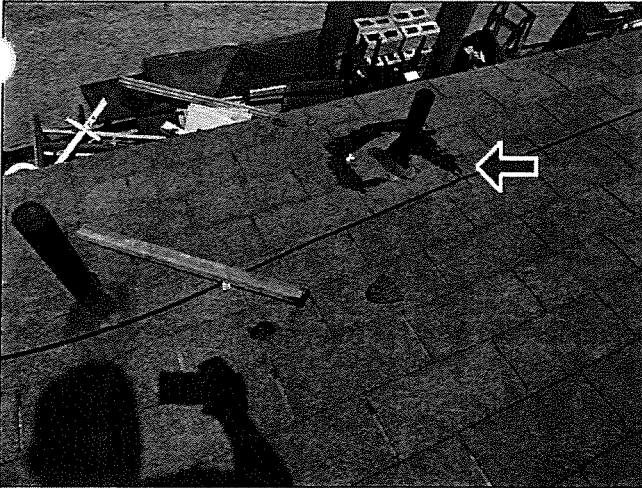
1.4.A Item 1(Picture)

**1.4.A (1)** The plumbing vent pipes need caulking around the perimeter of pipe and boot where boot flange has failed. Advise to have a Roofer inspect and repair as needed.

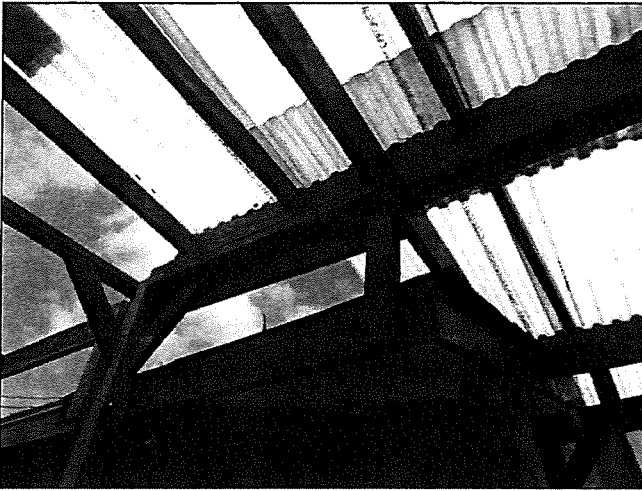
2.3.A Item 2(Picture)

(2) The patio awning is not attached properly to the wall or band of the home. It should have 5/8 galvanized "Lag Screws" or "Carriage Bolts" approximately every 16 inches.

Decay noted to the awning post. Refer to the termite report.

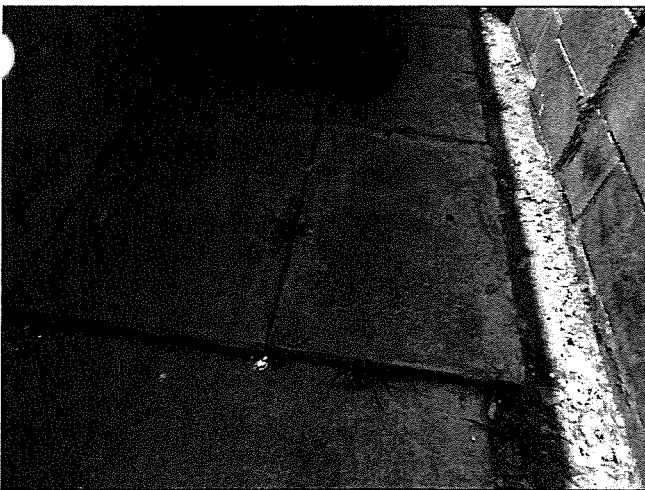
2.4.A Item 1(Picture)

**2.4.A** Cracks noted to the concrete driveway and walkway.

Uneven area noted to the concrete walkway right side of the house.

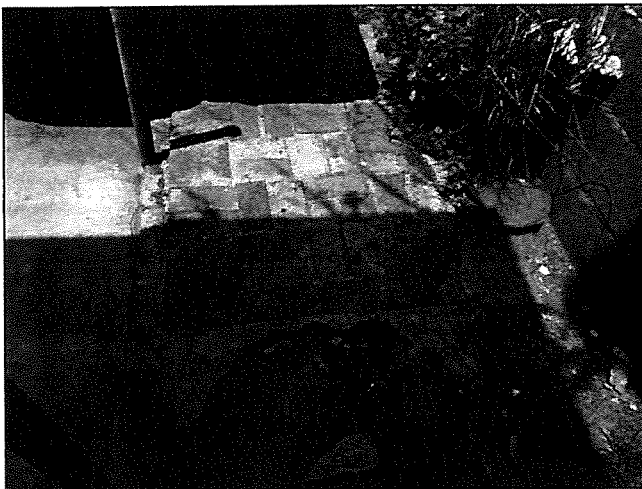
2.3.B Item 1(Picture)

Cracks noted to the concrete flooring.

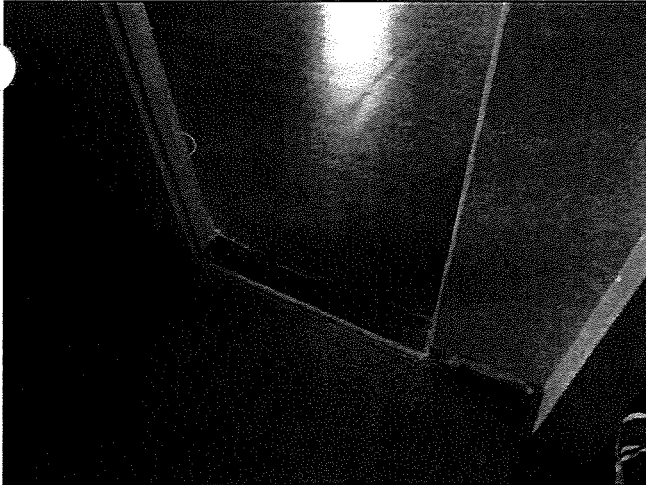
5.2.F Item 1(Picture)

5.2.F Patchwork noted to the wall at the doorway.

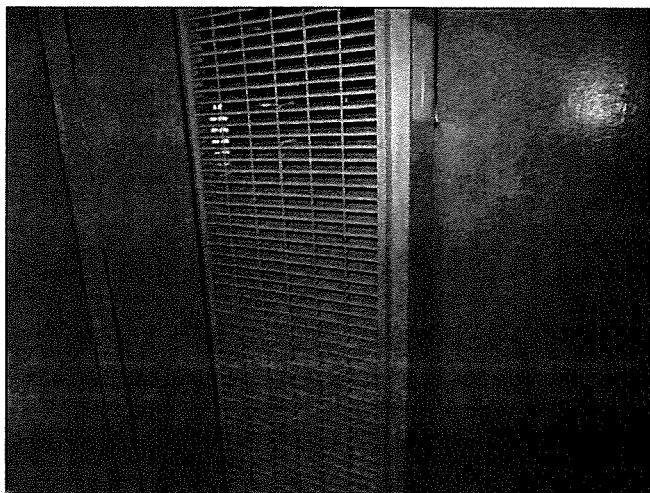
0.0.B Item 1(Picture)

**10.0.B** Could not test wall heater, pilot is shut off. Advise to have the Gas Company light and inspect and needed.

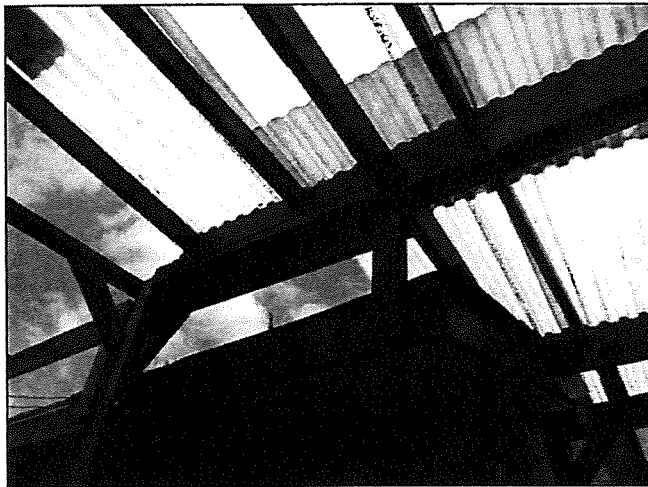
2.3.A Item 2(Picture)

Decay noted to the awning post. Refer to the termite report.

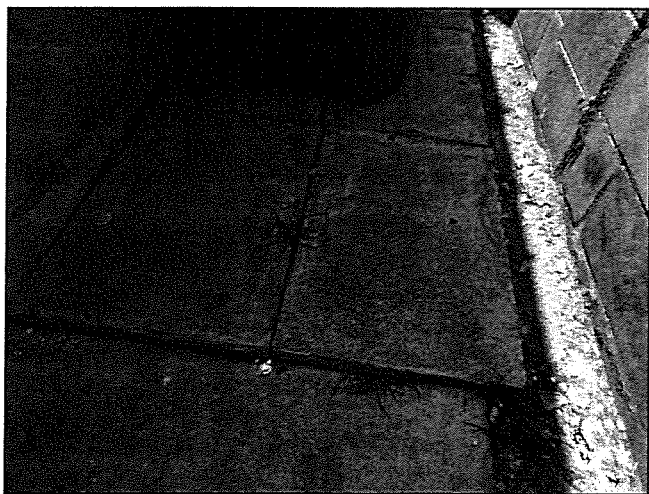
2.4.A Item 1(Picture)

Uneven area noted to the concrete walkway right side of the house.

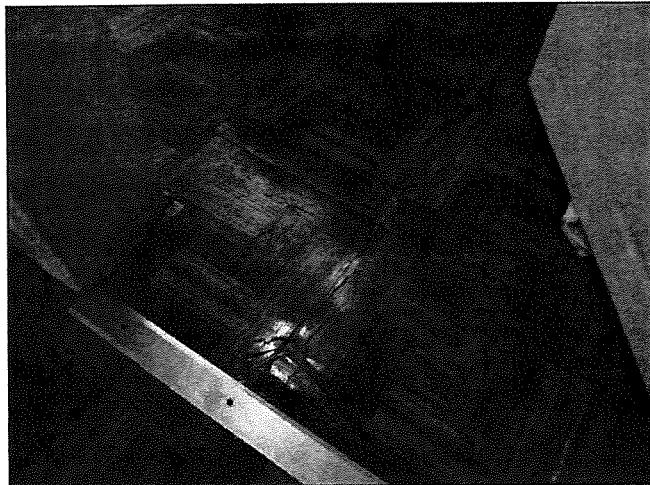
6.2.B Item 1(Picture)

Self adhesive tiles are lifting and damaged at several areas.
