**PRELIMINARY ENDANGERMENT ASSESSMENT WORK PLAN**  
**Carson City Hall Renovation Project**

701 and 801 East Carson Street

Carson, California

Project No. IR1316460K

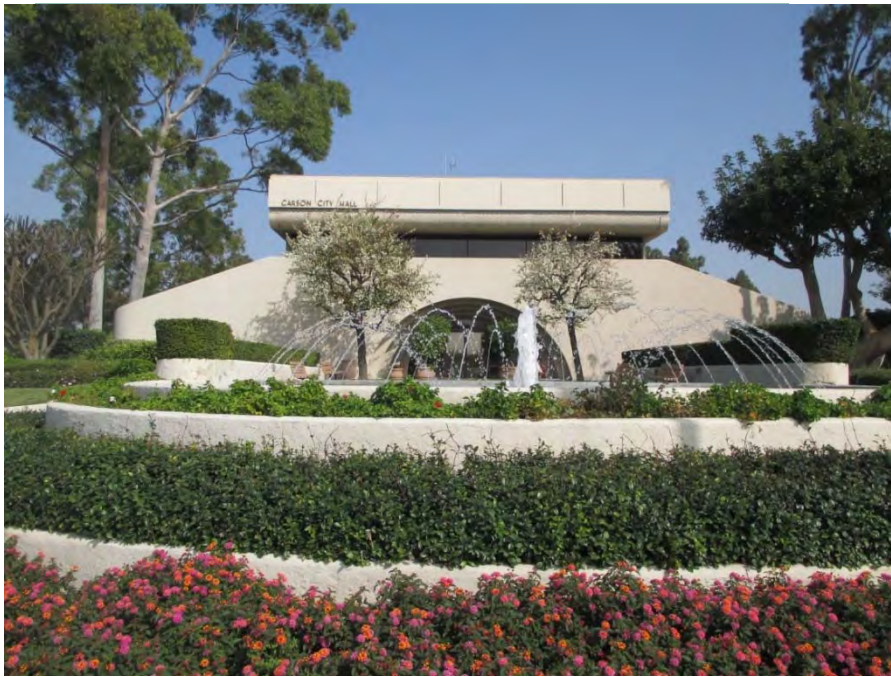
**Photo 1**

View to north of City Hall entrance.

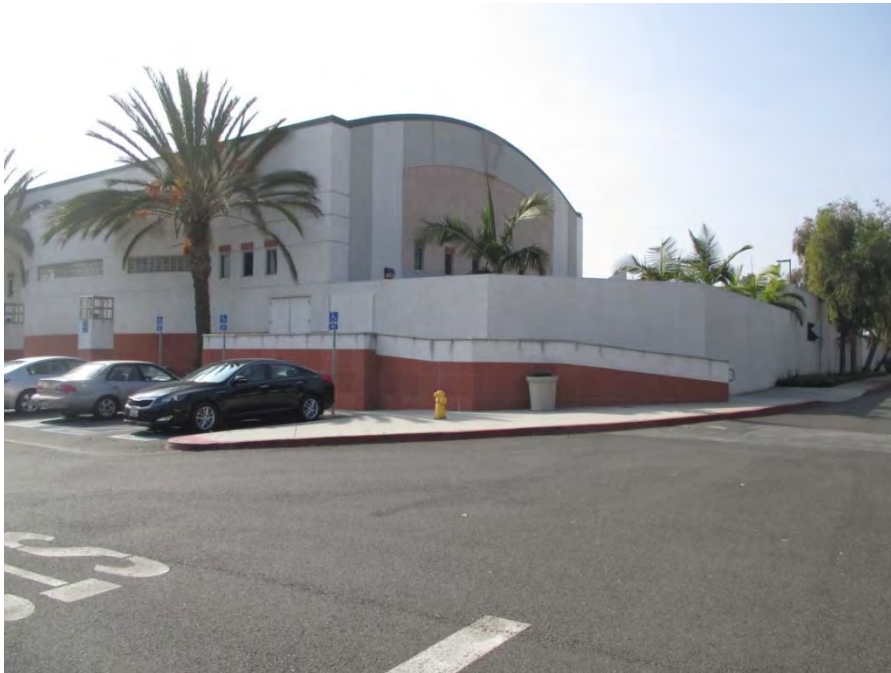
**Photo 2**

View to the southwest of north side of Community Center building.

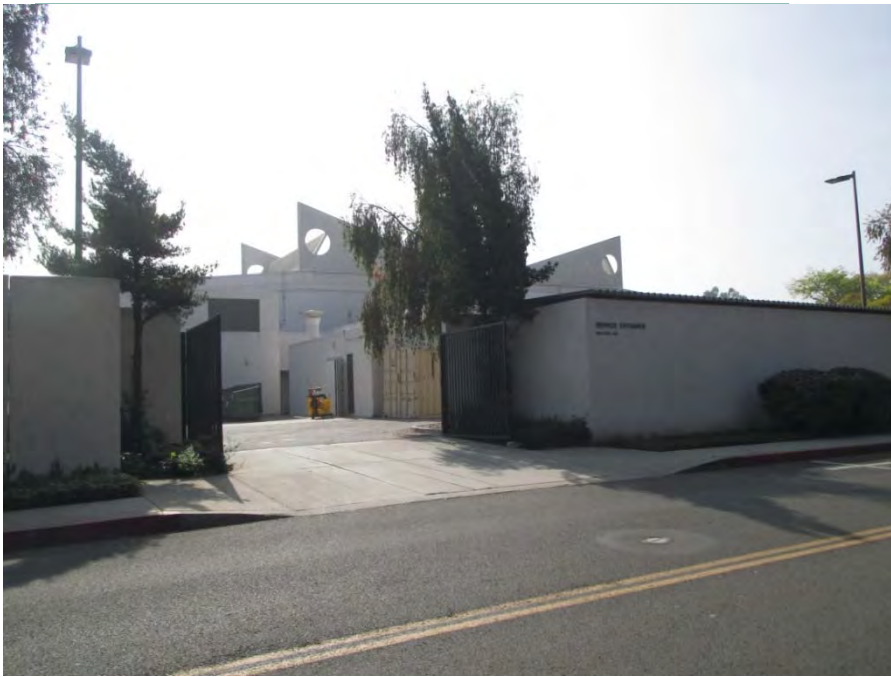
**Photo 3**

View to south of maintenance yard on north side of Community Center building.

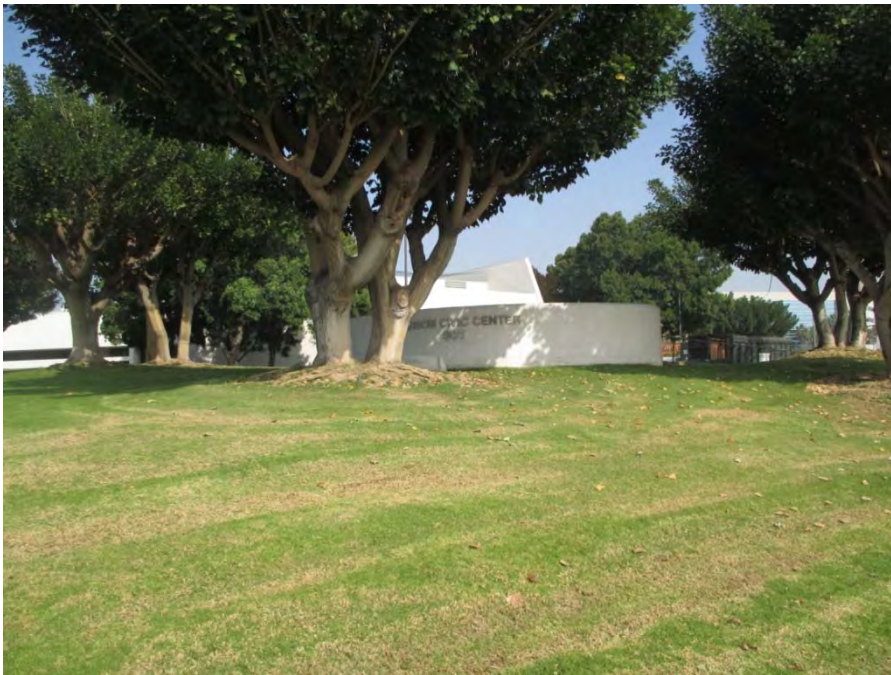
**Photo 4**

View to northeast of Community Center entrance.

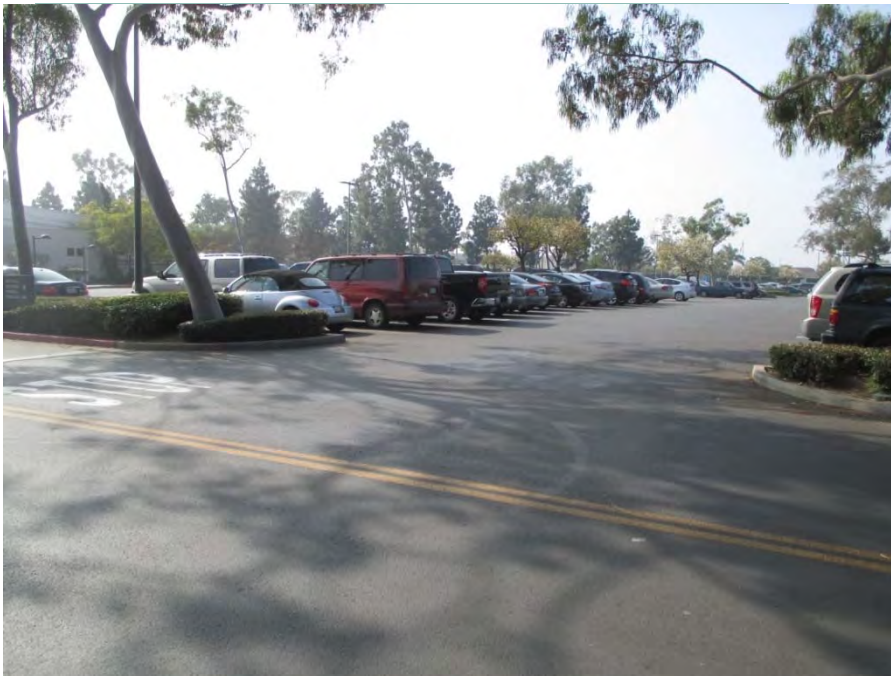
**Photo 5**

View of typical parking lot located in the northern and eastern portions of the site.

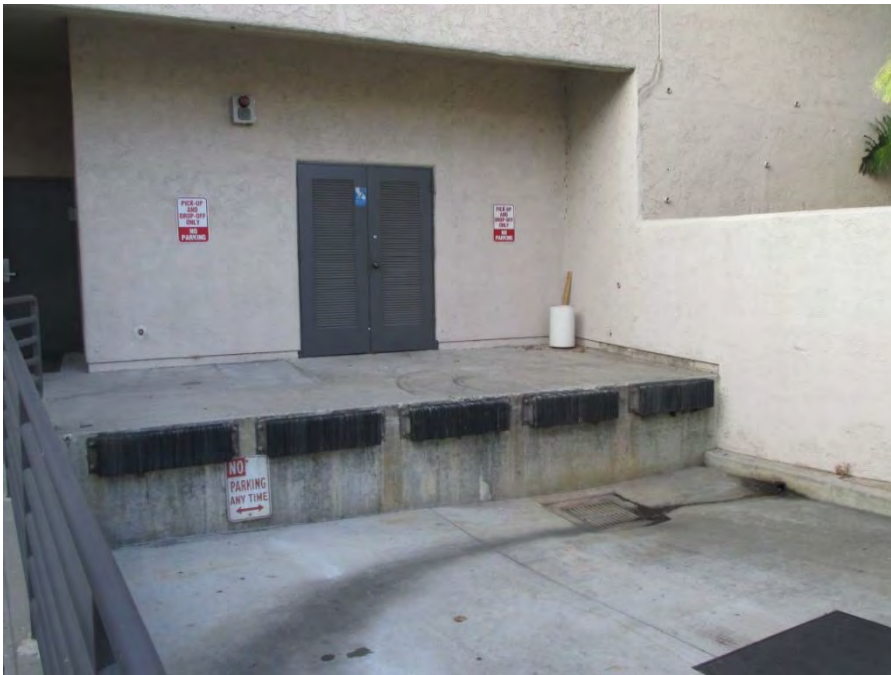
**Photo 6**

View of loading dock and generator room on east side of City Hall building.

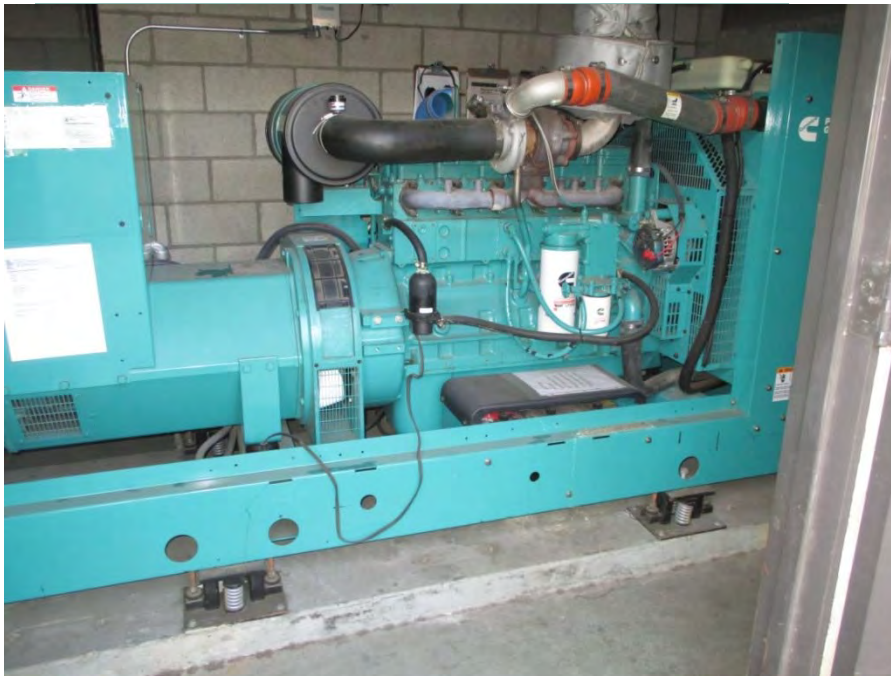
**Photo 7**

View of emergency generator inside generator room. No stains, spills, or leaks were visible.

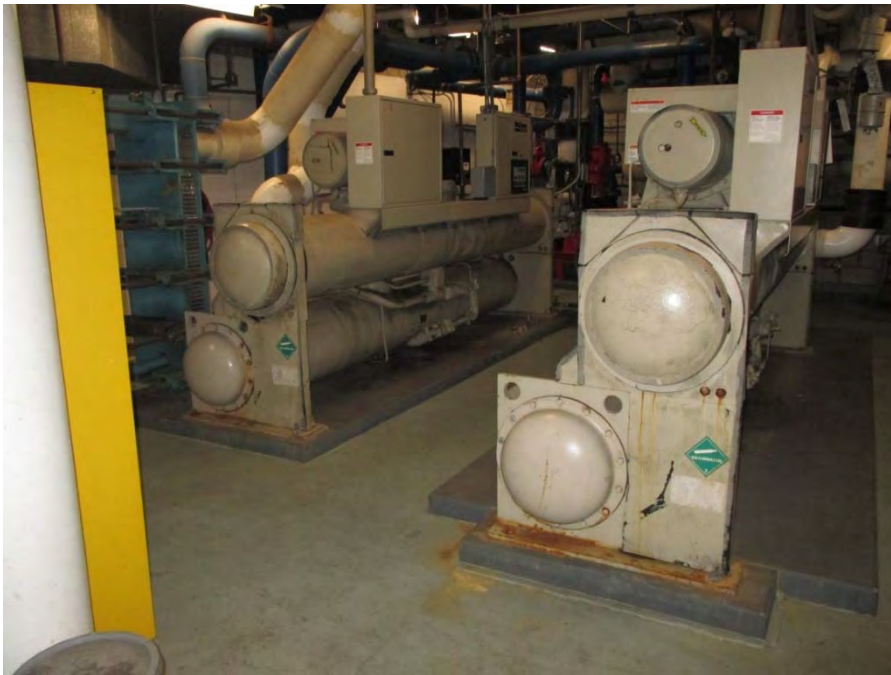
**Photo 8**

View of chiller room in City Hall basement. Chillers were installed in 1995. No stains, leaks, or spills were visible.

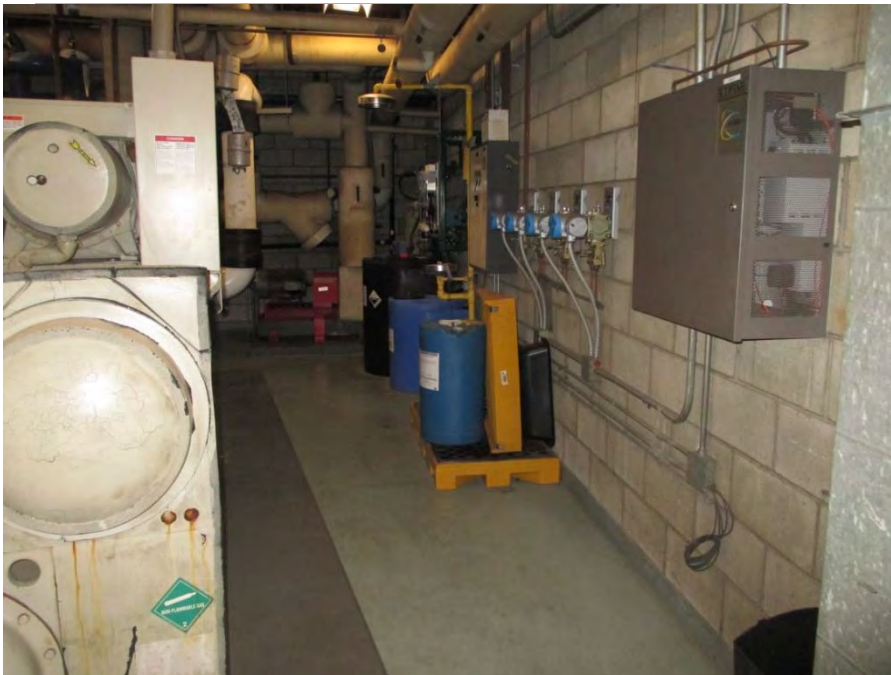
**Photo 9**

City Hall, located at 701 East Carson Street, has two stories of administrative floors and a basement that includes the following rooms: generator (photo 7), chiller (photos 8 through 10), boiler (photos 11 and 12), compressor (photo 13), electrical (photo 14), and HVAC. The generator is fueled by a 4,000-gallon diesel UST in the driveway/loading dock area just east of the generator (photo 15). No spills, leaks, or odors were observed in the equipment rooms, other than minor staining from the boiler (photo 12). Chemicals on secondary containment

Another view of chiller room.

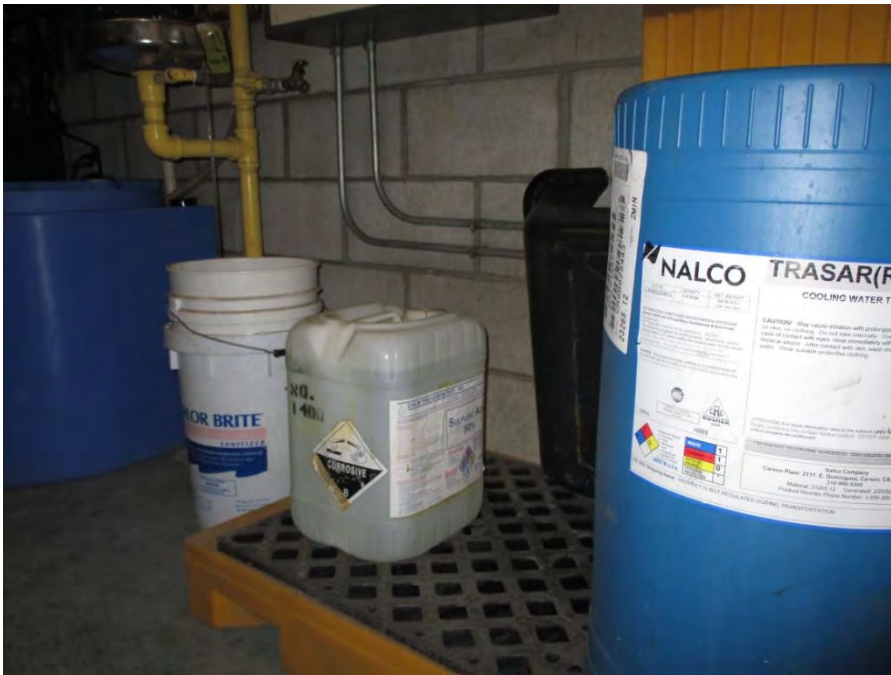
**Photo 10**

View of chiller room hazardous substances on secondary containment.

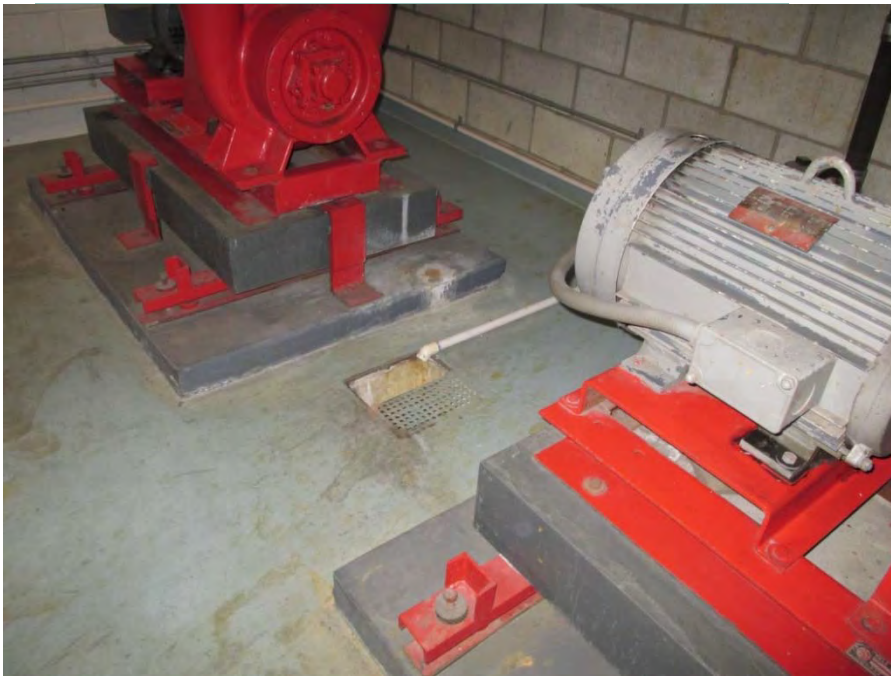
**Photo 11**

View of boiler room located in City Hall basement. Floor drains are connected to the sanitary sewer. No leaks or spills were observed, and staining was considered minor. Boilers were installed in 2011.

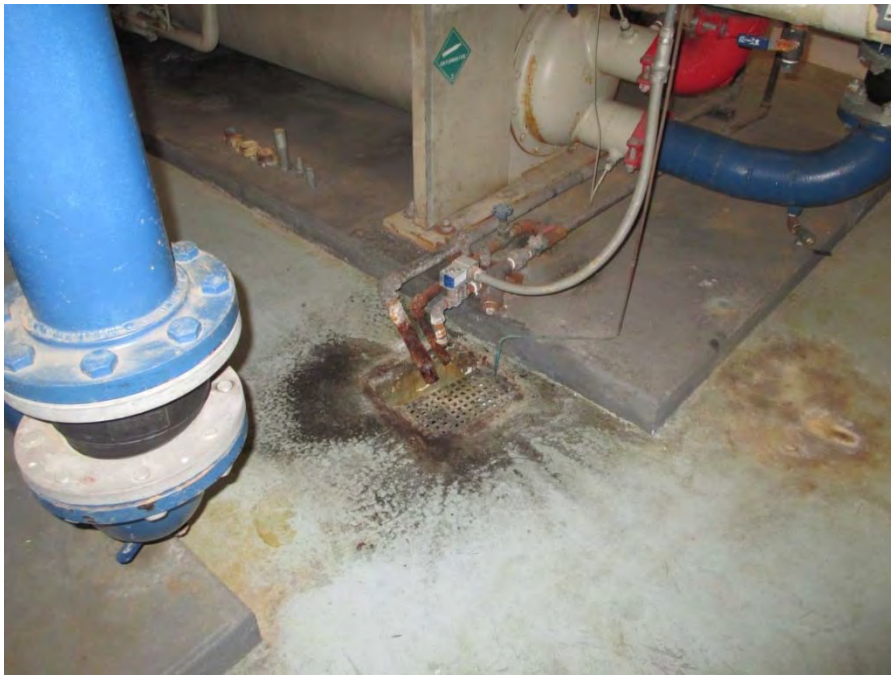
**Photo 12**

View of boiler room showing minor staining near floor drain.

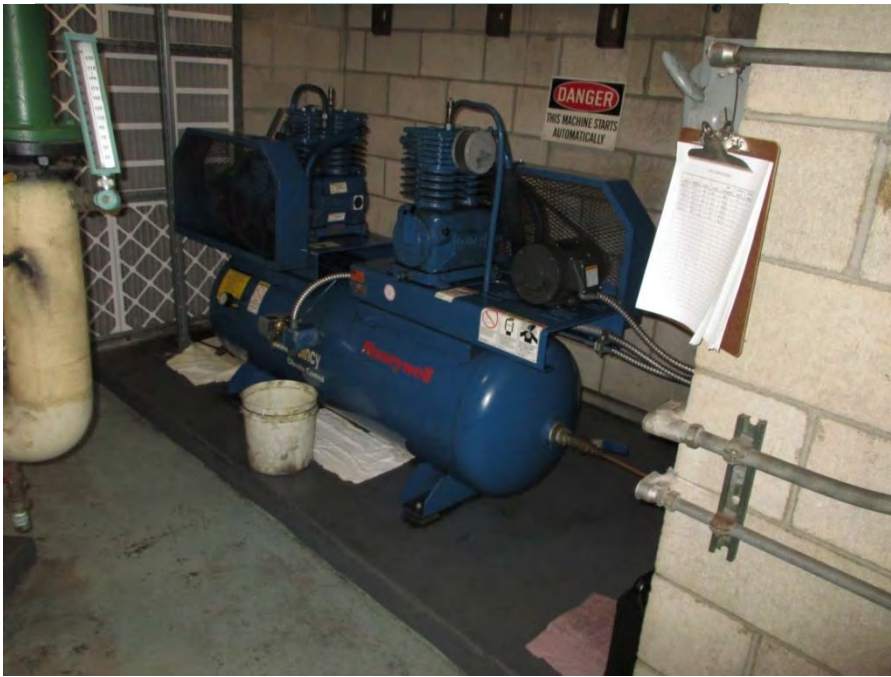
**Photo 13**

View of air compressor room in City Hall basement. Air compressor was dated 1976. No leaks, spills, or stains were visible.

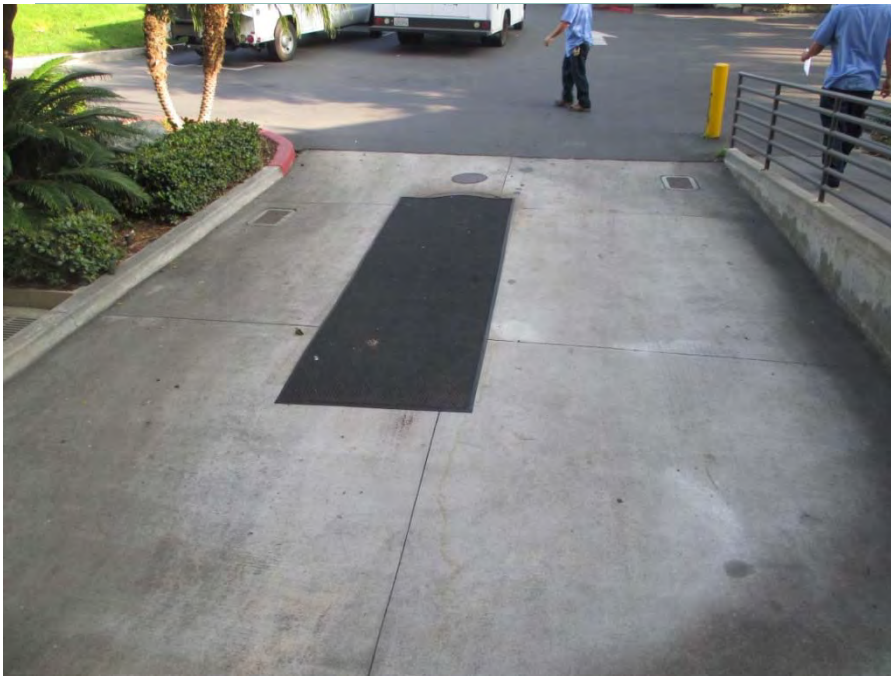
**Photo 15**

One 4,000-gallon diesel UST is located on the east side of City Hall (Figure 2). In 1998, Miller Brooks Environmental (MBE) replaced the original single-walled 4,000-gallon diesel UST and associated piping reportedly installed in the mid-1970s with a new double-walled fiberglass 4,000-gallon diesel UST in the same location. Approximately 76 tons of petroleum-impacted soil was transported to TPS Technologies, Inc. facility in Azusa, California (MBE, 1998). Confirmation soil sampling was conducted and no significant hydrocarbon impacts were reported in the UST excavation.

View of 4,000-gallon diesel UST area (under black pad), located in loading dock area on east side of City Hall.

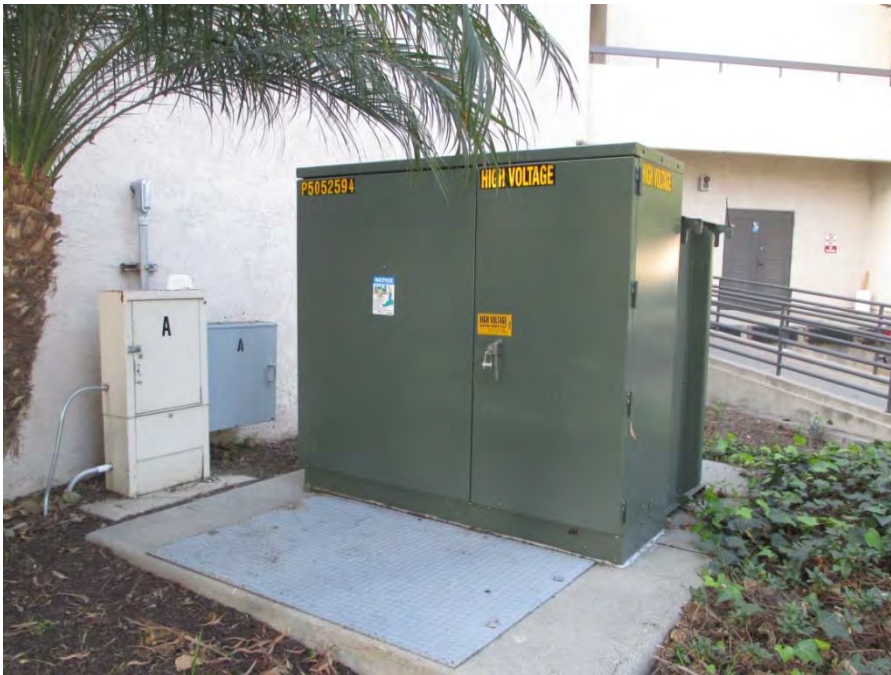
**Photo 16**

View of pad-mounted transformer on east side of City Hall. No stains, leaks, or spills were visible.

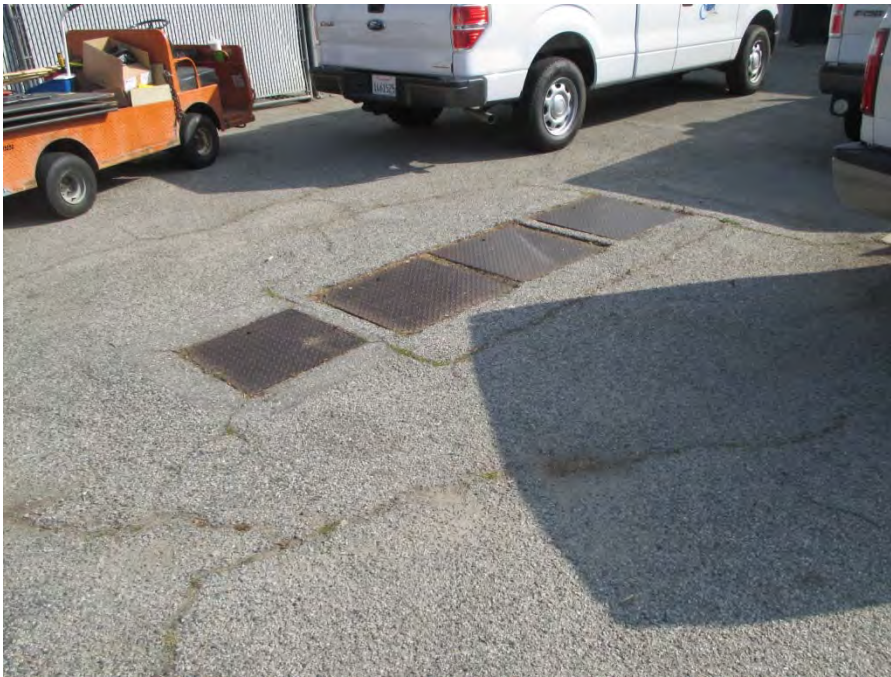
**Photo 17**

The Community Center is occupied by equipment rooms similar to those observed in the City Hall building. A loading dock and 1,250-gallon clarifier are located in the maintenance yard on the north side of the building. The maintenance yard is used to load/unload primarily general office supplies. Various city employees interviewed during the Phase I ESA stated that to their knowledge the maintenance yard was not used as an automotive repair shop (Amec Foster Wheeler, 2015). Instead, the yard was used to park vehicles, store small quantities of paint, store light bulbs, and park small lawn mowers. As noted in the Phase I ESA (Amec Foster Wheeler, 2015), the clarifier was used to contain water used to wash large high power lawnmowers and accessory equipment. City employees interviewed during this Phase I ESA stated that, to their knowledge, no lawnmowers or accessory equipment are washed at the site and the clarifier is no longer used.

View of clarifier in maintenance yard, Community Center building.

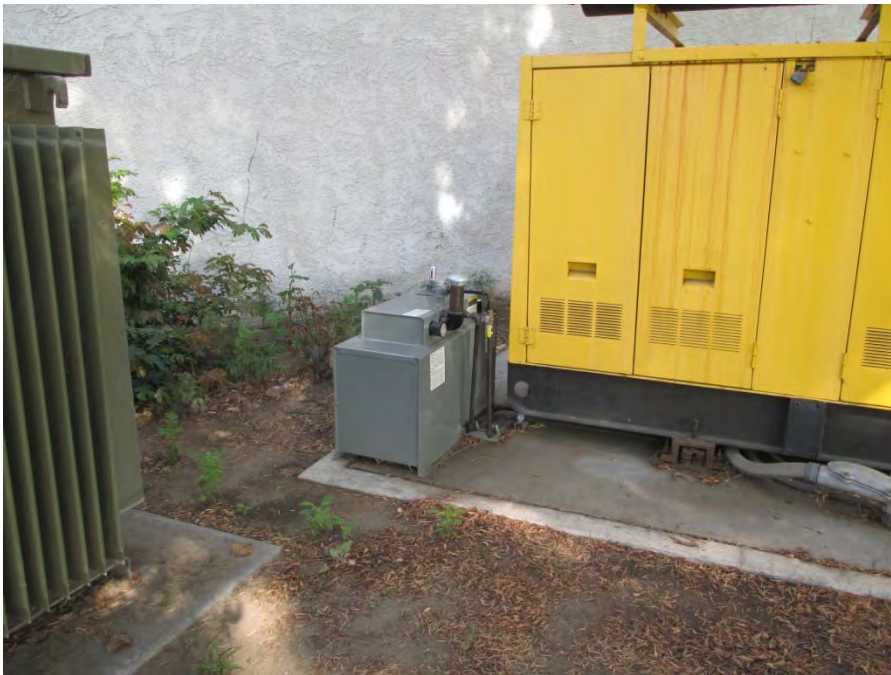
**Photo 18**

One double-walled, 25 gallon diesel aboveground storage tank (AST) located on the southeast side of the Community Center building was identified as a PEC. However, given the small size of the AST and no evidence and spills or releases, operation of the 25 gallon diesel AST is considered a *de minimis* condition and thus not subject to PEA sampling as described herein.

View of generator and associated double-walled 25-gallon diesel AST adjacent to southeastern exterior of Community Center building.

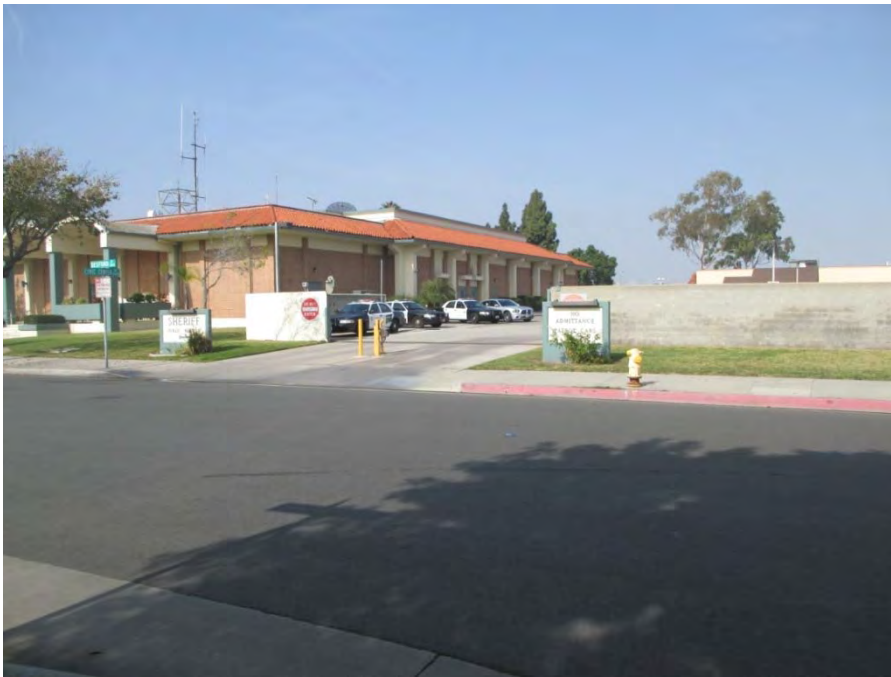
**Photo 19**

- A residential neighborhood is located northeast of the site (photos 19 and 20).
- Los Angeles County Facilities MGM, also identified as Los Angeles County Sheriff (Site C-1), is located north of the northwest portion of the site on the northern side of Desford Street (photo 19). As discussed in Section 5.1.2, petroleum impacts to groundwater are associated with this property and remediation is ongoing. During the site reconnaissance, two groundwater monitoring wells, believed to be associated with this property, were observed in Desford Street (photos 20 and 21). This location is considered a REC for the site.

View to north of Los Angeles Sheriff Station entrance. Desford Street is in the foreground.

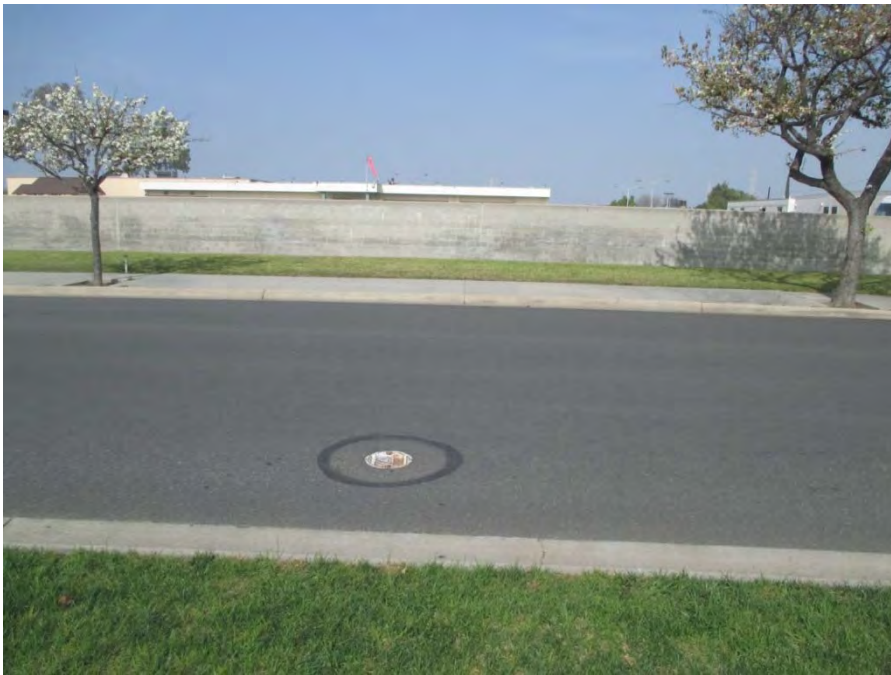
**Photo 20**

View to north of groundwater monitoring well located in Desford Street. The building behind the concrete wall is the Los Angeles County Sheriff Station. The site is to the south.

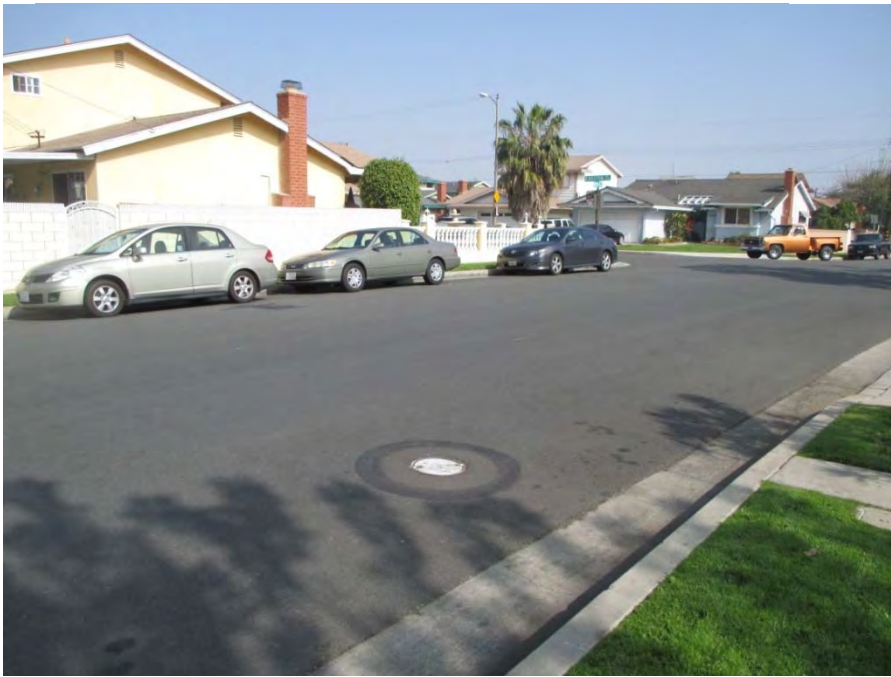
**Photo 21**

View to northeast of groundwater monitoring well located in Desford Street, north of the site.

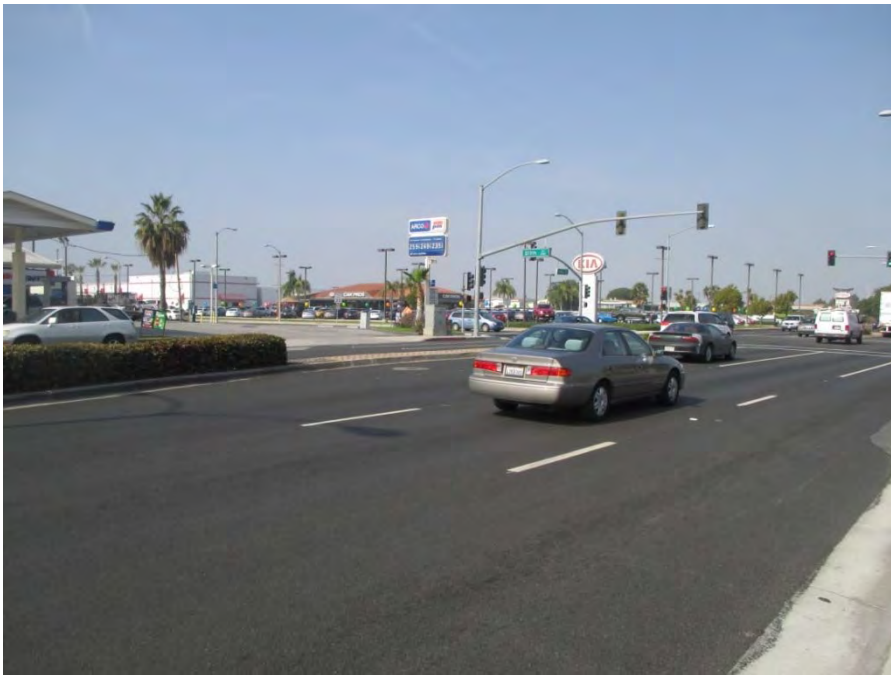
**Photo 22**

- An Arco gas station is located north-northwest of the site (photo 22). As discussed in Section 5.1.2, groundwater has been impacted by gasoline; however, the property meets the LARWQCB's low-threat criteria for a case closure. Based on this information, the property is considered a REC for the site. If, however, the Regional Board grants the site a closure, this property may be considered as a CREC.

View to northwest of ARCO Gas Station, located at 213<sup>th</sup> Street and Avalon Boulevard. Former Shell Station is off to the right side of the photograph. The site is to the southeast.

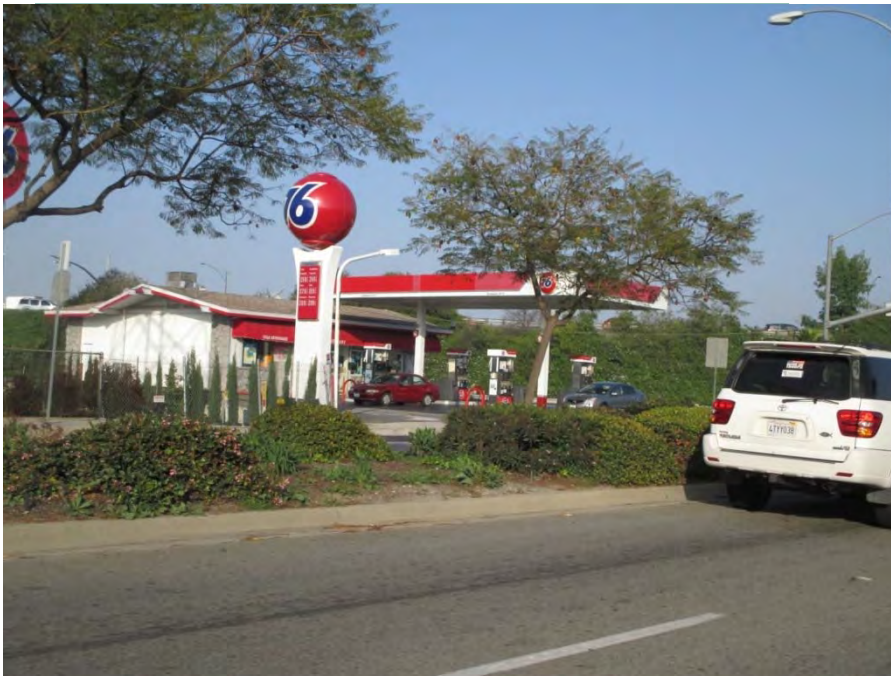
**Photo 27**

- A Tosco 76 Station, located at 1025 East Carson Street, is situated approximately 700 feet east of the site (photo 27). As discussed in Section 5.1.2, it is listed as a LUST Cleanup project with ongoing remediation involving gasoline impacts to groundwater. This location is considered a REC for the site.

View of Tosco – 76 Station, located east of the site.

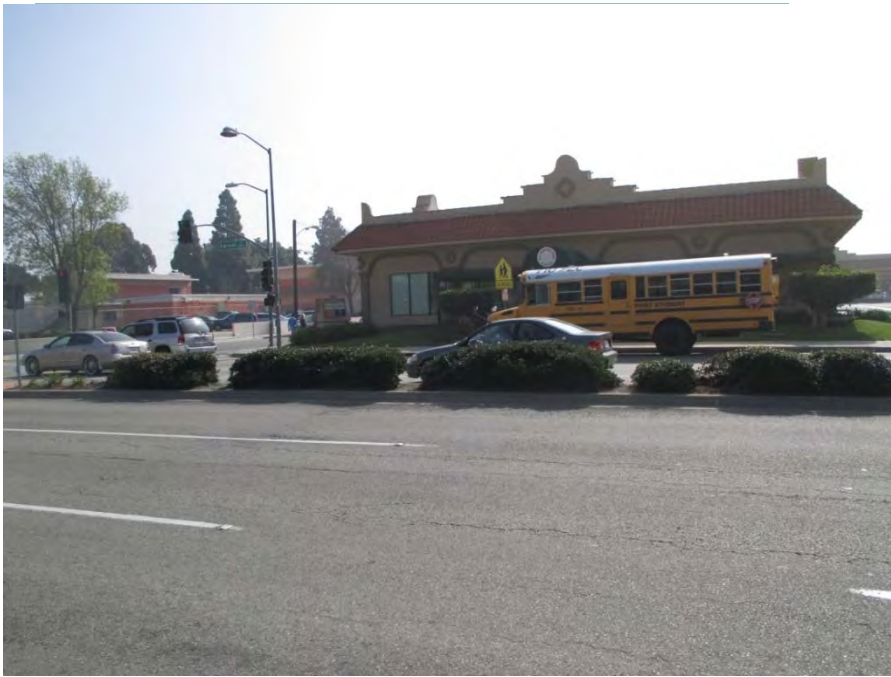
**Photo 29**

- Along the southern boundary of the site and west of Andrew Carnegie Middle School is a restaurant (860 East Carson Street) where the former Bonita Cleaners was located (photo 29). Bonita Cleaners is considered a PEC for the site.

View to the south of 860 Bonita Street, currently a restaurant and formerly Bonita Cleaners. East Carson Street is in the foreground. The site is to the north.

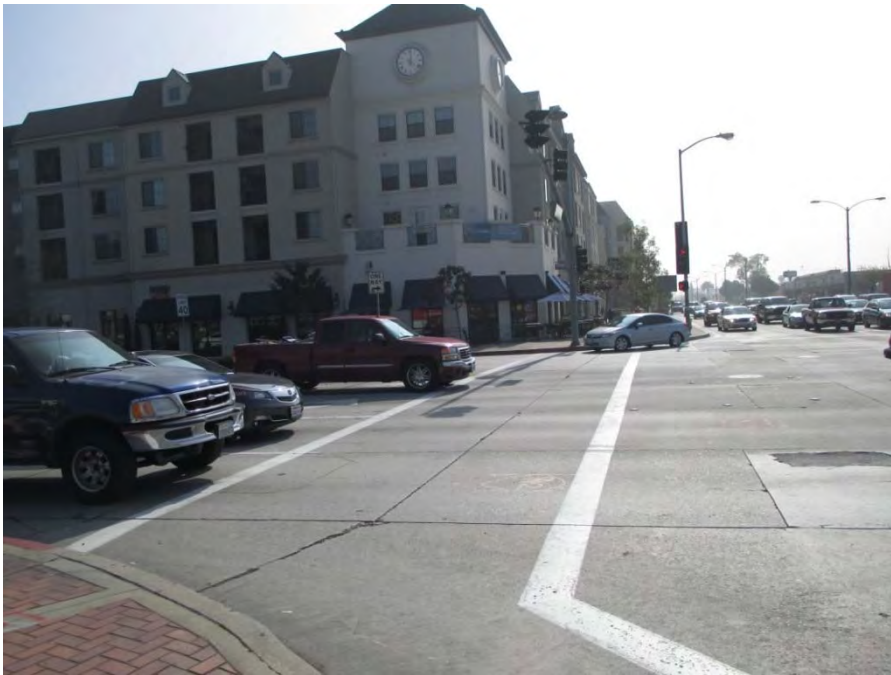
**Photo 30**

- An IHOP restaurant, located southeast of the intersection of Carson Street and Avalon Boulevard, is the former location of Econo Lube N' Tune (photo 30). As discussed in Section 5.1.2, petroleum impacted groundwater was identified and remediated, and an NFA letter was issued. This location is considered a CREC for the site.

View to south of intersection of Carson Street (in foreground) and Avalon Boulevard (on right). IHOP restaurant (formerly an Econo Lube N' Tune) is at the southeast corner of the intersection. Site is to the north.

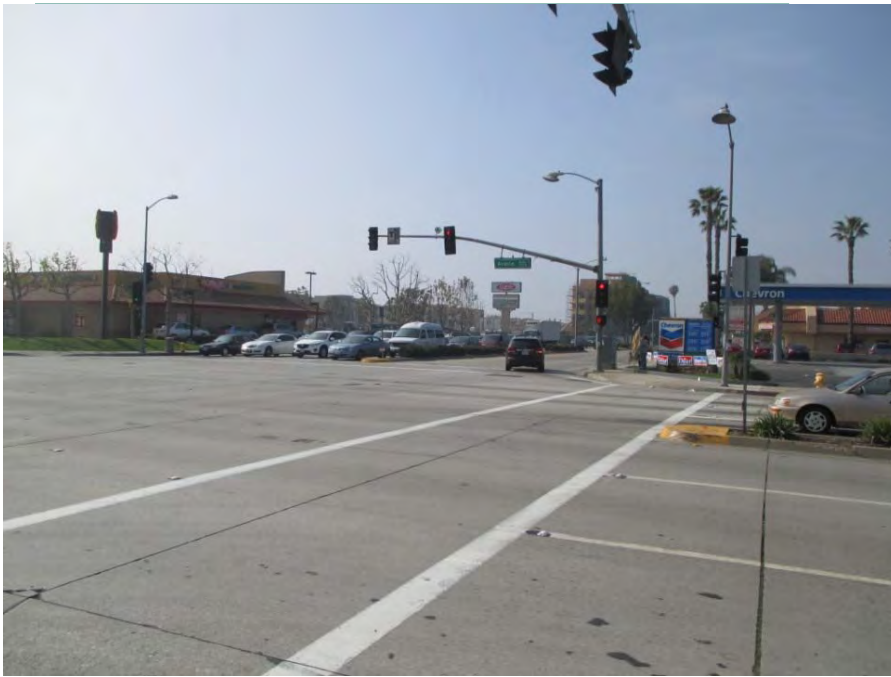
**Photo 31**

- A Carl's Jr. is located southwest of the intersection of Carson Street and Avalon Boulevard, southwest of the site (photo 31). This is the former location of the Chevron Station. As discussed in Section 5.1.2, this property was identified as an open LUST Cleanup project involving petroleum-impacted groundwater. This location is considered a REC for the site.

- A Chevron Station is located at the northwest corner of Carson Street and Avalon Boulevard, situated west of the southwest corner of the site (photo 31). An Exxon/Mobil Station previously at this location is identified in Section 5.1.2 as a closed LUST Cleanup project involving gasoline impacts to groundwater. This location is considered a CREC for the site.

View to southwest of Avalon Boulevard and Carson Street. Chevron Gas Station (formerly an Exxon Mobil Station) is on the right, located west of the site. Carl's Jr. (formerly a Chevron Gas Station) is on the left, located southwest of the site.

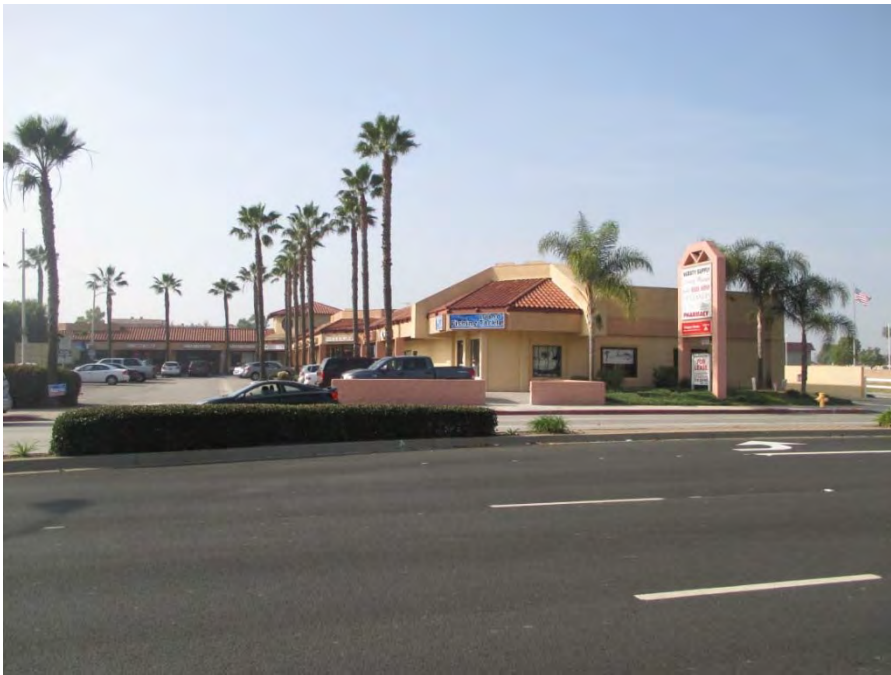
**Photo 32**

View to west of strip mall, including Happy Cleaners. Avalon Boulevard is in foreground. The site is to the east.
