# CITY OF CARSON

## PLANNING COMMISSION STAFF REPORT

PUBLIC HEARING: October 27, 2009  
SUBJECT: Conditional Use Permit No. 745-09  
APPLICANT: America's Tire Company  
C/o: Steven J. Eichberg, Esq.  
2046 Kirsten Lee Drive  
Westlake Village, CA 91361  
REQUEST: Conditional Use Permit approval to facilitate exterior improvements to an America's tire sales/repair store on a site located in the CR-D (Commercial, Regional-Design Overlay Review) zone district  
PROPERTY INVOLVED: 20741 S. Avalon Boulevard

# Property Inspection Report

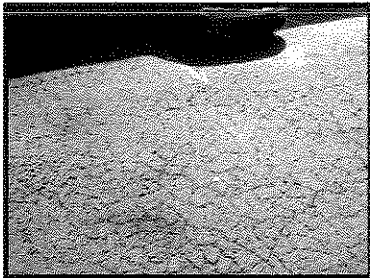
#### PARKING LOT:

1. [CR] The asphalt parking lot had deteriorated to the point where repairs will be needed. We recommend correcting the condition(s) noted. There were common cracks in the parking lot, no action is needed at this time.(front concrete section)

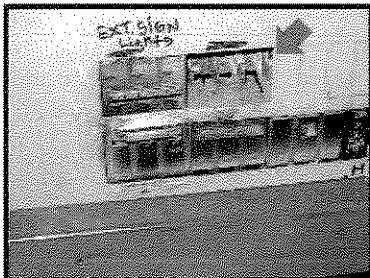
#### MAIN PANEL:

2. [SC] There were missing twist-outs/unused breaker slots in the panel. This condition is a safety hazard. We recommend correcting the condition(s) noted.

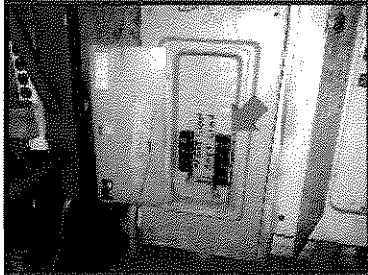
ELECTRIC PANEL:

3. [SC] The buildings main electrical service panel was manufactured by Federal Pacific / Stab-Lok. This panel has been known to present latent hazards by malfunctioning under certain conditions resulting in jammed circuit breakers. The breakers may not trip (disconnect) under imposed load conditions. Failure can also occur at the connections to the bus bars due to inadequate bending space for the service entrance conductors. We recommend further evaluation by a specialist in the appropriate trade.

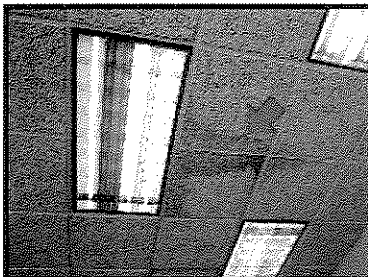
WALLS/CEILING:

6. [CR] Moisture stains were noted on the wall(s)/ceiling. We recommend locating and correcting the source and any damaged materials. (numerous areas) These areas appeared dry We recommend locating and correcting the source and any damaged materials.

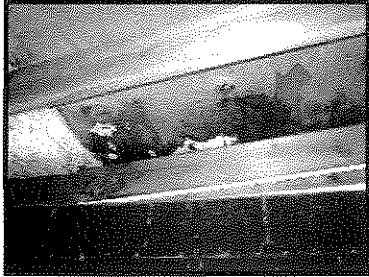
*WALLS/CEILING:*

7. [CR] Moisture stains were noted on the wall(s)/ceiling. We recommend locating and correcting the source and any damaged materials. The area tested dry during the inspection. We recommend locating and correcting the source and any damaged materials.

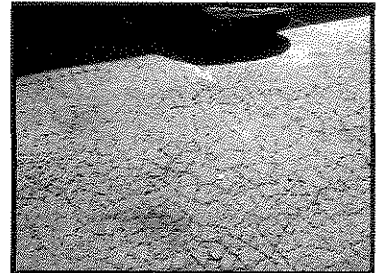
**PARKING LOT:**

[CR] The asphalt parking lot had deteriorated to the point where repairs will be needed. We recommend correcting the condition(s) noted. There were common cracks in the parking lot, no action is needed at this time.(front concrete section)

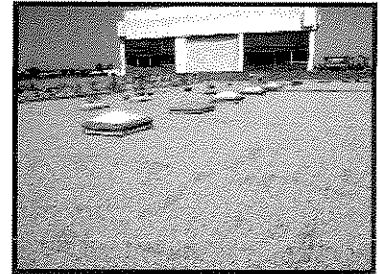
**ROOF COVERING:**

Materials: built-up with a cap sheet surface.

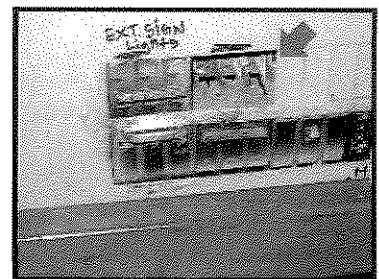
**MAIN PANEL:** [SC] There were missing twist-outs/unused breaker slots in the panel. This condition is a safety hazard. We recommend correcting the condition(s) noted.

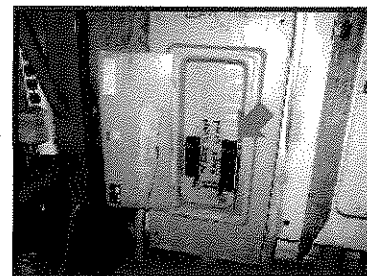
**ELECTRIC PANEL:**

[SC] The buildings main electrical service panel was manufactured by Federal Pacific / Stab-Lok. This panel has been known to present latent hazards by malfunctioning under certain conditions resulting in jammed circuit breakers. The breakers may not trip (disconnect) under imposed load conditions. Failure can also occur at the connections to the bus bars due to inadequate bending space for the service entrance conductors. We recommend further evaluation by a specialist in the appropriate trade.

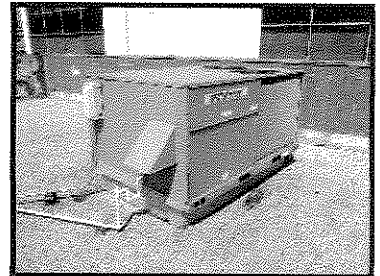
**LOCATION(S):**

The unit was located on the roof.

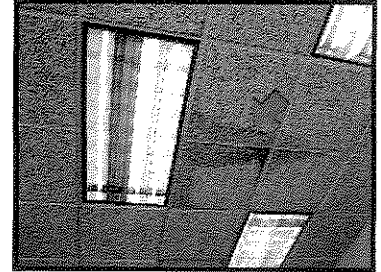
**WALLS/CEILING:**

[CR] Moisture stains were noted on the wall(s)/ceiling. We recommend locating and correcting the source and any damaged materials. (numerous areas) These areas appeared dry. We recommend locating and correcting the source and any damaged materials.

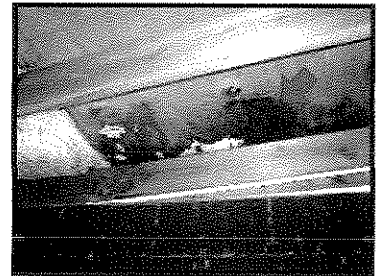
**WALLS/CEILING:**

[CR] Moisture stains were noted on the wall(s)/ceiling. We recommend locating and correcting the source and any damaged materials. The area tested dry during the inspection. We recommend locating and correcting the source and any damaged materials.
