# CITY OF CARSON

## PLANNING COMMISSION STAFF REPORT

PUBLIC HEARING: February 12, 2013  
SUBJECT: Conditional Use Permit No. 882-11  
APPLICANT: Gabriel Varela  
2729 and 2731 E. Van Buren Street  
Carson, CA 90810  
REQUEST: To approve a Conditional Use Permit for a second dwelling located within the RS (Residential, Single Family) zone district  
PROPERTY INVOLVED: 2729 and 2731 E. Van Buren Street

**2729/2731 East Van Buren St**

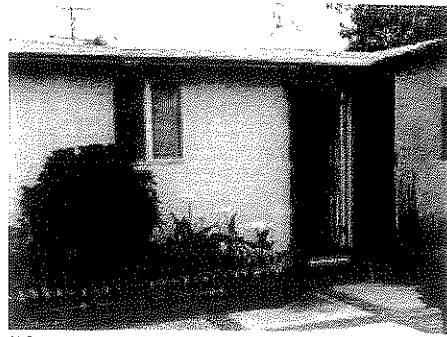
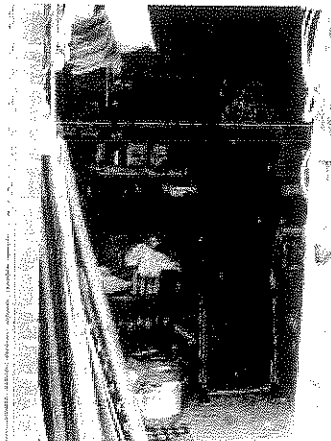
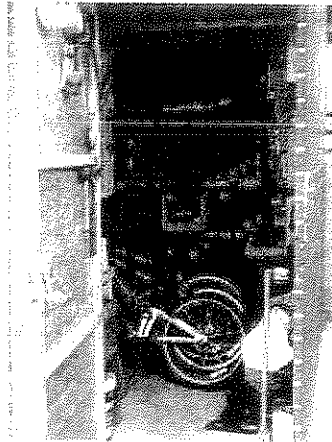
At the time of the inspection, the exterior of the property appears to be in good and serviceable condition. There were two storages at the back of the house in serviceable condition.

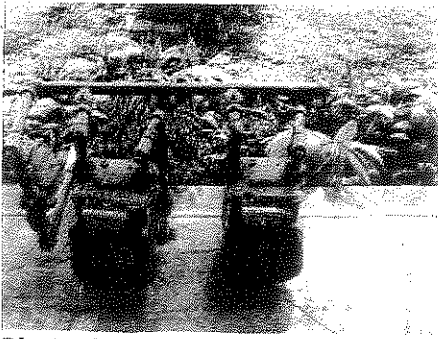
Photo 6

2) An excess flow gas shut off valve or earthquake gas shut off valve should be installed .A licensed plumbing contractor should do it

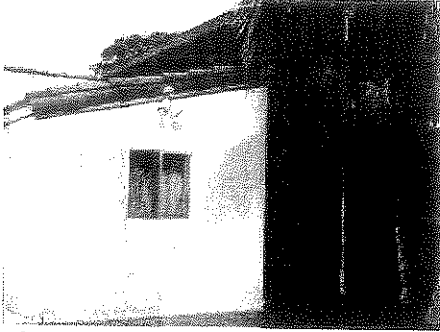
3) At the unit # 2729 the garage was converted into a studio and laundry area. At the unit # 2931 there is a laundry area at the garage.

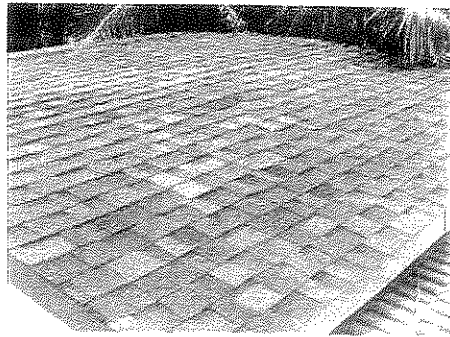
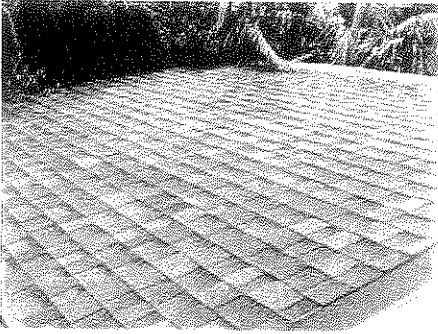
4) ✓ The roof, in general appears to be in serviceable and good condition.

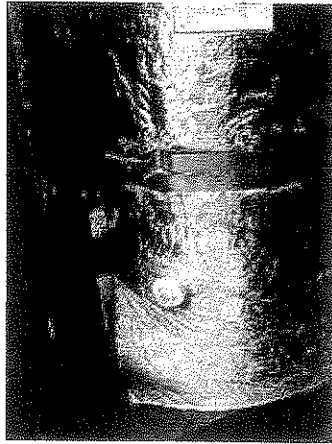
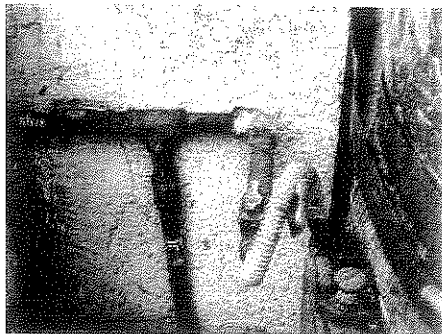
7) Both water heater are in serviceable and working condition. There was hot water at the bathrooms and kitchen in both units.

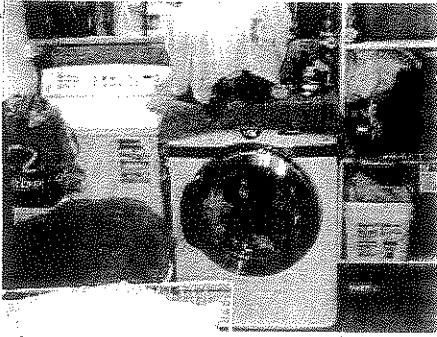
Photo 14

Neither the clothes washer nor dryer were operated or evaluated. They are excluded from this inspection.

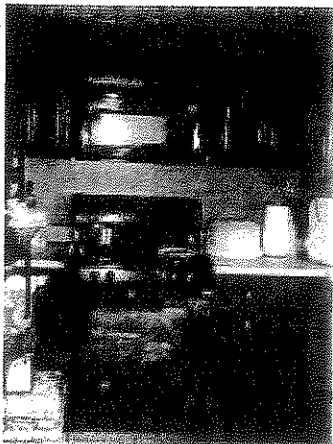
10) At the unit # 2729, the kitchen appears to be in serviceable and good condition.

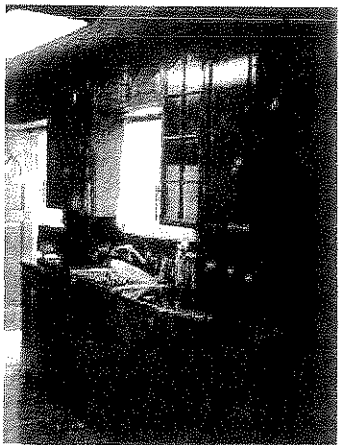
11) At the unit # 2931, the kitchen appears to be in serviceable and good condition.

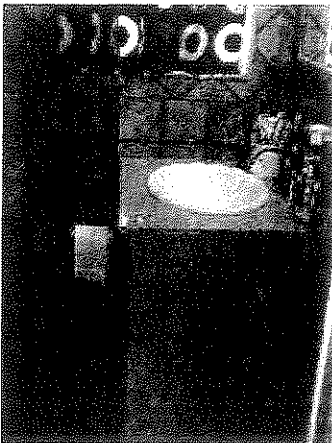
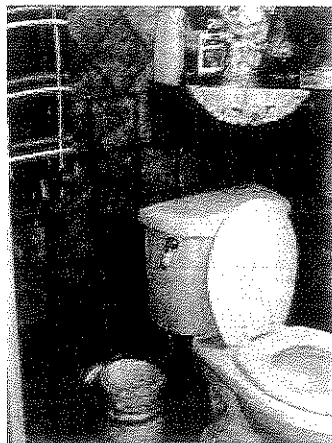
14) ✓ At the unit # 2729 The bathroom appears to be in serviceable condition. Toilet, sink, shower are in good condition. Cabinets is fine.

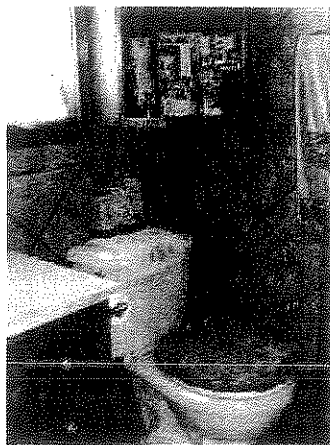
15) ✓ At the time of the inspection, the bathroom at the unit # 2931 appears to be in serviceable condition. Toilet, sink, shower are in good condition. Cabinets are fine.

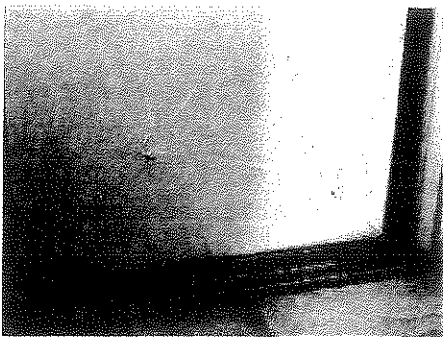
Photo 28

16) ↖ Glass in one or more windows is broken. A qualified contractor should replace glass where necessary. house 2729

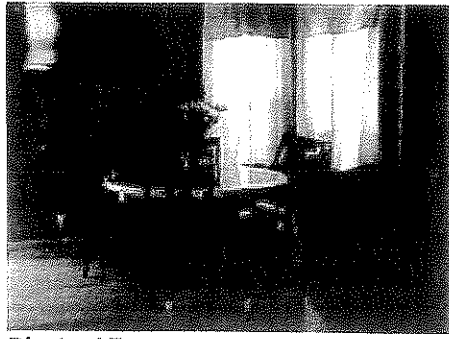
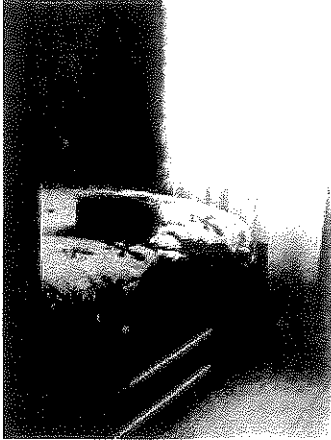
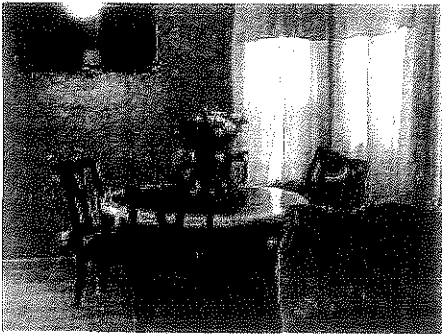
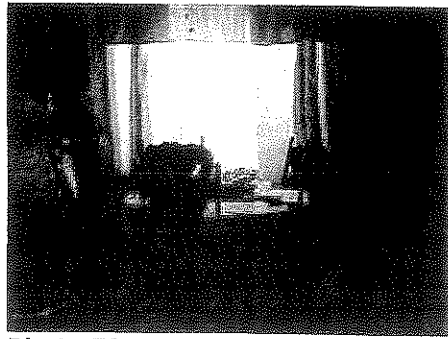
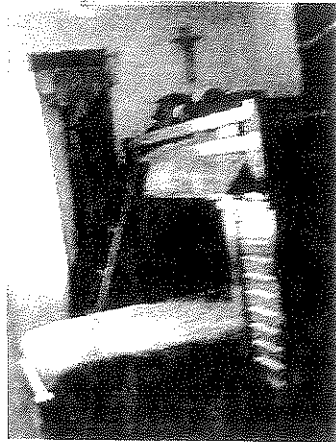
17) At the time of the inspection, the interior of both units are in good and serviceable condition. Walls are clean and painted. Floors and/or carpet are fine. Windows and doors open and close correctly.
