CITY OF CARSON

CASE 4
MEANDERING SIDEWALK

SIDEWALK REPLACEMENT DETAILS

REVISIONS	SIDEWALK AND DRIVEWAY REPAIR		DRAWN BY:
DATE APPROVED: 2-15-01	RECOMMENDED: <i>Fanokh A. Joffe</i> CIVIL ENGINEERING MANAGER	APPROVED: <i>Kern Boyce</i> DIRECTOR OF PUBLIC WORKS	GILBERT M. MARQUEZ, P.E.
SHEET 1 OF 1			NO. 119B

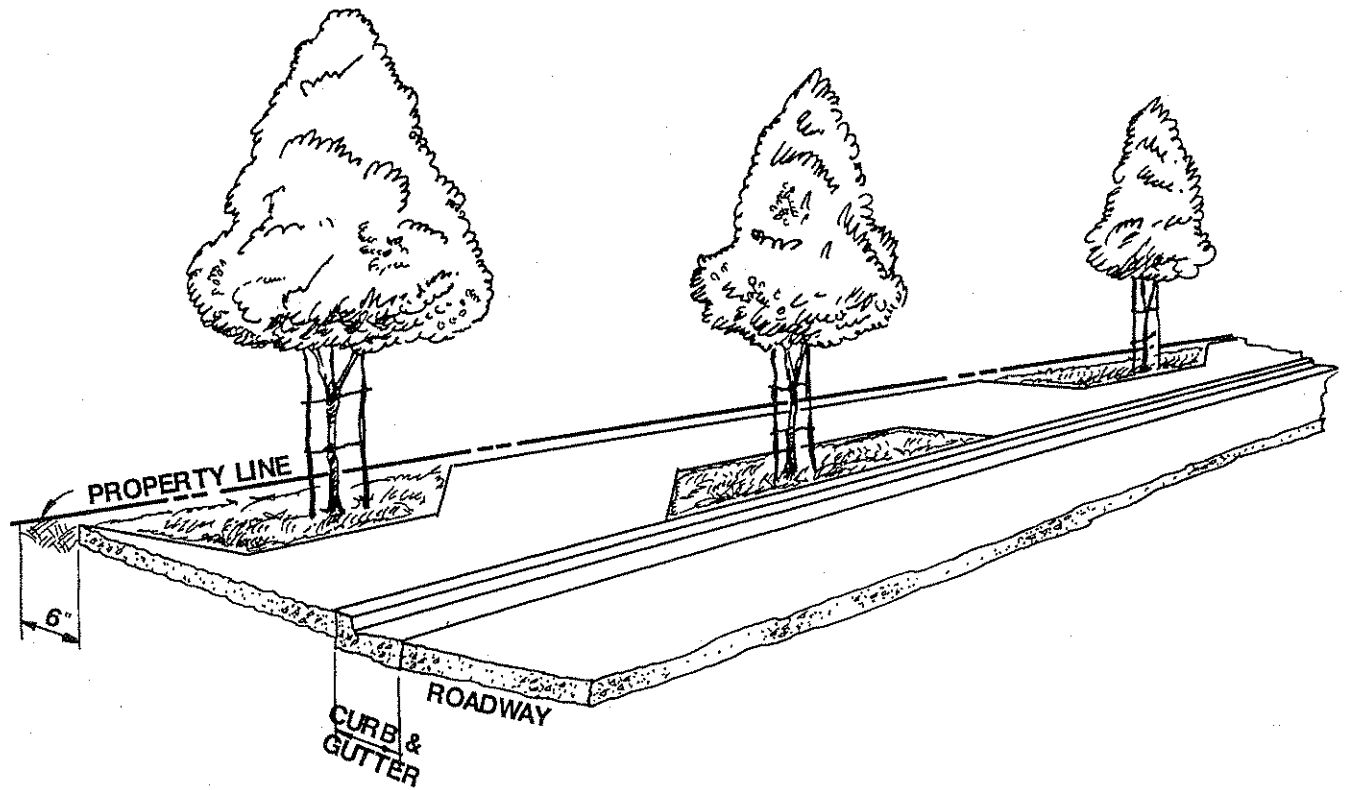
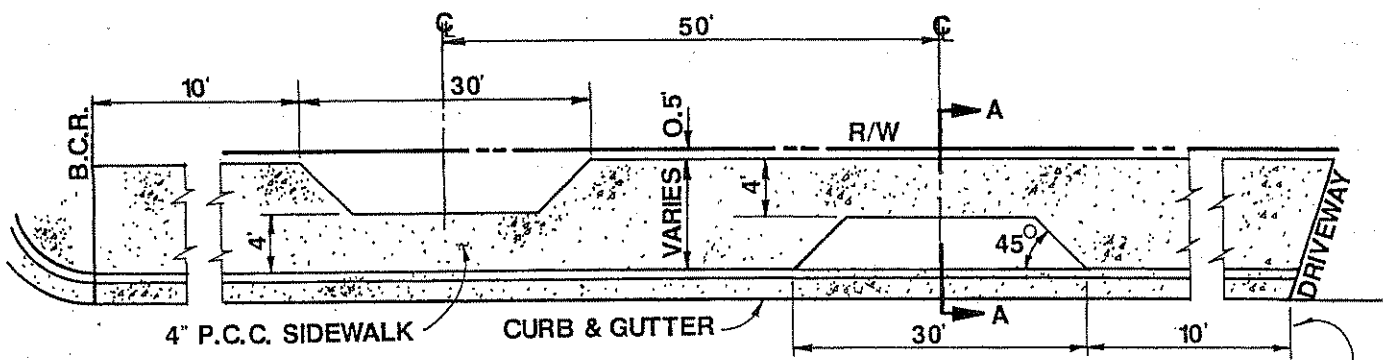
PLAN

BEGIN MEANDERING SIDEWALK
10' FROM EXISTING DRIVEWAY

- 1. SEE STANDARD DRAWING NO. 104 FOR BASE REQUIREMENTS UNDER SIDEWALK,
